STRUCTURAL REHABILITATION AND REAL TIME MONITORING OF THE “PONTE DELLE GRAZIE” BRIDGE IN FAENZA, ITALY

G. Corsi^{1,*}, F. Frediani¹, M. La Monica², M. Lapi³, L. Miccinesi³, M. Micheloni², M. Pieraccini³

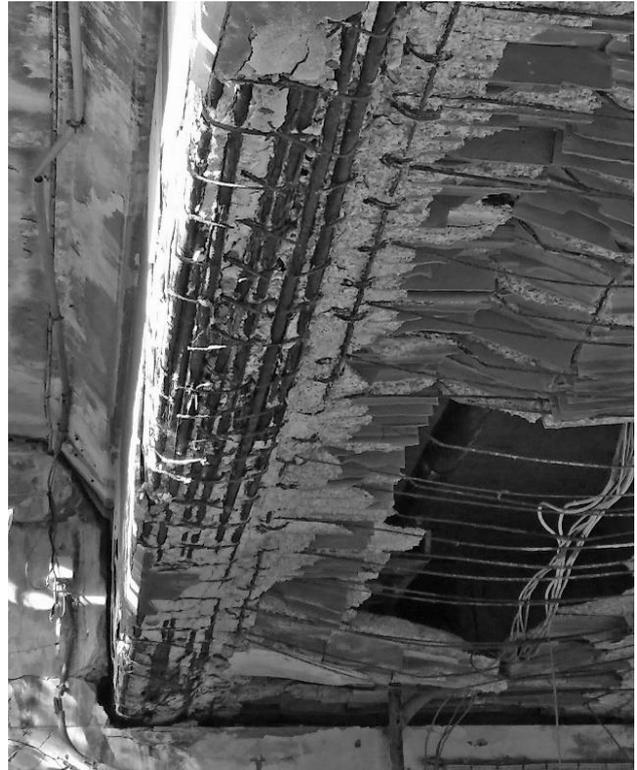
The main beams of the side spans presented a strong deterioration, especially near the abutment, as demonstrate by visual inspections and laboratory tests on materials.

Figure 5. Beams deterioration on the side span.

The dangerous state of the main beams in the area near to the abutments was evident. In fact not only the concrete is strongly damaged, but also the steel bars are deeply corroded and the stirrups are exploded.

The main beams of the side spans are repaired with a deep cleaning and restoration of concrete and reinforced with a wrapping of carbon fiber textiles.

- Deep cleaning of concrete surfaces with high pressure hydro-scarification (2000 bar)
- Reconstruction of the concrete section with a two-component thixotropic, fiber-reinforced cement mortar with low elastic modulus that is shrinkage compensated.
- Wrapping with carbon fiber textiles.

In the areas where the cognitive tests on the concrete had given the lowest results, a large quantity of deteriorated concrete was removed. In these points the 40cm wide beam has been reduced to only 18cm.

Inside the new part of concrete reconstruction, a steel net and some steel bars are placed to increase the reinforcement bar cross-section, that was lost due to corrosion.

After the reconstruction of the beam section a wrapping with carbon fiber textiles of 1000gr/sqm was necessary to satisfy the verification for the shear loads, in accordance with the CNR-DT code (CNR-DT 200R1/2013).

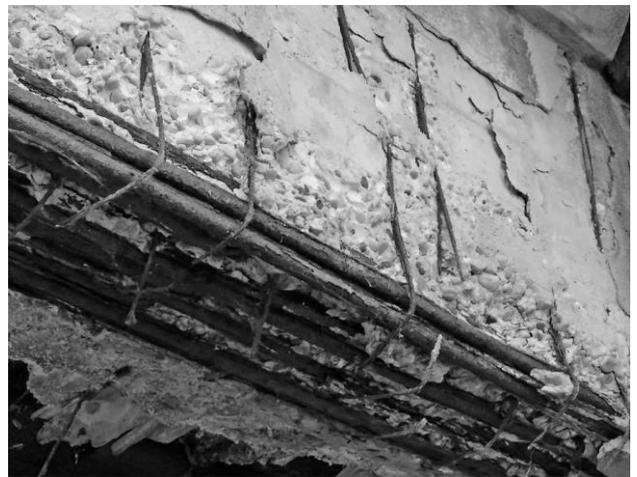
Figure 6. Beams deterioration on the side span.

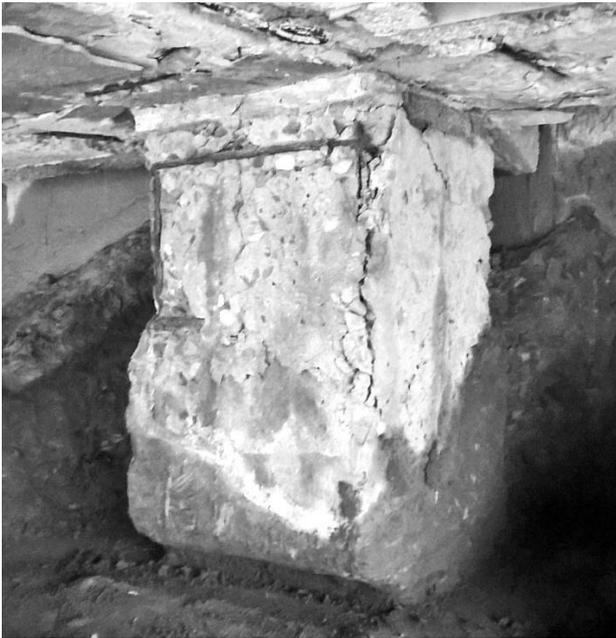
In detail this concrete bearings exhibit a strong degradation phenomena, with evident breaking lesions in place, as evidenced by the following images.

The dangerous state of the supports is evident and it has become necessary to take urgent action.

Figure 7. Deterioration and cracks on the concrete pendulum bearing.

The reinforced concrete pendulum bearings are repaired with a soft cleaning and restoration of concrete and reinforced with a wrapping of carbon fiber textiles. In this way the bearing strengthening is verified considering a reduced loading scheme.

For these reasons some steel columns are put in place as a structure of defense, that comes into operation only in case of collapse of the concrete bearings.
