# (REHABILITATING HERITAGE PLACES) STRUCTURAL REPAIRS AND CONSERVATION WORKS FOR ASTOR KOLKATA, INDIA

### 1.2 The Astor

### 1.3 Project & Objectives

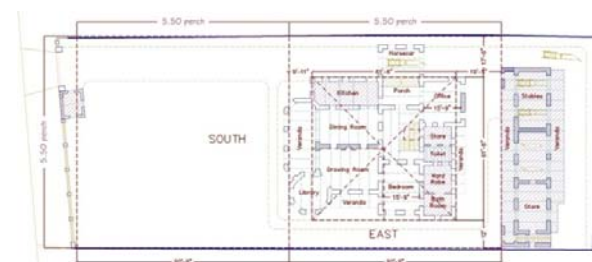
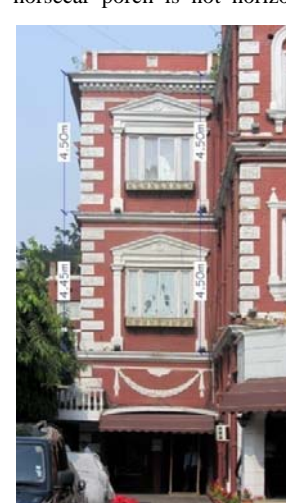
Evidence of vertical extension done in phases As in several other buildings of Kolkata's colonial period, the cornice of the horsecar porch is not horizontal. This could be because the

standardized strip foundations were the same everywhere but the more lightly loaded horsecar porch did not settle as much as the rest of the building during the initial settlement period. A few decades later, the first and second floor were added and remained horizontal, because the initial settlement had already taken place. Today, the non-parallel cornices are evidence of construction in phases, with long intervals in-between.

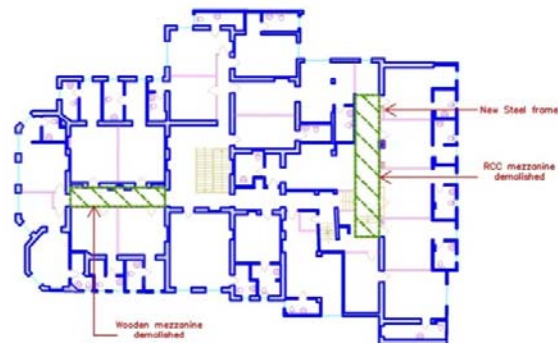
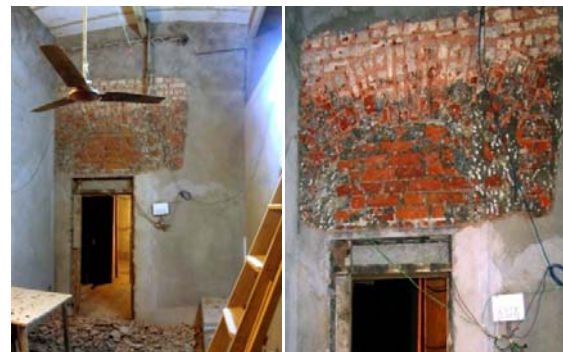
Most masonry arches relieving the door lintels can be seen even today after removing the plaster.

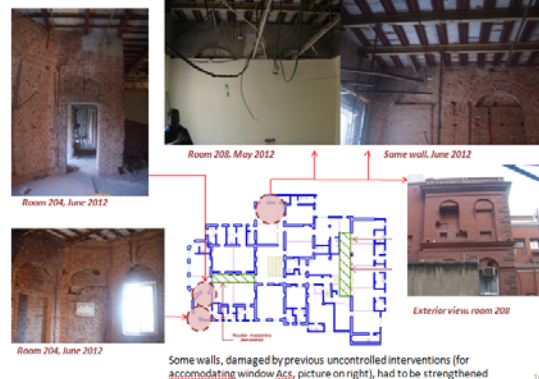
Some walls, damaged by previous uncontrolled interventions (for accommodating window Acs, picture on right), had to be strengthened

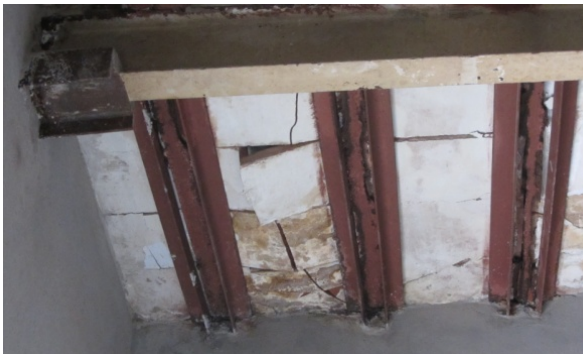
Oblique cracks seen above the false ceiling, old repair of roof "T-bars" already corroded, terra cotta tiles collapsing  
Investigations after removing the false ceiling:  
Many cracks caused by differential settlement (less than 1 inch-wide cracks), corrosion of the entire steel roof structure, lime concrete slab collapsing at some places.

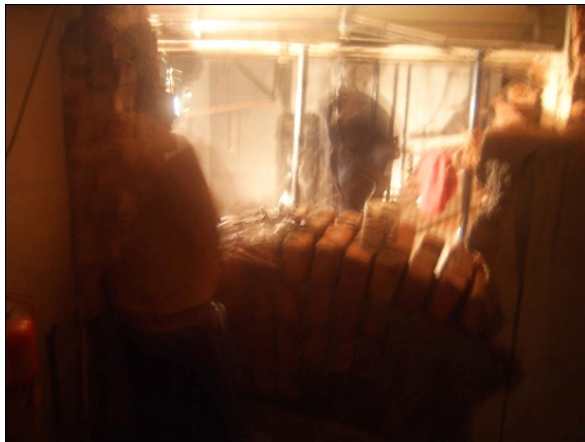
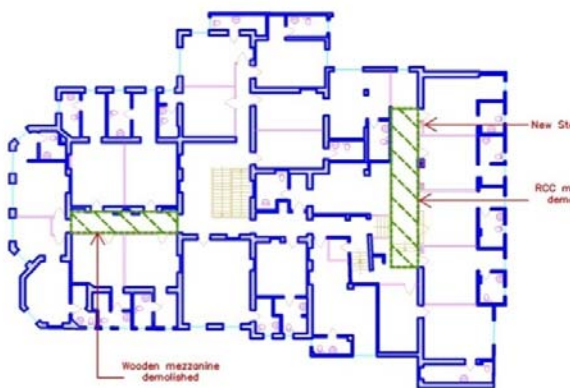
After demolishing the first floor wooden mezzanine that was unsafe because resting on 3''-thick brick partitions, we have restored the load-distribution capacity of the load-bearing shear wall by re-constructing the arch that had been demolished when the mezzanine was made in the 1960s.

Taking support from the existing inclined brick layers at the spring points of the ancient arch, we have avoided the disturbance that a steel beam would have necessitated for creating its supports in the heavily loaded adjacent masonry pillars.
