DIGITAL DOCUMENTATION OF FRANK LLOYD WRIGHT'S MASTERPIECE, FALLINGWATER

Pamela Jerome^a, Douglas Emilio^a

^a Architectural Preservation Studio, DPC, 740 Broadway, New York, NY 10003 USA (jeromep,
emiliod)@preservationstudio.com

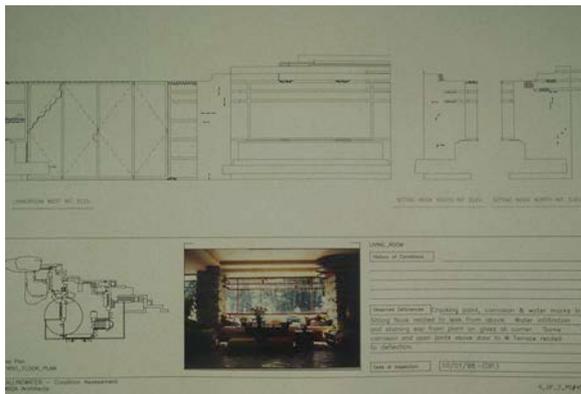
Once drafted, we then recorded all deficiencies. By 1999, we had developed a two-volume preservation master plan, which included 170 existing conditions drawings. These drawings were used to produce a graphically annotated conditions survey based on a legend developed to reflect typical conditions (Figure 1).

Figure 1. Page from the existing conditions survey (Wank Adams Slavin Associates, 1999)

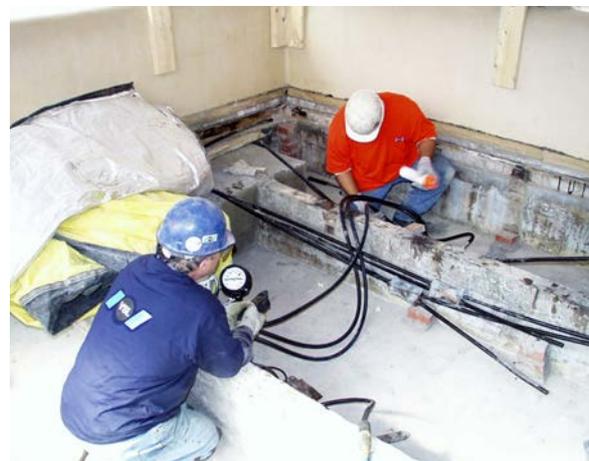
Robert Silman Associates, structural engineers, had monitored the creep of the cantilevers over the course of several years and had come to the conclusion that it was ongoing (Silman, 2000). The upturned cantilever beams of the living room along with those of its terraces were to be post-tensioned to halt this progressive creep, which had caused the cantilevers to deflect by as much as 7" (Figure 2). For the premiere space of the main house, the living room, this meant that the flagstone floor and built-in furniture had to be removed in order to access the tops of the cantilever beams and grout any cracks; this was done to prevent the post-tensioning from substantially lifting the living-room slab during structural reinforcement, thereby damaging the windows along the south end, which followed the sag of the cantilevers (Figure 3).

Figure 2. Post-tensioning cables being installed to structurally reinforce Fallingwater's sagging cantilevers; in this case they are being applied to concrete joists on one of the living-room terraces (courtesy of Robert Silman Associates, 2004)

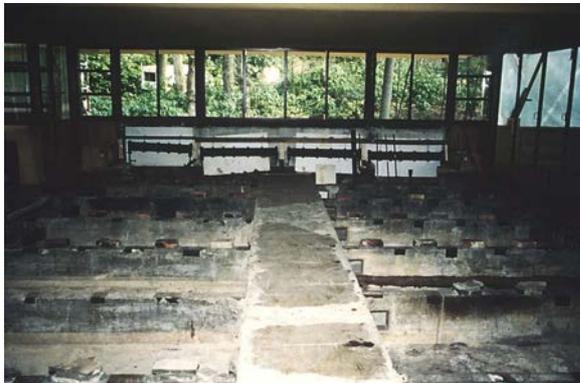
Figure 3. The gutted living room looking south at the windows (Wank Adams Slavin Associates, 2004)

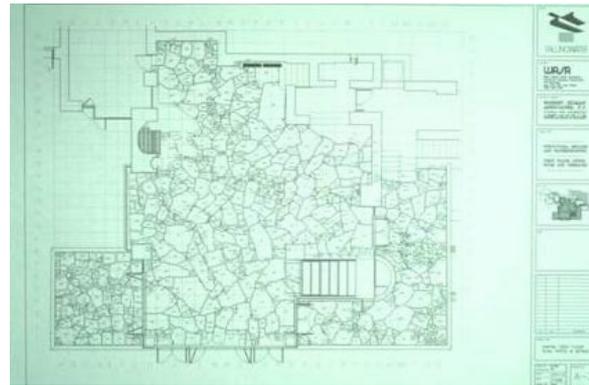
Figure 4. Documentation of the living-room flagstone floor and east and west living-room terraces (Wank Adams Slavin Associates, 2004)

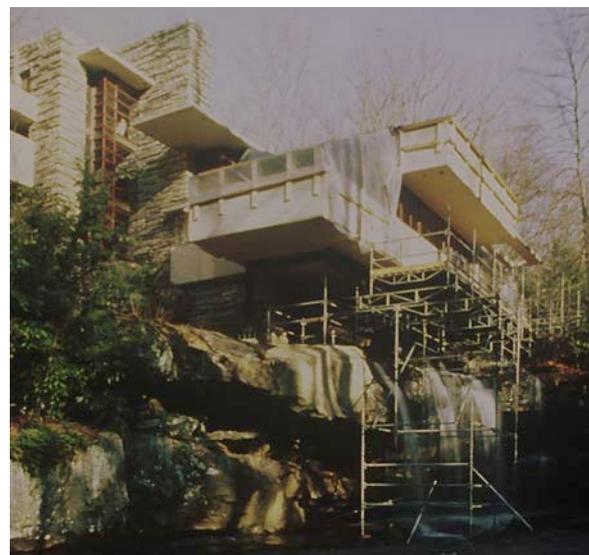
Figure 5. Fallingwater during Phase 3 of the restoration when the flagstones were lifted from the living room, its east and west terraces, and the master-bedroom terrace above (Wank Adams Slavin Associates, 2004)

With funding from Save America's Treasures and other sources, including the state of Pennsylvania, the \$13.5 million restoration was completed by 2005 (Figure 5). During this period, the complex never closed for visitation, with the exception of the annual winter closure. Even while the living-room cantilever beams were structurally post-tensioned, the building was open for hard-hat tours.
