CONSERVATION OF THE SINCLAIR INN MUSEUM, AND THE PAINTED ROOM ANNAPOLIS ROYAL, NOVA SCOTIA, CANADA

Ann Shaftel^a, John Ward^b

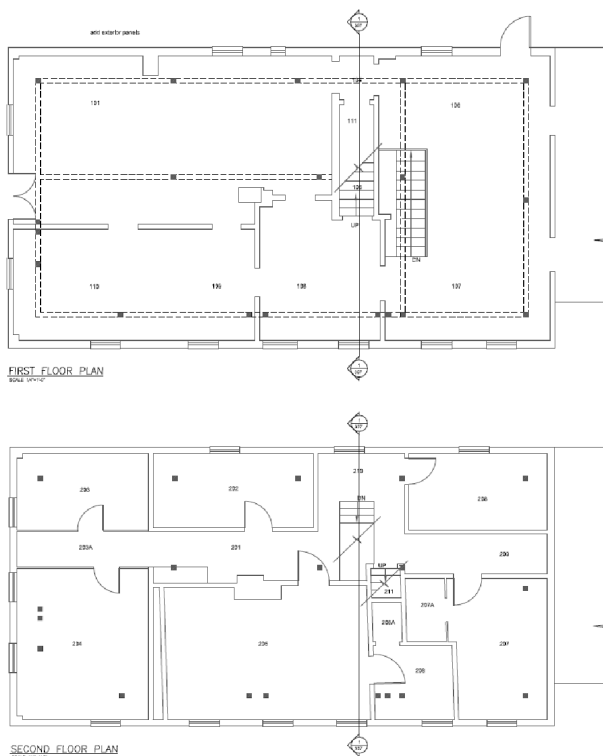
Figure 4: Sinclair Inn Museum Ground and Second Floor Plans showing reinforcing structural upgrades. Plans Prepared by Jost Architects Ltd.

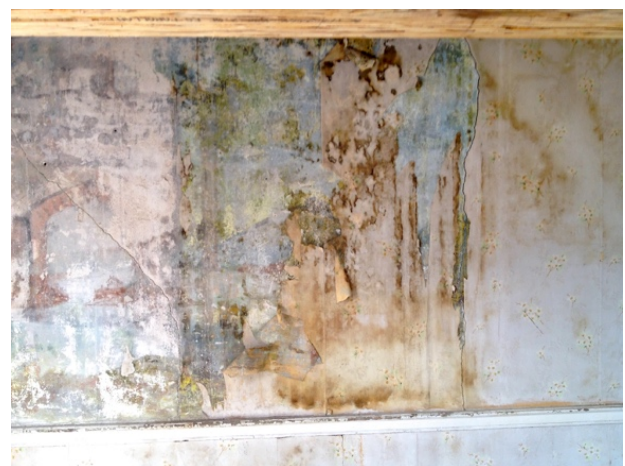
In c.2008, a roof leak on the north wall revealed the existence of a large wall mural hidden beneath layers of wallpaper. These wall paintings are the immediate subject of this paper.

Figure 5: North wall paintings and wallpaper after roof leak. Source: Ann Shaftel

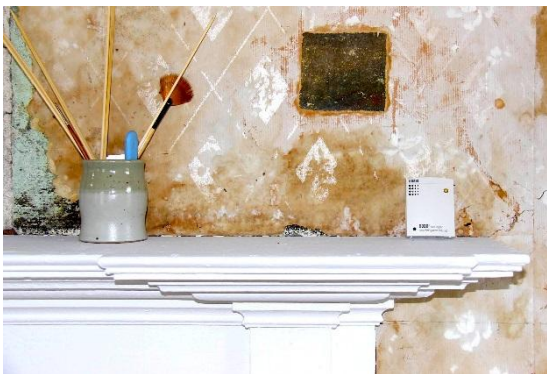
Figure 6: Conservator revealing the painting underneath the wallpaper above the fireplace. Source: Ann Shaftel

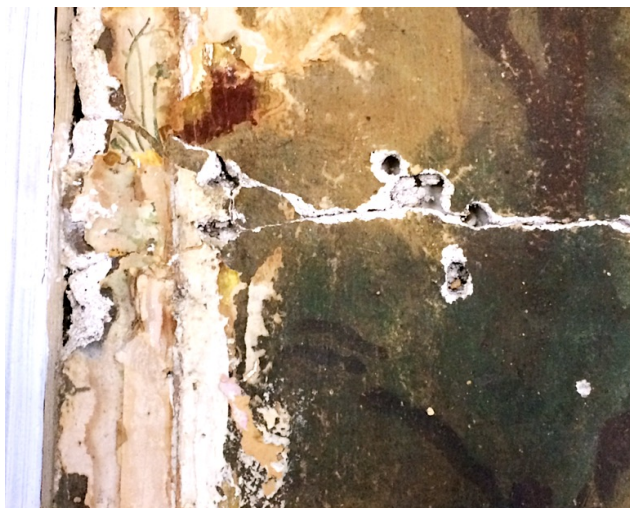
There are cracks and divots overall in the plaster of the walls that form the paintings' support, causing damage to the paint layers. This damage was present but hidden below the wallpaper layers, or had been exposed where the paper was removed by roof leaks or by construction. Past and more recent construction and painting also damaged the wall murals.

Fig 8: Documentation of condition. Source: Ann Shaftel

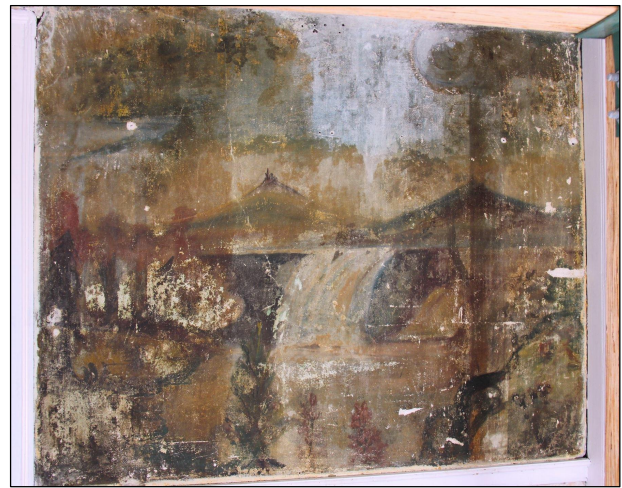
The condition of the paintings is also a result of the artists' painting technique. Investigations suggest that the wall murals were painted by different artists at two or more times, rather than by a master artist and apprentices painting at one time. On every wall, the conservator found several layers of painting on top of each other. As the binder and pigments changed over time, and as they became damaged, they may have become either translucent (?). For example, as shown below, a mountainous landscape is painted over the outline of a classical Greek style pillar with an ionic capital (left image, column to right hand side), and then another mountain is painted on top of the original mountain. Therefore, detailed documentation was essential.

Figure 9: South wall layers of paintings. Source: Ann Shaftel

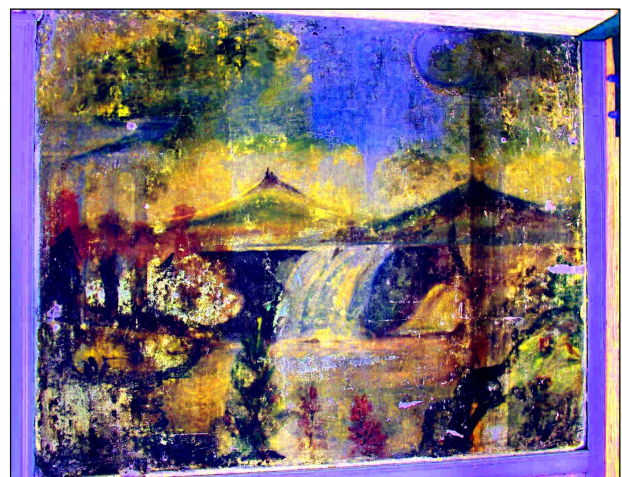
Figure 10: Post capture enhancement with iDStretch further reveals work of various artists. Source: Ann Shaftel
