DAMAGE CLASSIFICATION TO HISTORICAL WOODEN STRUCTURES: A PRELIMINARY SURVEY AND RECOMMENDATION FOR DONG MINORITY DRUM TOWERS

Shiruo Wang^{1*}

¹ School of Architecture, Soochow University, 215000, Suzhou, Jiangsu, China

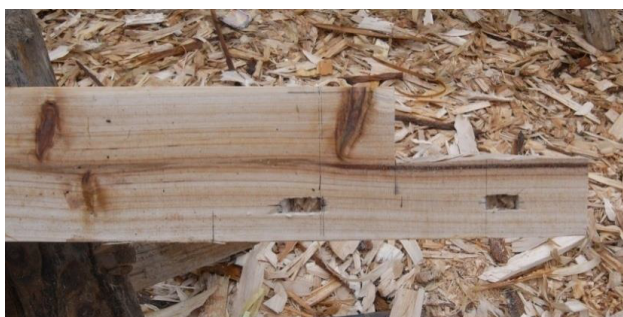
Defect implies wood features which can negatively influence strength and stiffness, and/or the general structural behaviour (e.g. the efficiency of joints) of timber members. Defects include knot and splitting, etc. Generally, knot is one of the defects that could provoke dangerous conditions, like slope of grain. However, knot is not considered as one of the defects in Drum Tower because of two reasons: firstly, their presence, extent and distribution have not been accounted for in terms of influence on strength, for instance based on some sort of visual grading approach. Secondly, local carpenters prefer to use the green wood with small knots (Figure 1), from their perspective, the more knots the timber has, the stiffer and better structural behavior it has. Apparently, the conclusion from their years long experience is totally opposite to the knowledge of timber engineering, which the knots would weaken the structural properties of wood. It is considered the prevalence of compressive and shear stresses could even take advantage of knots depend on the type of stress conditions.

Figure 1. Green wood with knots used as wooden component

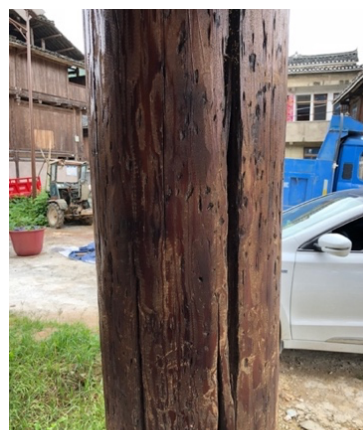
Shrinkage is a natural phenomenon in wood that can lead to splitting, it occurs because wood is a hygroscopic and anisotropic material, so the moisture content of wood changes in response to daily and seasonal changes in the relative humidity. When the air is humid, wood absorbs moisture and swells; when the air is dry, wood loses moisture and shrinks (Figure 2). Splitting can occur in longitudinal, radial, and tangential directions. They are very different in the three directions, and less important in the longitudinal direction. Splitting occur in Drum Towers distributed on the upper and lower surfaces of joint where connection between tie-beam and column is present, and expand along the depth direction (Figure 3). Splitting could cause a reduction of resistance and can pose serious risks to the whole structural frame.

Figure 2. Splitting on column

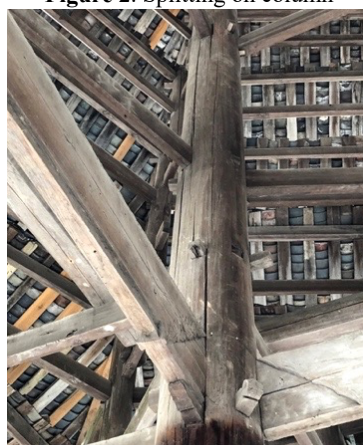
Figure 3. Splitting along the connection of column and tie-beams.

It is found that there were a lot of splits are along the direction of wood fibre on the main columns and short columns of the Drum Tower. The splits distribute on the upper and lower surfaces of joint where connection between tie-beam and column, and expand along the depth direction. The splits s could be caused by the combination of shrinkage and the load of the upper frame.

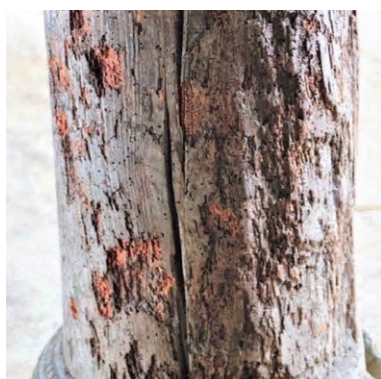
2.3.1 Insect attacks: The timber elements of Drum Towers are sometimes attacked by various types of wood-boring insects. Many of the most destructive saprophyte insects are beetles (Coleoptera, such as *Anobium punctatum* and *Hylotrupes bajulus*). These beetles use the wood as food and abode, boring complicated cavities inside the timber, reducing the bearing strength (Figure 4). The second most destructive is the wood wasp (Imenoptera), which causes less severe damage than the beetles. The wasps generally create a hole as a nest in the surface of the timber but do not live in the wood, the hole usually is not deep and could approximately contain one wasp (Figure 5). Termites (Isoptera Order) are extremely serious insect pests that affect timber, causing serious damage inside the wood that is barely visible from the outside (Figure 6). Wood decay caused by insects can lead to progressive loss of mass, resistance to load, and hardness, as well as weakened bearing sections.

Figure 4. Column attacked by beetles

According to visual inspection and drilling testing, the insect attack grade of wood components is classified by five levels, "0" indicates no insect attacks, "1" indicates trace insect attacks, "2" indicates light insect attacks, "3" indicates minor insect attacks, "4" indicates severe insect attacks. The corresponding rot condition seen Table 1.

Firstly, to address the risk of beetle attacks: Apply transparent and uncolored preservative, which is brushed on to wooden elements for a better result; a double layer of preservatives should be applied using different techniques. Chemical treatment must be employed only if the attacks are active or it is determined that future attacks are probable after an in-deep survey.

Spray a preservative product within the building to create a fumigation fog. Fogs are particularly indicated where large or inaccessible places must be treated, such as the upper space in the Drum Tower, which is may be inaccessible if additional scaffolding or ladders are lacking. And smoke production in the Drum Tower have also contributed to prevent insects at some extend.

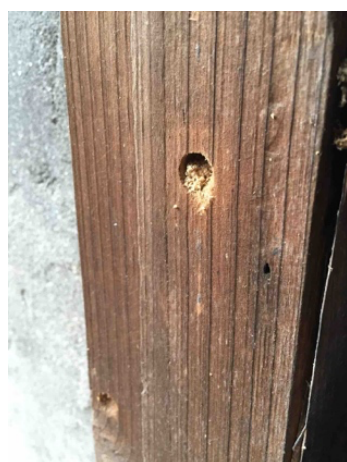
Figure 5. Timber attacked by wasps

Secondly, the risk of wasp attacks must be addressed. Wasps create holes in the timber as a nest for laying eggs. Compared with other insect attacks, generally, the wasp attacks produce less damage. All the existing holes should be sealed with natural beeswax after monitoring the timber surface. If sealing is not effective against the wasp attacks, the applications for dealing with beetle attacks could be also applied.

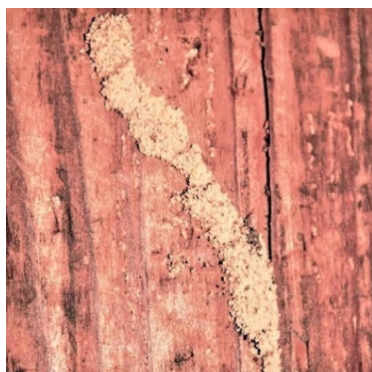
Figure 6. Timber attacked by termites

According to the survey investigation, the main insect pests are beetles, of which *Anobium punctatum* and *Hylotrupes bajulus* are common in the Dong area. Termites were rarely found in Dong Drum Towers during the investigation. However, termite prevention activities should also be conducted.

Thirdly, the risk of termite attacks. The previous treatment with preservatives could also be effective against termites but may not be sufficient. The key method used to prevent termite attacks is to destroy the termites' community as much and as soon as

possible. If the survey finds signs of termite attacks, electronic termite detector diagnostics could be employed by experts.

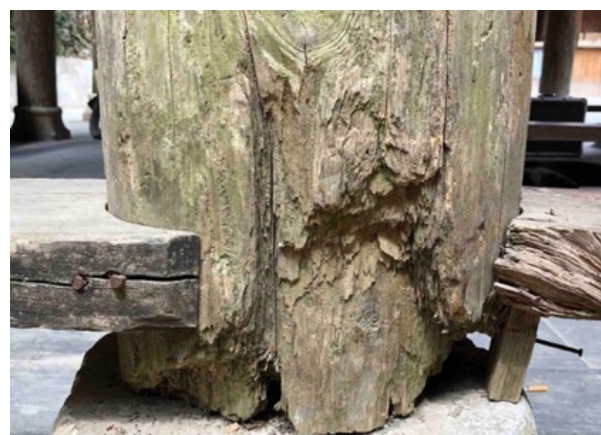
2.3.2 Fungi attacks: Rot is usually caused by the fungi attacks. Most of the fungi have a fine network of "roots" (hyphae) that extensively extend within the substrate and grow together and result in a visible loss of mass, resistance to load, and hardness, as well as changes in color and appearance of the wood. Fungi are present only with humidity in wood of more than 18%–20%. For Dong Drum Towers, there are two problems: the first main problem is absorption of water from the ground through capillary action (the conductive cells in wood), especially in the column without a platform that is directly in contact with the soil (Figure 7). Another problem is the risk of infiltration due to poor or absent tile maintenance (Figure 8).

According to visual inspection and drilling testing, the rot grade of wood components on enveloping layer is classified by five levels, "0" indicates no rot, "1" indicates trace rot, "2" indicates light rot, "3" indicates minor rot, "4" indicates severe rot. The corresponding rot condition seen Table 2.

Figure 7. Rot in the bottom of column

3.3.2 Control fungi risks: Rot is generally confined to areas where the moisture content in the timber has remained high. Therefore, identifying the origin of the dampness, stopping the entrance of moisture, and Maintaining Dryness are required. For columns supported on a platform, the platform should be maintained in good condition avoiding the absorption of water from the soil. If the platform is in good conditions, regular checks of it are needed. If it is in poor conditions, with the column already decayed, then preservative treatment should be applied. For columns without a platform, adding a new platform under the column is not recommended. Preservative treatment should be applied on the foot of columns to avoid the absorption of water from the soil.

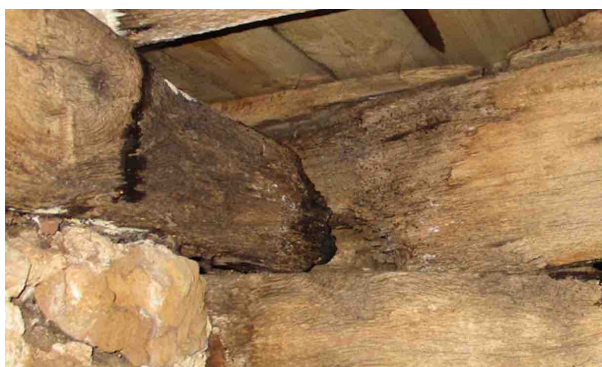
Figure 8. Rot on the top of column

Due to the infiltration risk caused by rain, periodic maintenance of the roof tiles is greatly needed. Weeds or other plants should be entirely and regularly removed. Any applied chemical treatment should be safe for people using the Drum Tower as well as for the roof tiles or wooden components. The roof tiles should be cleaned regularly and checked for leaks. Any problems should be repaired from the roof to the column. If the cause of damage due to absorption and infiltration is addressed, no further interventions are required beyond maintaining the good condition and periodic surveys.

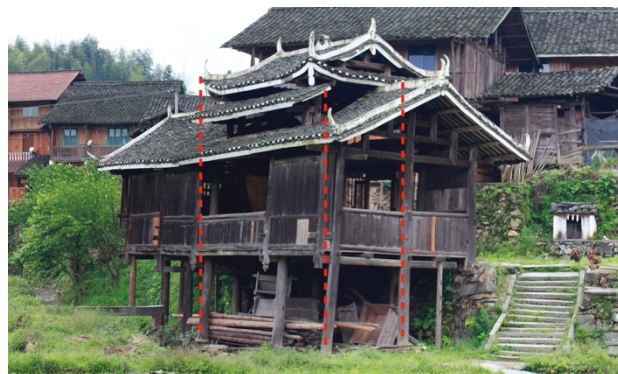
Tai-liang typology always applies a wooden frame with three or five main columns, the repeating and wooden frame extends horizontally to create an expanding interior space. This type of framework has excellent in-plane stability, but the number of out-of-plane columns is relatively small, and usually consists of a small number of horizontal tie-beams. Therefore, this kind of typology would possibly cause a horizontal overall tilt (Figure 9).

Figure 9. Overall tilt of a typical Tai-liang Drum Tower

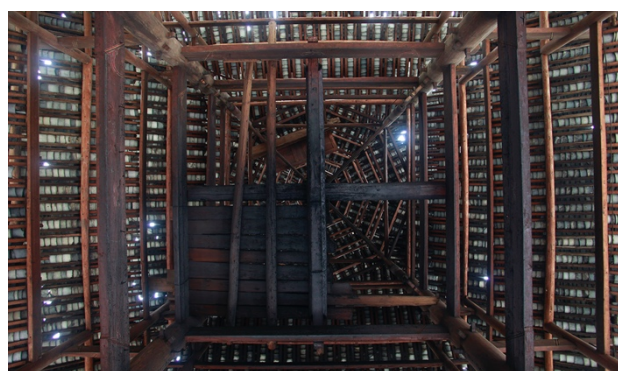
Despite Chuan-dou Drum Tower has different roof morphology because of the structural configuration, they share a repeating wooden frame that consists of tie-beams and short columns. The structure has a strong stability. However, Chuan-dou Drum Tower usually has 5 to 9 stories, which suggest the load of upper frame is transferred to the main load-bearing elements of lower frame, that is the main columns and cross beams (Figure 10). Therefore, usually carpenters apply thicker main tie-beams and columns in Drum Tower.

Figure 10. Timber frame of a typical Chuan-dou Drum Tower

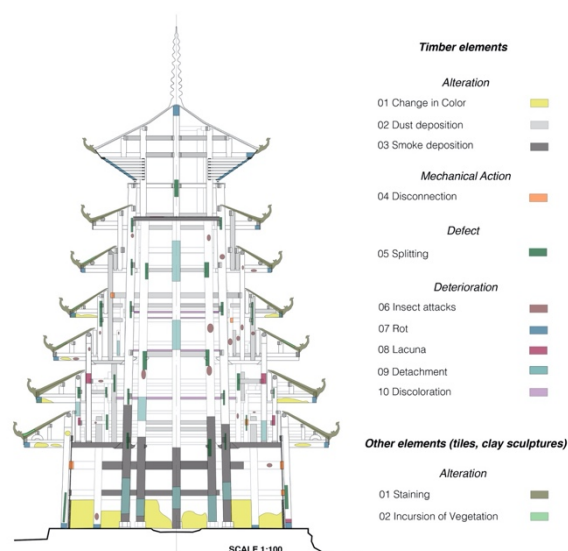
The problems in Zengying Drum Tower occurred in wooden elements (Table.3). Modifications are mapped in one of the representative sections (Figure 13), which reflect the distribution of the analysed features.

Figure 12. Distribution of damage in representative section of Zengying Drum Tower

Although Zengying Drum Tower has listed as a historical building protected at provincial level, the conservation and maintenance condition still remain negatively. Zengying Drum Tower encompasses alteration, defect, deterioration and mechanical failure, in which the problem of mechanical failure provoke less instability to wooden structure. Deterioration in Zengying Drum Tower address the primary risks that require proper intervention and maintenance. Insect attacks and rot has caused 2-3 decay grade to the wooden components. Therefore, a preliminary recommendation should be conducted foremost to the insect and fungi risks.
