INSAR-BASED INVESTIGATION OF SURFACE DISPLACEMENT OVER THE AREA OF THE COLLAPSED BUILDINGS IN ISTANBUL

Nusret Demir^{1,2}, Ufuk Yazgan³

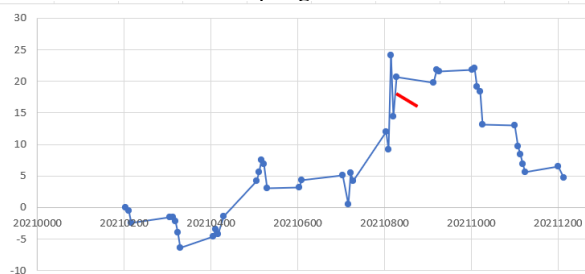
Figure 3. Surface displacement in mm where the collapsed building stands, the redline indicates the date of collapsing 24.08.2021

A maximum uplift is depicted in Figure 3 closer to the event's collapse date. The structure collapses shortly after the rising achieves its peak value.

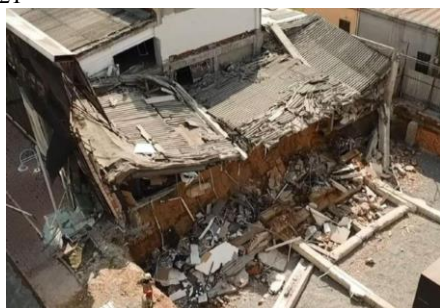
Due to the failure of the retaining wall of the building on the side, the one-story furniture store at Masko Mobilyacilar Sitesi in Ikitelli, Istanbul, collapsed (Web-2). The incident took place on August 23, 2021.

Figure 4. A picture of the collapsed building (source: DHA, from evrensel.net)

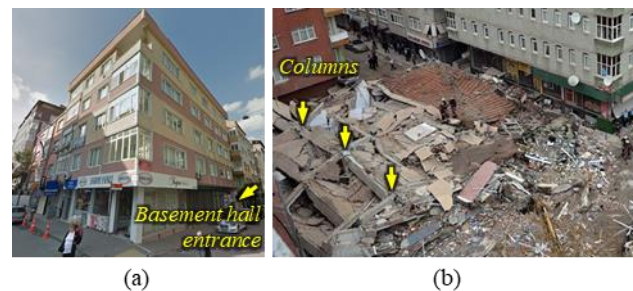
Here, we analysed one building which had been collapsed on September 22, 2016 in Bagcilar-Istanbul. The building was a 5-story reinforced concrete frame building (Figure 5a). Dimensions of the building plan area were 21×15 m². It was built sometime within the time period from 1980 to 2000 during which many structurally deficient buildings were constructed in Istanbul due to lack of proper seismic design code enforcement. Failure mechanism that was observed after the collapse indicated that building had weak columns and stiff beams which is a typical structural deficiency in substandard buildings (Figure 5b). Moreover, it is seen from the post-collapse photo that the beams along the southern axes of the building spanned in between the 3 columns. As a result, the beams had lengths in the order of 8~9 m which indicates that the axial load ratios in the columns were quite high. Besides the building also had a wedding hall in the basement. Such large open spaces also has the potential for rendering the building unsafe when the material quality is poor and the workmanship is inadequate.

Figure 5. Investigated building: (a) before collapse and, (b) after collapse (Modified from Google, 2022; IHA, 2016)

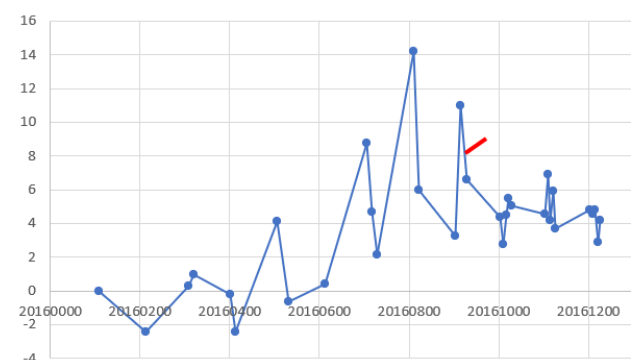
Figure 6. Surface displacement in mm, where there is the collapsed building, the redline indicates the date of collapsing.

Figure 6 demonstrates how the surface acted most uplifted over the year prior to the collapse.

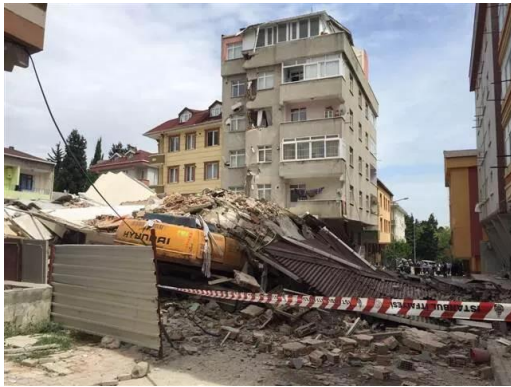
Due to the threat of collapsing, a building on Istanbul's Bahçelievler Kocasinan Mahallesi Nurlu Street has already been totally evacuated. The evacuated building eventually collapsed on May 21, 2016. Despite claims that the nearby foundation

excavation caused the building's destruction, a total of seven nearby structures were evacuated (Web-3).

Figure 7. The collapsed building (Web-3)

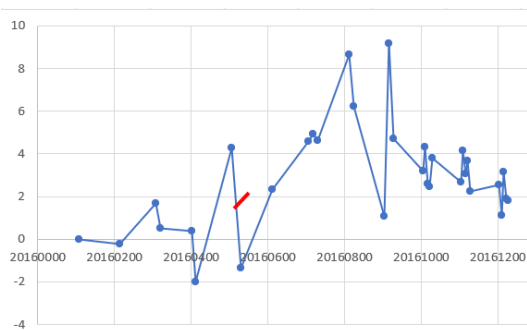
Figure 8. Surface displacement in mm, where there is the collapsed building, the redline indicates the date of collapsing.

The surface displacement relative to the January 1st is shown in Figure. Here, we see again a high uplift surface displacement before the collapsing event.

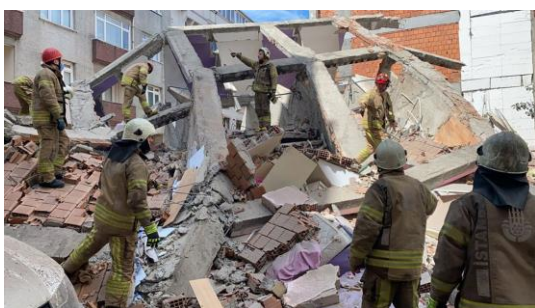
This building was located in Zeytinburnu Sümer Neighborhood. The 5-storey building had been evacuated already because its windows exploded and crackling sounds were heard one day before as stated in the newspaper Hurriyet (Web-4). The Figure 9 shows the collapsed state.

Figure 9. The collapsed building (Web-4)

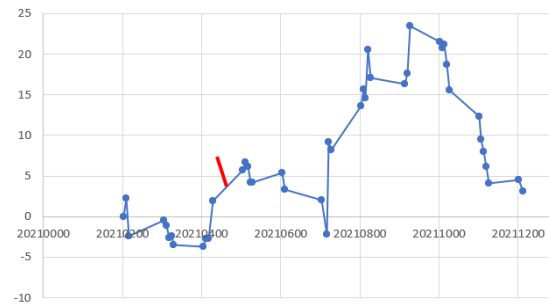
The graphic depicts an upward movement trend on the surface that reached a height of around 12 cm before the event collapsed.

Figure 10. Surface displacement in mm, where there is the collapsed building, the redline indicates the date of collapsing.

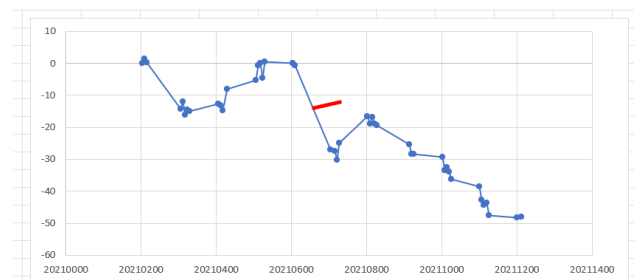
Figure 11. Surface displacement in mm, where there is the collapsed building, the redline indicates the date of collapsing.

This building shows considerable subsidence shortly prior to the incident that caused it to collapse. Subsidence occurs when the surface displacement rises in the same direction. At the conclusion of the year, the overall subsidence was around 5 cm.

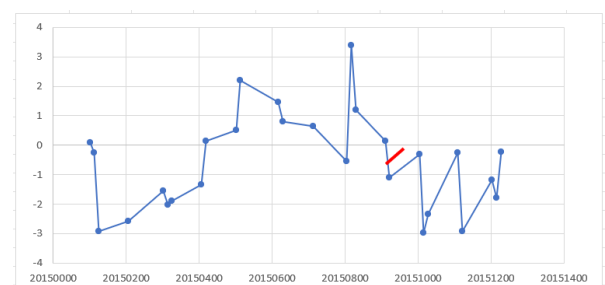
A 4-storey building on Üsküdar Halk Caddesi was destroyed as a result of the collapse in the construction area behind it, according to the newspaper Cumhuriyet (Web-5) The surface displacement graph demonstrates the subsidence (Figure 12) that occurs before to collapse, as was also highlighted in the news article.

Figure 12. Surface displacement in mm, where there is the collapsed building, the redline indicates the date of collapsing

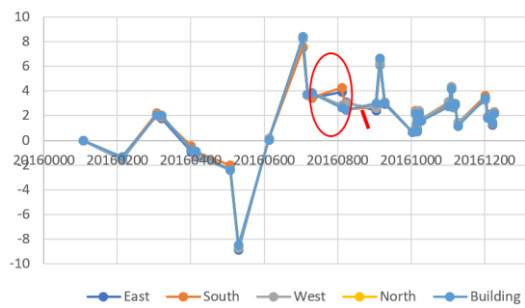
The collapse of building 1 had actually occurred on August 24th, 2021. With the exception of the time of observation immediately before the collapse, the grid containing the building in Figure behaves almost exactly like its neighbours. The building's grid reveals a subsidence in comparison to the neighbours (Figure 13).

Figure 13. The displacement plots of the building 1 with its neighbours.

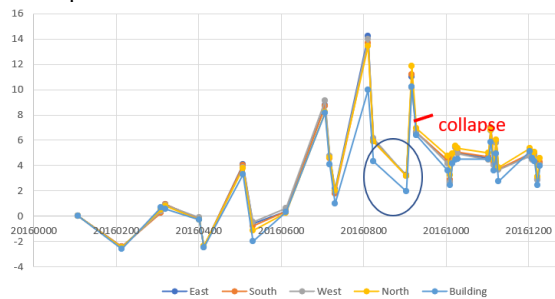
The circled area in Figure 14 represents building 2, which has subsidence movement once more compared to its neighbors before the collapse event.

Figure 14. Displacement on Building 2 location, and its neighbours.

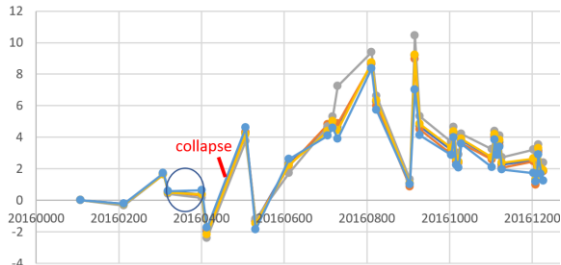
Focusing on building 3 reveals a slight variation in movement for the building's grid, once more in the direction of subsidence in Figure 15.

Figure 15. Displacement on Building 3 location, and its neighbours.

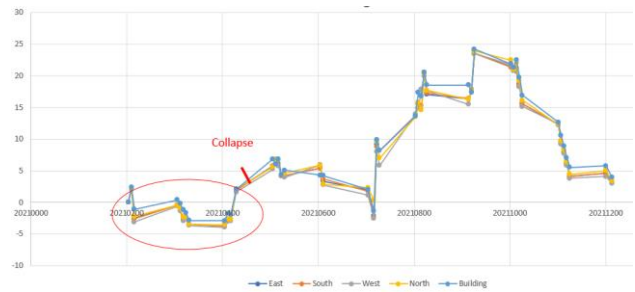
Figure 16. Displacement on Building 4 location, and its neighbours.

Figure 16 shows all neighboring grids have the same surface displacement except the one that has the building.

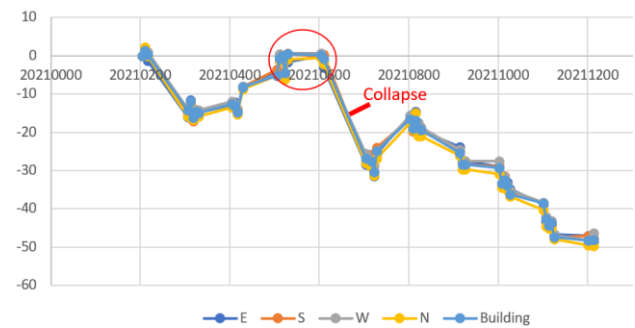
Figure 17. Displacement on Building 5 location, and its neighbours.

The plot (Fig. 17) of the Building 5 does not differ among the neighbors and with the grid with collapsing. Only a minor relative change is shown just before the collapse of the building. The relative difference between the building grid and neighbors reach ca 2 mm in this period.

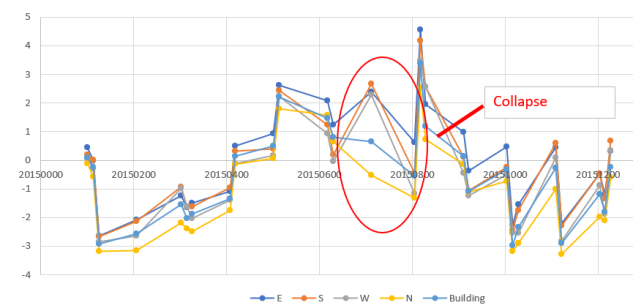
Figure 18. Displacement on Building 6 location, and its neighbours.

The collapse of building 6 took place on September 16, 2015. The plot makes it abundantly clear that the timeline just prior to the event differs noticeably from the other neighboring grids in a way that is not depicted in other timelines.
