IDENTIFICATION AND CHARACTERIZATION OF THE FOYER OF THE NATIONAL THEATER OF COSTA RICA AS PART OF THE METHODOLOGICAL STRATEGY FOR THE THREE-DIMENSIONAL MODELING OF THE FUTURE DIGITAL TWIN

I. Hernández-Salazar¹, J.P. Bulgarelli-Bolaños¹

¹ Instituto Tecnológico de Costa Rica, Escuela de Arquitectura y Urbanismo, Campus Tecnológico Local San José, San José, Costa Rica - (ihernandez, jpbulgarelli) @itcr.ac.cr

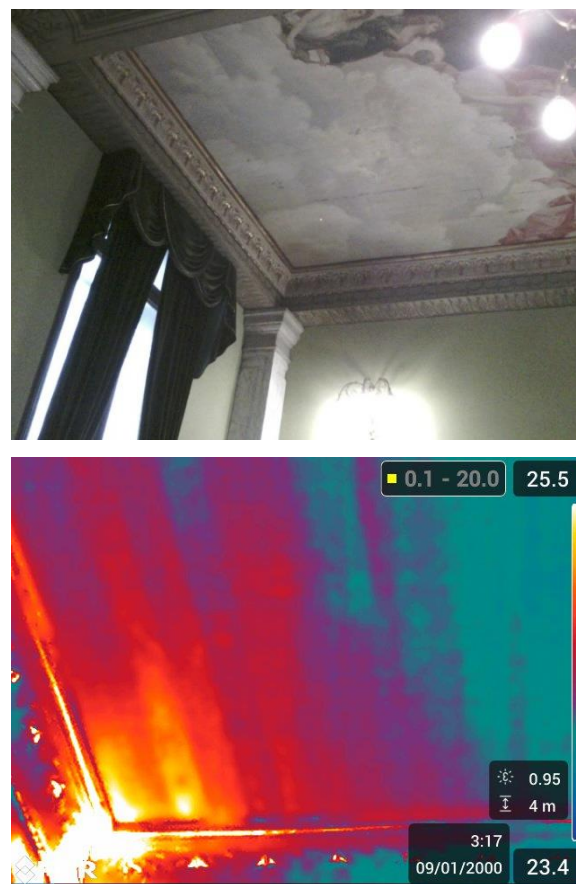
Despite the difficulties in identifying the pieces, images were obtained in the "*Salón de las Musas*". The thermographic photographs showed the type of support used for the paintings, which consisted of wide wooden planks on which the canvases with the paintings were placed. In addition, it was possible to know the direction in which they were placed and to evidence the presence of some humidity in areas of the ceiling and cornices (see Figure 8).

Figure 8. Photographs taken by thermographic camera of the sky in the "*Salón de Musas*", in the first body of the TNCR.

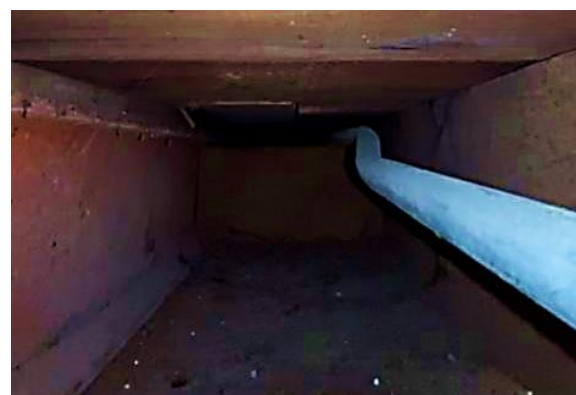
On the other hand, from the electrical registers located in the Foyer, it was possible to appreciate the joists that make up the mezzanine, as well as the wooden chain on top of them. These are W-type steel joists with a depth of 0.185 m and a width of 0.127 m, while the chain plates are made of wood and have a dimension of 0.045 m by 0.045 m. In addition, from the endoscopic camera observation, the presence of wooden joists located between the steel joists was detected. These elements have a dimension of 0.23 m in height by 0.045 m in width and are separated from the steel joists by approximately 0.30 m to 0.35 m. Finally, transverse timber chains were observed, perpendicular to the metal joists, which presumably serve to stiffen the structure (see Figure 9).

Figure 9. Photograph taken by endoscopic camera of the mezzanine of the first body of the TNCR.

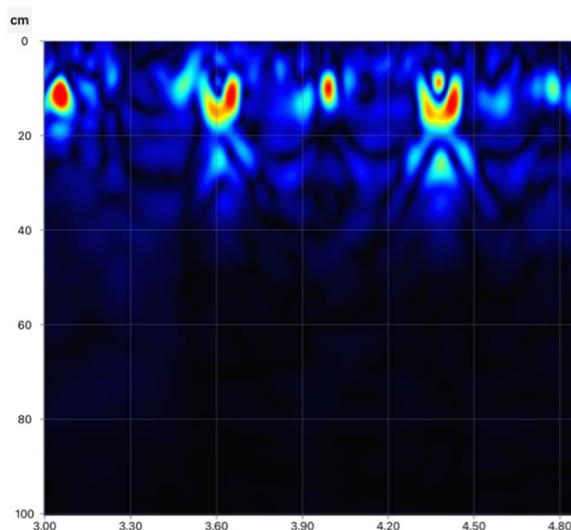
Figure 10. Partial result of GPR test in the TNCR Foyer, November 30, 2022.

The image shows two types of elements, the one that is seen with greater intensity is shown in the form of a "V", in red and orange colors, this is interpreted as the steel joist for being the densest, being the chain on it the one that causes the distortion in the image. The second element, much fainter, is observed as a vertical object, red or yellow in color and is interpreted as the wooden joist. The location identified on the y-axis of the longitudinal linear GPR test is corroborated with the metal and

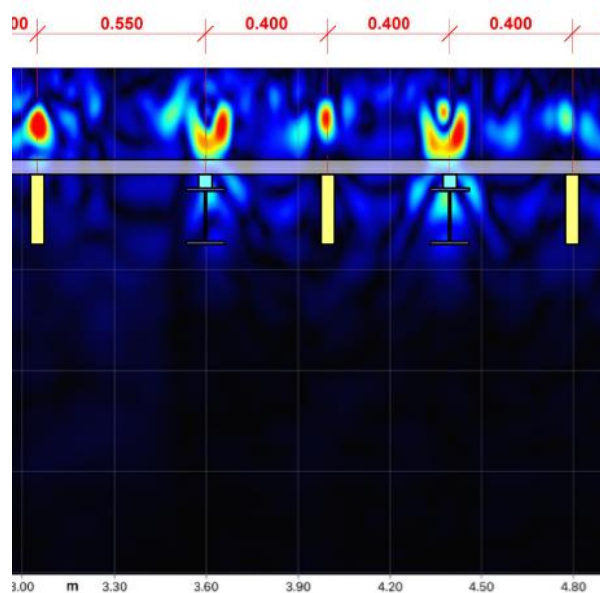
wood joists that are possible to observe through the electrical records of the Foyer. As a result of this technique, it was possible to accurately locate the steel and wood joists that make up the mezzanine of the TNCR Great Hall (see Figure 11).

Figure 11 9. Location of steel and wood joists, according to the results of the second longitudinal linear GPR test in the TNCR Foyer, November 30, 2022.

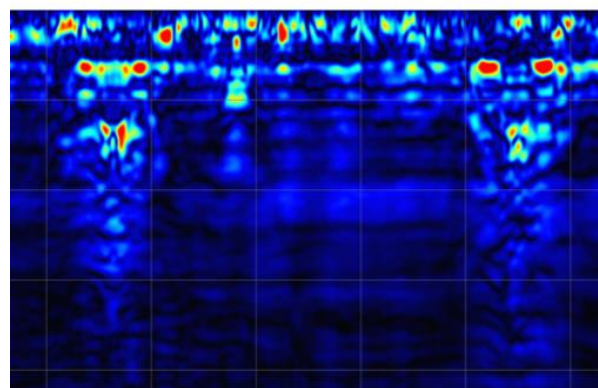
The third test was also linear, but in a transverse direction to the Foyer; that is, from east to west. It was carried out in the south block over the "Salón de las Musas". In this test, elements can be seen that are interpreted as W-type beams below the longitudinal joists, which coincide with the axes of the columns of the Main Foyer, as analyzed on site and as shown in Figure 12.

Figure 12 10. Partial result of the third linear cross-sectional GPR trial in the TNCR Foyer, November 30, 2022.

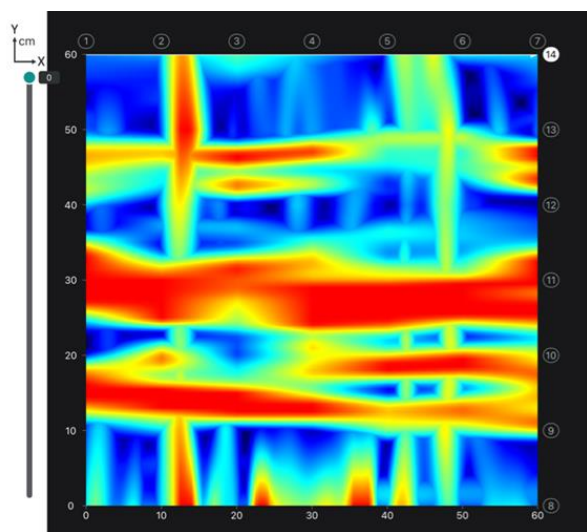
However, as shown in Figure 13, it was possible to verify the existence of a structural framework. It remained to be determined which elements represented each of the figures present in the image produced by the equipment.

Figure 1311. Result of the area test in the TNCR Foyer, on the column of the Main Lobby, November 30, 2022.

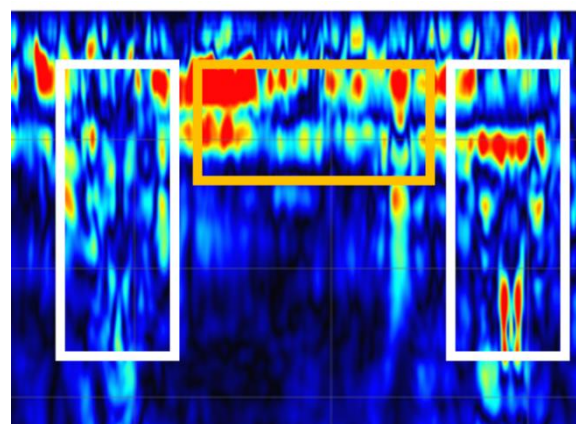
From the first four tests we can confirm the existence of two sets of double longitudinal beams and some other detections in the center (between each pair of beams) that, according to (Calvo-Navarro, L., personal communication, March 17, 2023) it is not possible to determine if it is an element at the same depth of the beams or if it corresponds to a reflection of some upper element that leaves a deeper signal (see Figure 14). In addition, the separation distance between the longitudinal beams in the north-south direction of the central section of the

Foyer block is smaller than that of the longitudinal beams located in the north and south sections. The longitudinal beams in the central section are spaced approximately 0.28 m apart and occupy a transverse spacing of approximately 0.54 m (being the same as the transverse beams of this section), while, in the north and south sections, the longitudinal beams are spaced approximately 0.40 m apart, occupying a transverse spacing of approximately 0.66 m.

Figure 1412. Resultado parcial de los primeros cuatro ensayos lineales transversales GPR en el Foyer del TNCR, del 16 de marzo, 2023.

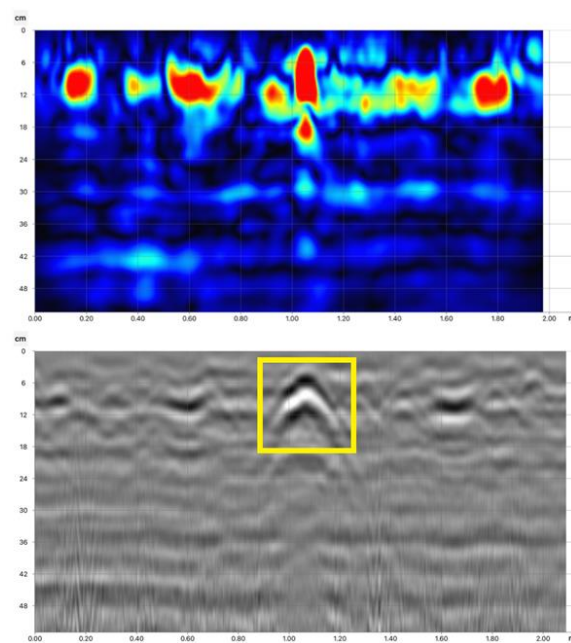
Figure 1513. Result of a linear and radargram test, carried out to the north of the sculpture of the Angel of Victory, located in the Foyer of the TNCR.

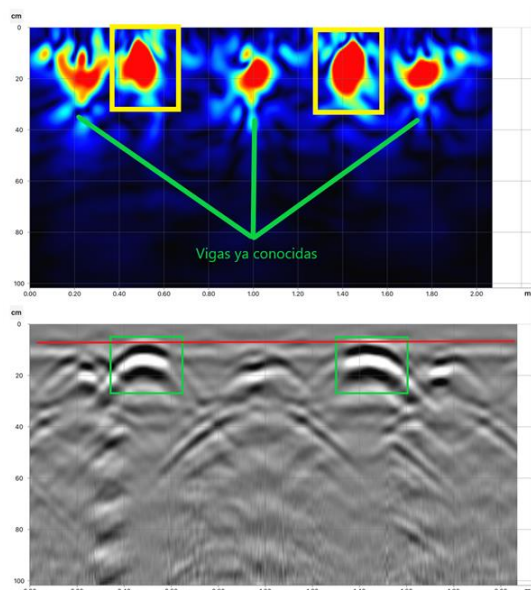
With respect to the tests made on the base of the sculpture "Angel of Victory" that corresponds to the central section of the Foyer block (first rectangle) adjacent to the east wall, (Calvo-Navarro, L., personal communication, March 17, 2023) points out that the images show a concave mark that agrees with the possibility of a metal reinforcement to the north (see Figure 15) and south of the base of the sculpture. On the other hand, to the east (back) and west (front) the already known beams are identified and two additional marks are visualized that could coincide with a metallic reinforcement for the installation of the sculpture. Even the

radargram seems to show them at a slightly higher level than the previously known beams (see Figure 16).

Figure 16 14. Result of linear test and radargram, performed to the west (front) of the sculpture "Angel of Victory", located in the Foyer of the TNCR.

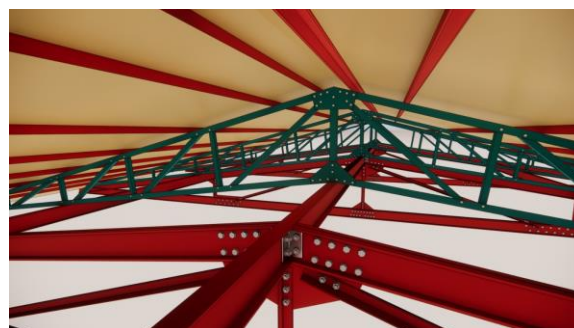
Based on the characteristics of the structural elements present as captured by the point cloud, as well as by the identification of these in the different documents reviewed during the documentary research, it is possible to generate a characterization in the three-dimensional model, identifying the "original" roof elements, i.e. those that correspond to the construction period of the building (prior to 1897) and those that are the product of later interventions, either the one carried out in the 1940s or at the end of the 1990s. As can be seen in Figure 17, the original roof of the Foyer comprises two types of trusses, the first represented with red in the model, corresponds to the main trusses that, according to the original plans, were manufactured abroad; however, the decision was made to increase the slope of the roof and for this purpose a second type of trusses was installed (represented in green in the model) that were placed over the main trusses, allowing a roof slope of approximately 15%. On the other hand, there is

also an American type of truss in a horizontal position, located next to the west wall. This element was installed in the 1990s to prevent the collapse of the west wall.

Figure 17 15. Modeling of the roof structure of the central section of the TNCR Foyer block. Prepared by Kevin Hernández-Cervantes.
