## An Examination of the Conservation Philosophy in Korea's Wooden Cultural Heritage Using HBIM – A Case Study of Geungnakbojeon Hall of Muwisa Temple, Gangjin

**Keywords:** HBIM, Conservation Philosophy, Seokkarae, Podongjaju, Maksae Giwa, Geungnakbojeon Hall of Muwisa.

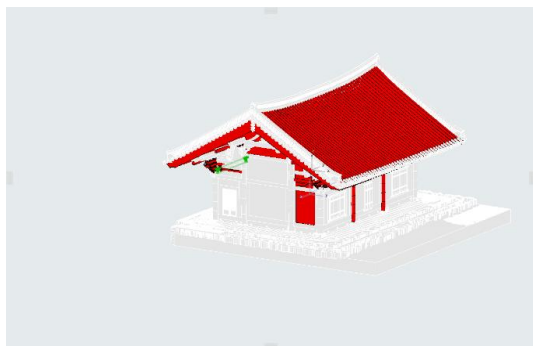
Figure 4. Repeatedly repaired components.

The lateral columns and rear columns also showed repeated reinforcement and repair, indicating the possibility of structural issues, such as ground subsidence, in those areas. In addition, other wooden components were also observed to be in a condition requiring ongoing maintenance and repair.

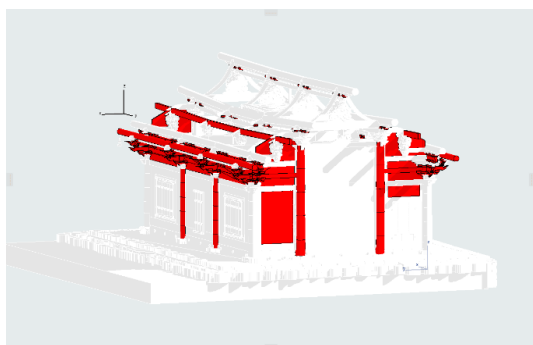
Figure 5. Repeatedly repaired components (interior).

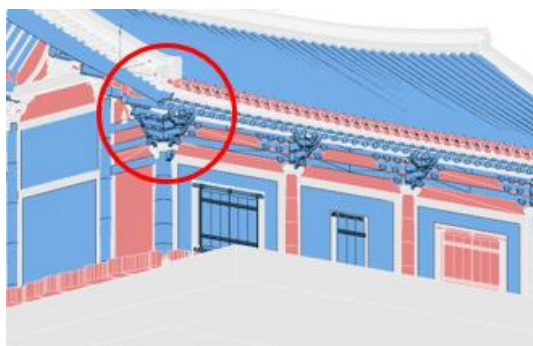
Figure 6. Bracket sets fully replaced in 1956.

The bracket set components underwent structural interventions in both repair periods, and a clear difference in repair methodology was observed. In the 1956 repair, most of the bracket sets were fully replaced (Figure 6), whereas the 1983 intervention marked the beginning of a shift toward reusing original components through reinforcement with epoxy resin (Figure 7).

This analysis indicates that the bracket sets have been subject to recurrent structural issues, likely due to the load-bearing stress of the roof. In particular, components reinforced with epoxy require close monitoring in future repairs. Detailed documentation of their current condition, along with long-term tracking of the physical properties of the reinforcing materials and their impact on structural integrity, will be essential.

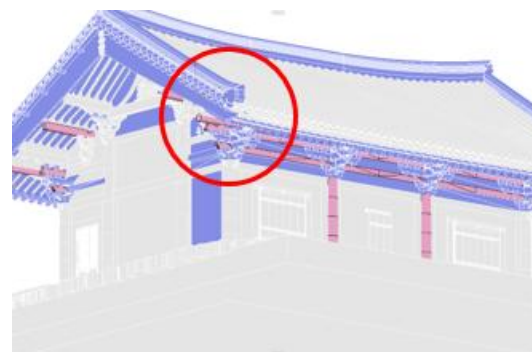
Figure 7. Bracket sets partially reinforced in 1983.

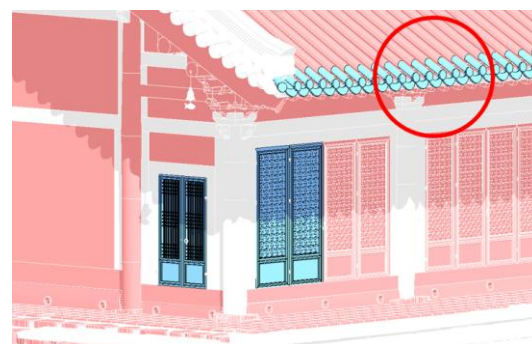
Figure 8. Restored ridge-end tiles (*Maksae giwa*) from the 1956 repair.

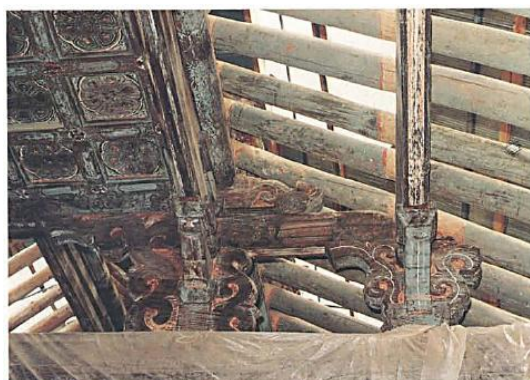
Figure 12. 1983 report photo of the same location.

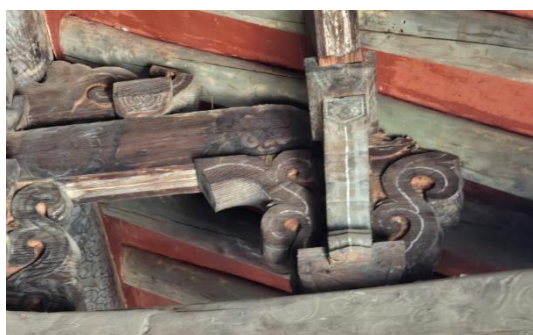
Figure 13. Current photo of the same location.

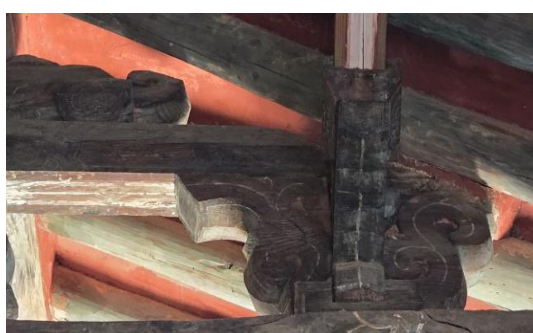
Moreover, the fact that identical cuts were made even in areas where no direct interference with the rafters (Figure 14) would have occurred strongly suggests that this was a preemptive measure taken for construction convenience.

Figure 14. Current photograph of a different location.

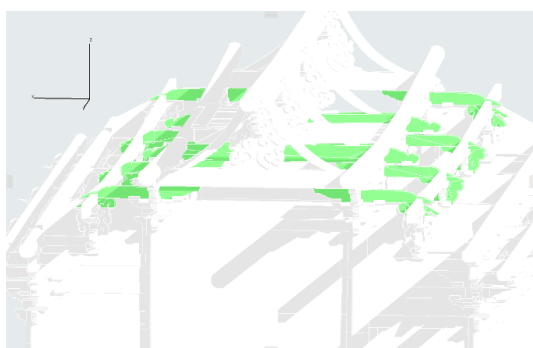
Figure 15. All *Podongjaju* components identified as trimmed in the HBIM data.

This case clearly demonstrates the dissonance between the conservation philosophy that emphasizes the reuse of original materials—as seen in the 1983 repair—and the pragmatic execution of repairs that prioritize efficiency and on-site workability. In particular, the trimming of the *Podongjaju* components to accommodate the installation of *Seokkarae* exemplifies this dissonance. The *Seokkarae* are regarded as a symbolic element in traditional Korean wooden architecture, as they typically preserve the natural curvature of the timber, thereby embodying the core values of traditional conservation philosophy.

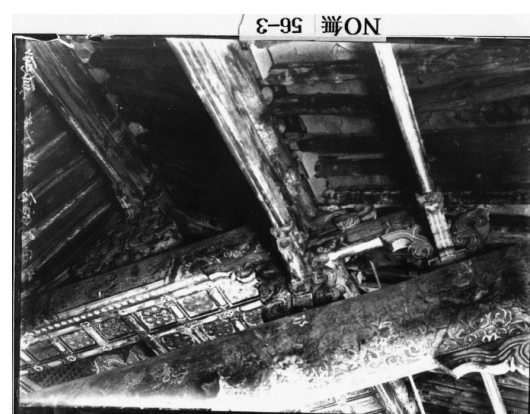
Photographs taken prior to 1950 (Figure 16) show that the *Seokkarae* were installed with irregular spacing and varied shapes, reflecting a reliance on the unaltered form of each timber. In contrast, the current condition (Figure 17) of the rafters, as confirmed by both field surveys and the HBIM dataset (Figure 18), reveals uniform spacing and standardized shapes, suggesting that this change was introduced during the repair process.

Figure 16. Archival photograph taken before 1950.  
 © National Museum of Korea, 2025. Image used under KOGL  
 Type 1 License.

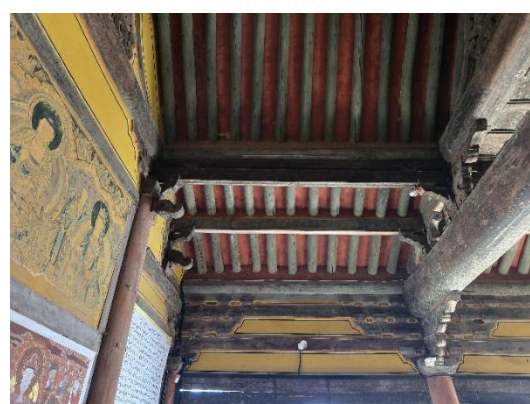
Figure 17. Current photograph.

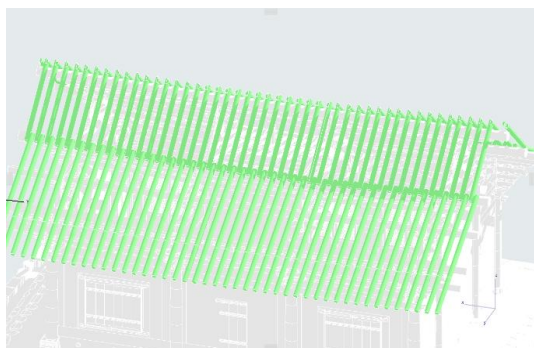
Figure 18. *Seokkarae* as visualized in the HBIM model
