EXPLORATION AND PRACTICE OF BEIJING BELL AND DRUM TOWERS SAFETY DETECTION PROJECT

Zhang Xunhu¹, Yang Yongxing², Zhang Jixian¹, Liu Jinhu¹, Wan Mingying¹

¹ National Quality Inspection and Testing Center for Surveying and Mapping Products, 28th Lianhuachi West Road, Beijing 100830, China - 8893784@qq.com; zhangjx@casm.ac.cn; 94586053@qq.com; 1055033299@qq.com ² CIGIS LIMITED, 177 Dongzhimen nei Street, Beijing, China- 422488127@qq.com

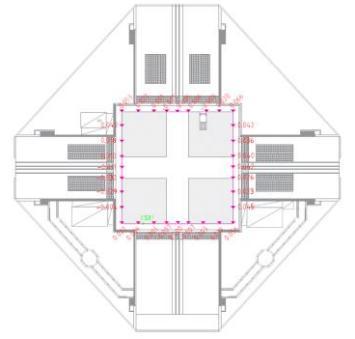
Figure 3. Clock Tower Base Platform level measurements

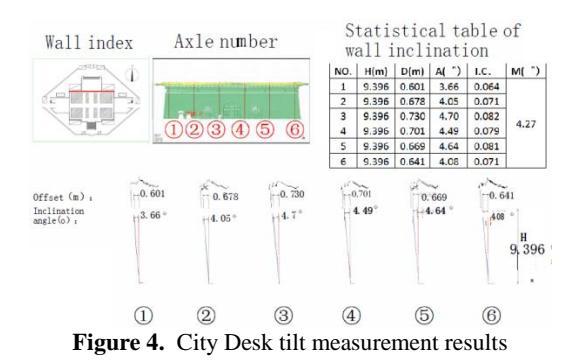
3.2.2.1 Tilt measurement wall: We use three-dimensional laser point cloud data to draw walls tilt measurement map. Draw walls cross-line vertical line, a fitting wall section break. Tilt the angle of the top and measure the yawing amount.

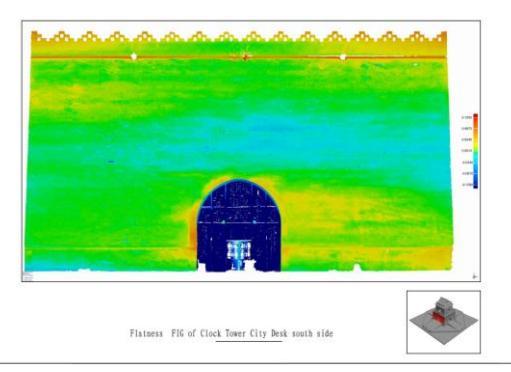
Figure 5. Clock tower wall roughness result map

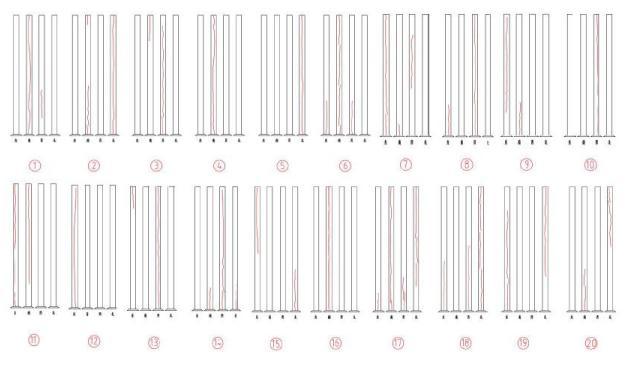
3.4.2 Wood structure appearance quality inspection and survey damage: The material diseases and component diseases of wood members were detected. Material defects are mainly material cracks and internal defects, and component damage is mainly torsional displacement, buckling and imperfection. Using Vernier callipers and non-metal detection analyser (LIN J., TAN YF., LI SK., 2014b), the cracks on 23 sides of 20 wooden columns were detected. The results show that the crack width is about 1mm-7mm, and the crack depth is about 22mm-143mm.

Figure 6. Four square pillar surface cracking

4.2.3.1 The recent focus on conservation projects: It is suggested that measures should be taken in time or immediately to ensure that the damage of components will not continue to develop and deteriorate, and ensure the safety of local structure. It is suggested that the timber columns with severe cracking, torsional displacement and buckling can also be strengthened by adding supports or hoops, and regular inspection should be carried out.
