CONSERVATION OF STONE CLADDING ON THE FAÇADE OF ROYAL PALACE IN CASERTA

I. Titomanlio^a

^a Department of Architecture and Industrial Design, Second University of Naples, Aversa (CE), Italy
ingrid.titomanlio @unina2.it

KEY WORDS: Royal Palace in Caserta, stones cladding, façade, cultural heritage, non – structural elements, seismic risk

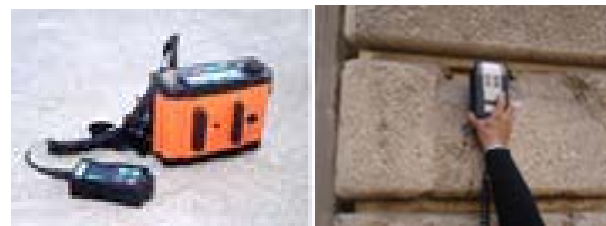
Figure 9. Covermeter high precision digital
COVERMASTER Elcometer P331-
H

The Covermeter used is a Covermaster CM9, the Protovalle Ltd. (Oxford). Unlike most of the similar tools, that use the principle of magnetic induction, the CM9 is based on the operational

principle theory of eddy current (eddy current) retaining all the advantages of stability (there are interference electrical, magnetic, thermal and there are no constraints due to the effects of ionic material moisture investigated), precision and repeatability (Figure 9).

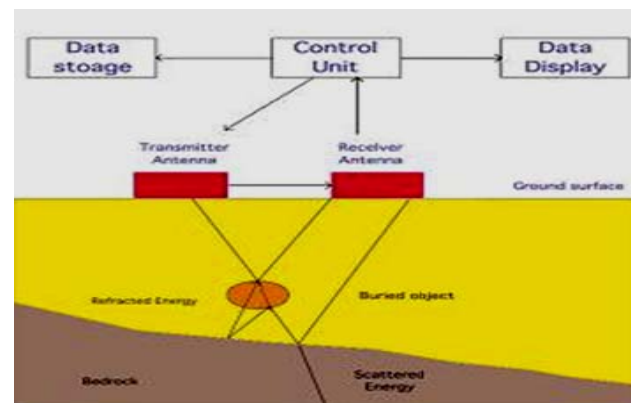
Figure 10. Principles of Operation of the G.P.R.

The GPR, in applications to the constructions, it is, in general, a technique that allows to disclose non-destructively and non-invasively the presence and location of anomalies or submerged objects using the phenomenon of reflection of electromagnetic waves.

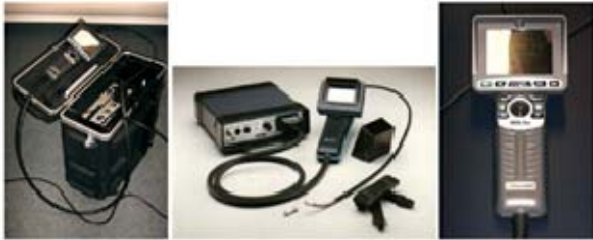
Figure 11. PXL Series - XL PRO Base System of Benecon S.C.aR.L

Endoscopic examination allows a visual examination of the internal cavity or the interior of small diameter holes made in specific parts of the construction. The operation is based on the properties of optical fibers to transmit light by means of successive reflections. Endoscopes, in fact, incorporate fiber optics and a light source to illuminate the internal cavity under consideration, they have also a graduated scale in the viewfinder that helps in the identification and estimation of the size of the observed objects. The returned image is reconstructed with the aid of a computer system, and the main results are presented as images to process and interpret. For the investigation has been used a flexible endoscope (fiberscope) PXL series XL PRO which has the particularity of being able to adapt to the change in linearity of the hole, allowing

investigations in holes or cavities of at least 10 mm wide. The program uses a patented system of control of the camera using a joystick and articulation All-Way™ that allow easy positioning and re-orientation of the probe with a diameter of 3.9 mm. The fiberscope has a high resolution color camera (440000 pixels) (Figure 11).

Endoscopic examination allows a visual examination of the interior of internal cavities or holes small diameter made in specific parts of the construction. The operation is based on the properties of optical fibers to transmit light by means of successive reflections. Endoscopes, in fact, incorporate optical fibers and an internal light source for illuminate the cavity under examination; have, moreover, a graduated scale in the viewfinder which helps identification and estimation of the size of the observed objects. The image returned is reconstructed with the aid of a computer system, and the main results are presented as images to process and interpret. For the investigation we used a flexible endoscope (fiberscope) PXL XL series PRO which has the particularity of being able to adapt to the change in linearity of the hole, allowing investigations into holes or cavities of at least 10 mm wide. the system program uses a patented system of control of the camera

using a joystick and an articulation All-Way™ that allow easy positioning and reorientation of the probe, 3.9 mm in diameter. The fiberscope has a high camera Color resolution (440,000 pixels).

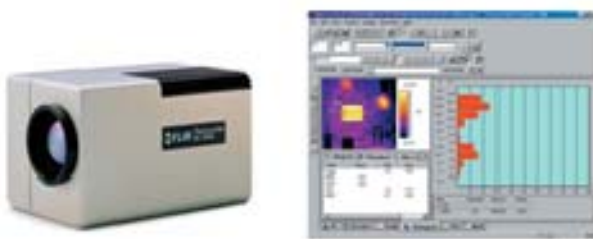
Figure 12. FLIR Thermacam SC3000 High Speed Thermal Imaging System

Different surface temperatures are indicated as color variation, giving a measure of the disparity of heat transmission or absorption in the entire region under investigation. Temperature differences of the order of 0.18 ° C can be detected by infrared cameras to the ordinary type, the information is recorded digitally (Figure 12).

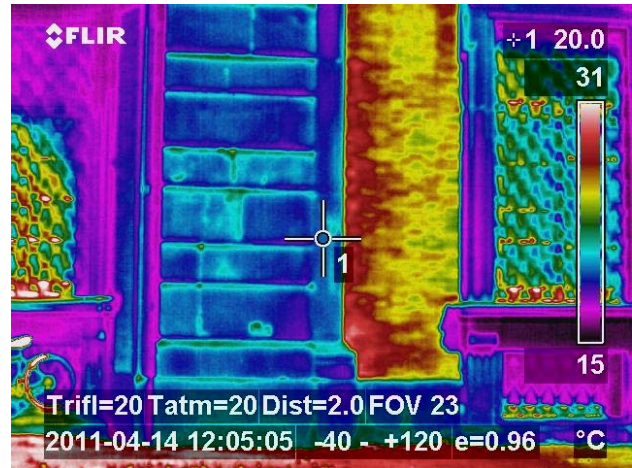
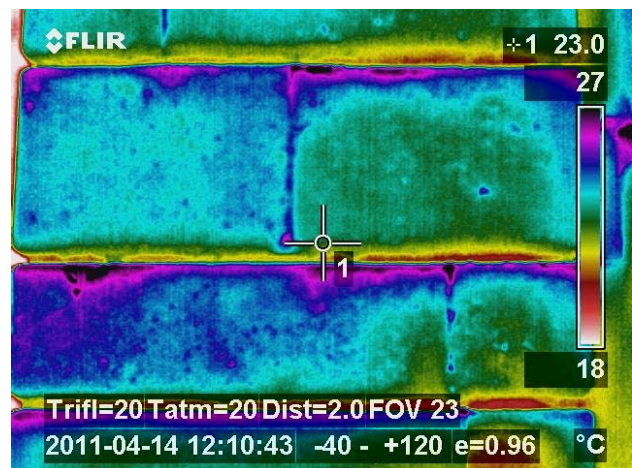
Figure 13. Façade of Royal Palace in Caserta

Figure 14. Stone cladding on façade of Royal Palace in Caserta

During the investigation, GPR and paco metrics, aimed at finding the metallic elements, were also carried out some readings with the heating chamber, and where holes or cavities, also of visual inspections with the fiberscope to have a further "Reading" of the acquired data. Figures 13 and 14 contain some images taken with the camera infrared, taken both on the internal walls of the courtyards is exposed on the main façade south, where the greatest temperature difference gave a better analysis to infrared. The selected images produced by the infrared thermal imager developed on different color scale, in

the first place detect the different materials used for interventions maintenance and restoration of the facade of the blocks, in different centuries. In addition, it detects the presence of different metal elements used in appeals of vertical and horizontal joints to equalize the differences in height between the blocks. By the presence of the different colors can also be inferred a degradation layer of very strong at the blocks and between them.

The selected images produced by the infrared thermal imager developed on different color scale, in the first place detect the different materials used for interventions maintenance and restoration of the facade of the blocks, in different centuries. In addition, it detects the presence of different metal elements used in riscorsi of vertical and horizontal joints to equalize the differences in height between the blocks. By the presence of the different colors can also be inferred a degradation layer of very strong at the blocks and between them.
