Wooden Bay Window (*Rowshan*) Conservation in Saudi-Hejazi Heritage Buildings

KEY WORDS: *Rowshan*, *Rawasheen*, Repair, Technique, Heritage buildings, Old Jeddah

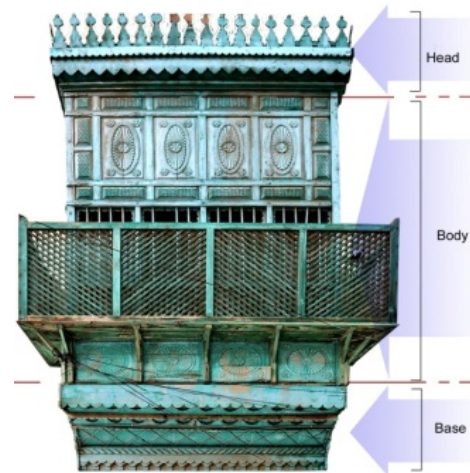
Fig .1 *Roshan* main parts adopted from Alitani (2011)

A number of *Rowasheen* in heritage buildings in old Jeddah were investigated including Sharbatly, Naseef, Basyooni and Abu Safiah buildings. Investigations of the wooden elements aimed at documentation of architectural details, detection of failure types, determination of deterioration factors, and elaboration of suitable conservation and renovation methods. *Rowasheen* in old Jeddah heritage buildings can be found extending from ground floor level to upper levels which typically reach four to five stories high. The *Roshan* can be recognized as a large projecting wooden structure on a building facade, with a recognizable latticed components. A typical *Roshan* is about 2.5m in width, 0.5-0.70 m in projection depth, and 3.0-3.5m in height. *Rowasheen* can be bigger in height and width, By combining the inside width of *Roshan* with its outside projection, its total width reaches 1.2 m that accommodate enough seating area. The *roshan* has an internal height of 2.7 m. In general, when we observed the facades of traditional buildings in historical Jeddah, the large variation of *Roshan* types and the diversity of assembled parts can be clearly seen. Despite of the different variations, all types of *Roshan* are ultimately composed out of similar main parts, so the absence or presence of other secondary parts decides the *Roshan*'s type. These parts can be observed in a single *Roshan*. A single complex *Roshan* can generally be divided into three separately made parts, from bottom to top, into Base, Body, and Head as shown in figure 1.

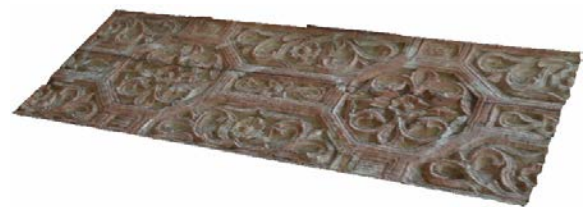
Fig.2 3D model of *Roshan* decorative panel

According to Etani et al (2011) Dense stereo matching (DSM) as digital modeling technique offers unexpectedly good 3D results, from many perspectives because it has high geometrical precision with high level of visualization. This is why Dense stereo matching (DSM) technique was used in documenting the *roshan* and its components as can be seen in and it yielded very good results

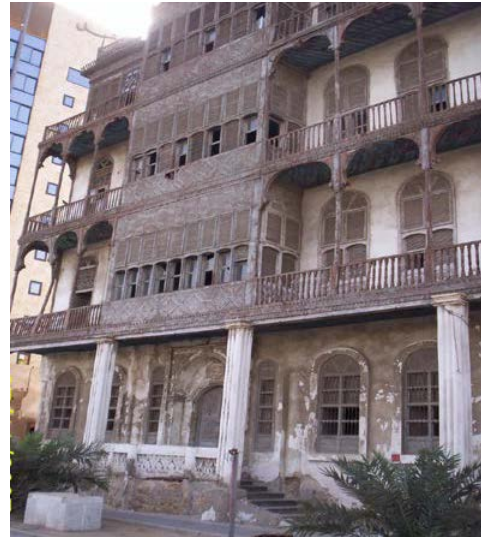
Fig 3. *Rawasheen* in Sharbatly building

In Sharbatly heritage building shown in Figure 3., main wood damage in *Rawasheen* was detected as a result of wood-destroying biotic agents and wood-destroying insects. In addition chemicals factors also affected the decay of wood in as result of exhausts from cars and trucks and smoke from industrial and commercial facilities in the form of dryness causing cracks and splitting of layers. Other factors include material faults (presence of bark, large knots in wood), water damage as result of capillary actions, unsatisfactory ventilation, poor design and sloppy joints, undersized wood elements, using wood with a moisture content of above 20 %, no or inadequate protection against wooddestroying fungi, moulds and insects.

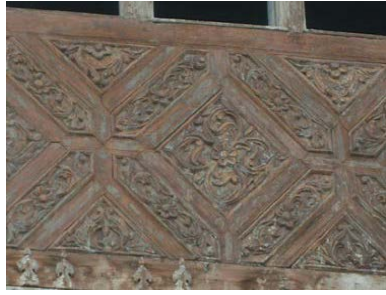
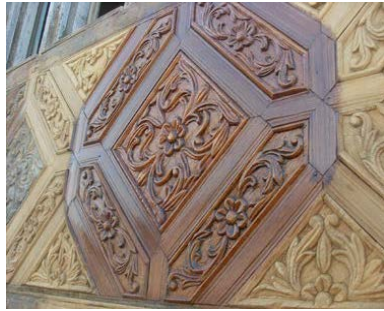
(a) Original decorative pattern of *Roshan* panel

(a) New panel with similar decorative pattern

Fig 4. Repairing *Rawsheen* in Sharbatly building

In order to control termite in historical Jeddah heritage buildings we must incorporate termite shields (ant caps) on stumps and piers. These are not intended to prevent termites entering the timber above, but to slow them down and force them to build shelter tubes out and around the shields, where the tubes can easily be seen. The wood must not be wet and its moisture content must not be above 20 %. Damaged elements of *Rowshan* can be either be replaced with new ones using new parts of the same kind of wood and sized from the 3D digital models prepared during documentation as shown in Figure 4., or reinforced by stiffening of weakened parts of the wooden elements or indirect reinforcing
