THE INTEGRATED SURVEY FOR EXCAVATED ARCHITECTURES: THE COMPLEX OF CASALNUOVO DISTRICT WITHIN THE WORLD HERITAGE SITE “SASSI” (MATERA, ITALY)

KEY WORDS: survey, preservation, 3D modelling, historic heritage, non-destructive techniques

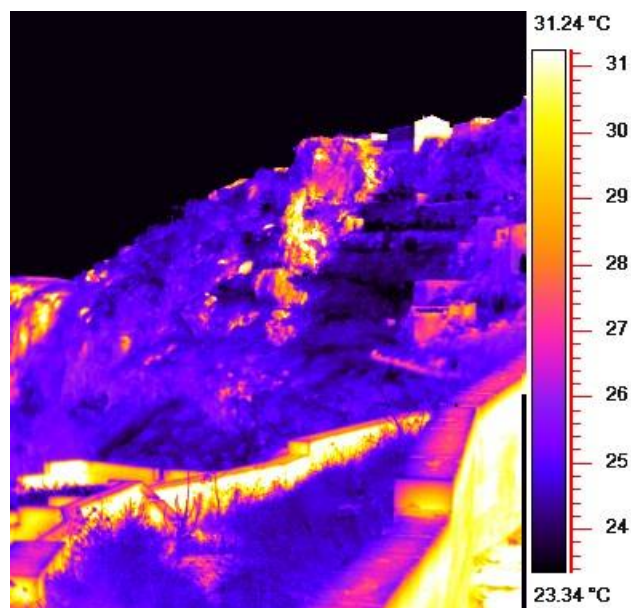
Figure 1. Thermal image of the ravine of an area of the *Casalnuovo District*

In this perspective, are then presented the results of several applications within the *Rione Casalnuovo* in the area of the *Sasso Caveoso* (a part of the *Sassi* complex) in the city of Matera (Figs. 1, 2, 3).

From an instrumental point of view, the images were taken using a Fluke Ti32 thermal camera with detector FPA (Focal Plane Array) micro bolometer operating in the long wave spectral range between 8 and 14 microns. Regarding the spatial resolution of the acquisition system, the FPA is equipped with a matrix of sensitive elements of dimensions 320 (H) x 240 (V) with a field of view of 23.0 °(H) x 17.0 °(V) and is capable of producing a thermal resolution minimum equal to or less to 0.45 °C with a precision of the measured temperature of ± 2 °C within a

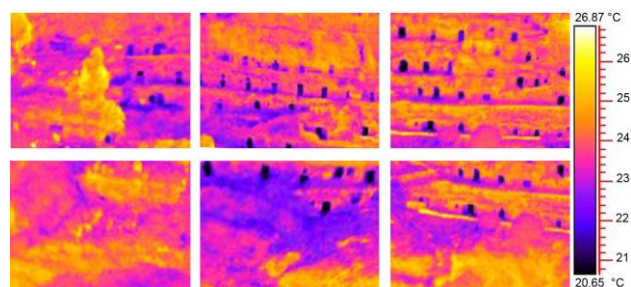
Figure 2. Mosaicking of thermograms processed with the aid of the software NRG © Microgeo

These images were processed with the demo version of the dedicated software Microgeo NRG, one of the best software on the market, able to straighten and create mosaics of the thermograms, optimizing the measurement distance from the object and standardizing the values of emissivity, relative humidity, together with the temperature intervals, in order to subsequently be combined into more complex photo mosaics able to return in a unified manner the entire portion consisting of the facades of the Casalnuovo District facing the ravine.

During post-processing, the obtained image is (geo) - codified and mapped to a reference metric system that allows you to accurately measure the lengths and the surfaces of the represented objects and structures. This superposition of layers is then interrogated within any CAD environment.

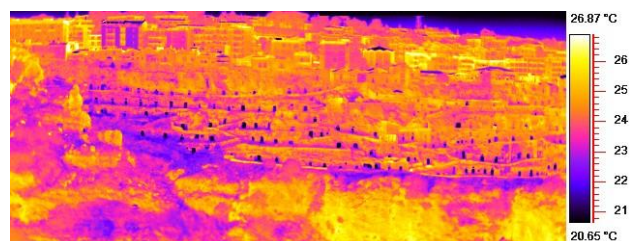
Figure 3. Results of the thermal mosaicking of a big area of the *Casalnuovo District*

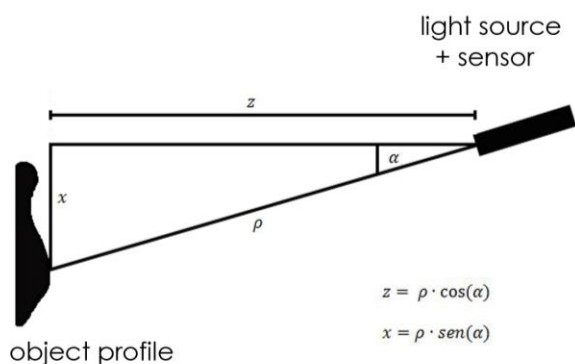
Figure 4. Schematic diagram of a time of flight scanner

Based on light waves, the active sensors realized, as a direct result of the measurement session, a set of three-dimensional coordinates which are related to a high number of points in a reference system correlated with the instrument. Then, the so measured points are determined by polar spherical coordinates which are then returned in Cartesian coordinates. This is possible because the active optical sensors detect the spatial position of the surface or of the measured point, dividing the framed surface in picture elements similar to the pixels of a digital image. The color information can be recorded by the sensor itself or from a digital external integrated camera. Usually, the light source is integrated in the sensor, for this reason the light that invests the object has a defined structure (Fig. 4).

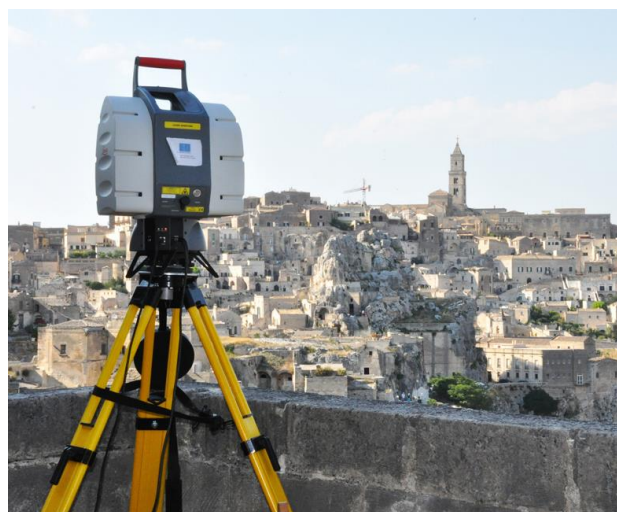
Figure 5. Laser scanner used for survey

The instrument used is a laser scanner Leica HDS 3000 (Fig. 5) which has a field of view up to $360^\circ \times 270^\circ$, integrated digital camera for photographic overlays calibrated automatically. The emitted laser beam reflected on the surface and acquires each point with coordinates XYZ with respect to a local reference system of the own machine. The figure you get is a very detailed point cloud that follows exactly the geometry of the detected object with an accuracy of 6 mm over a distance of 50 mt from the object.

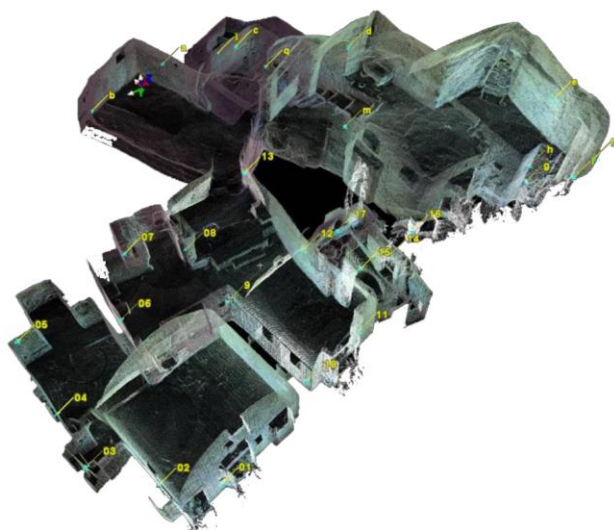
Figure 6. Identification and positioning of the targets

To be sure of being able to firmly connect with each other all the scans, we drew some sketches studying what could be the preferred location for each scan and the relative number of target (Fig. 6) sufficient for a proper registration. Another difficulty was to avoid gray areas to have a complete survey. Due to the complexity of the construction site, we had problems of different brightness between the excavated and constructed environments, therefore it was necessary to adjust the brightness of the instrument to find the right balance between overexposed and underexposed areas. The second phase, that of acquisition, lasted 5 days, with a total of 20 scans. Because of the geometry of space and of time at our disposal, the instrument has been set in order to have a distance between the points of 0,03 mt every 10 mt. The third phase, that of registration, was carried out with the roto-translation of a cloud on the other one through the automatic recognition of target HDS and the superficial matching. To minimize the error, the scans were recorded in groups to then obtain the final one with an error of 5 mm. Once you get the overall cloud of points, there is the creation of 2D drawings (plans, sections and elevations), from which it was possible to obtain all the necessary metrics information (Fig. 7). The next step was to make a 3D model that can be queried by a wide audience for educational, technical and touristic purposes.

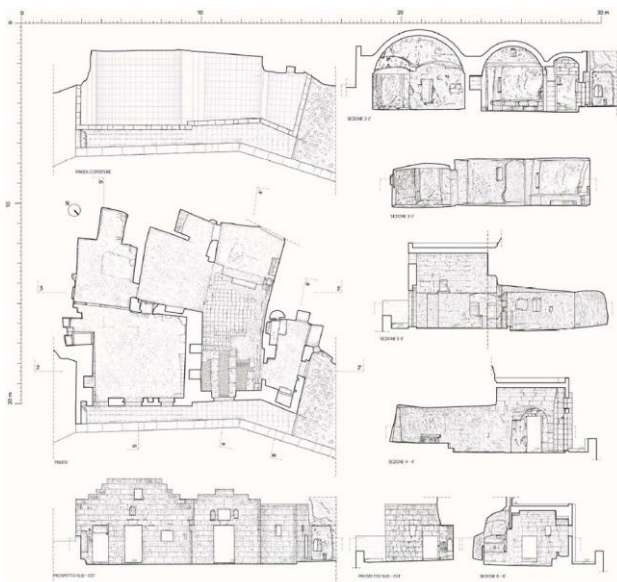
Figure 7. Plans, sections and elevations

Our study on a part of the *Casalnuovo district*, consists in obtaining a three-dimensional geometric model, from which to derive sections, elevations, indirect measurements and, more generally, all the graphic elaborations necessary for the representation and subsequent studies.

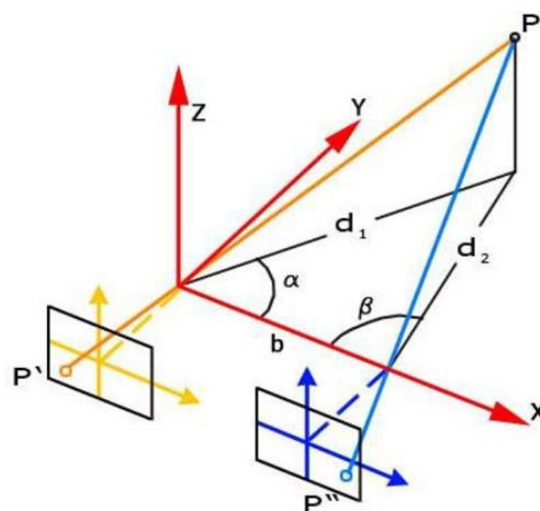
Figure 8. Collinearity

To obtain stereoscopic views and derive 3D information from the areas of overlap in the images, in photogrammetry, similarly to what happens in the human vision, you need to incorporate an object with at least two images taken from different viewpoints. For a good photogrammetric restitution and for data processing are required a proper amount of high-resolution images and a right calibration of the machine, knowing the focal length, the offset of the main point and the parameters of lens distortion. It often happens that the object to be represented is too complicated as size or geometry to be detected only through stereoscopic shots; in this case a large number of images, from different points of view around the object and with converging axes, are acquired and oriented simultaneously with the method of the compensation with projective bundles (Fig. 9).

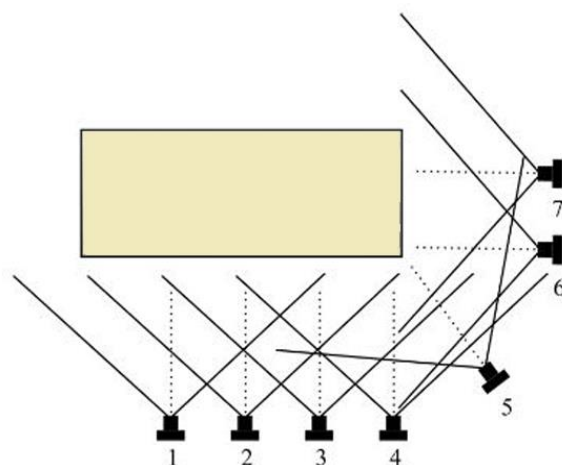
Figure 9. Method of compensating with projective beam

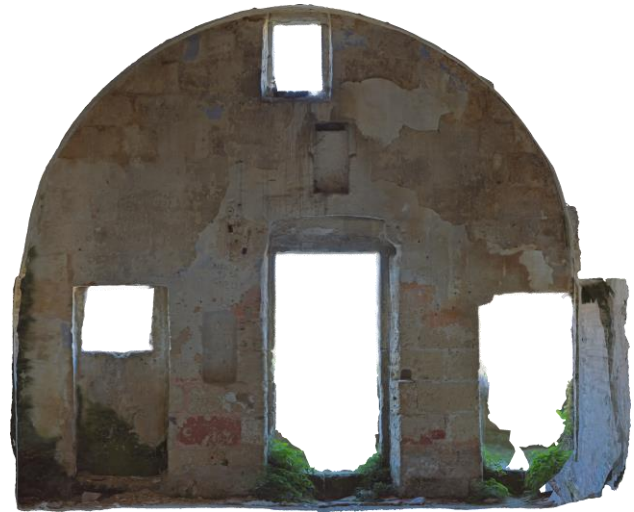
Figure 10. Orthophoto of the interior

The decision to use photogrammetry in the survey of the environments of Casalnuovo, was dictated by the need to analyze and map the present degradation. The laser scanner at our disposal did not allow us to obtain orthophotos of good quality to work for mapping degradation in a consistent manner with the prospect of recovery project of the environments. Precisely for this reason we had to resort to a photogrammetric survey, this time not to get a complete 3D model, but rather to produce orthophotos (Figs. 10, 11) and proceed in the restitution of a more detailed analysis. The texture obtained by the laser did not respond to our needs because the integrated camera was not with high definition and the overlap of the images was not ideal for the various exposures of light dictated by geometry and setting environments. Furthermore photogrammetry has allowed us to obtain an exact texture point by point because it reports pixel by pixel color information, which does not happen in the project images that show the color information on the detected points, but instead take into account regions of space in the vicinity of the point considered.

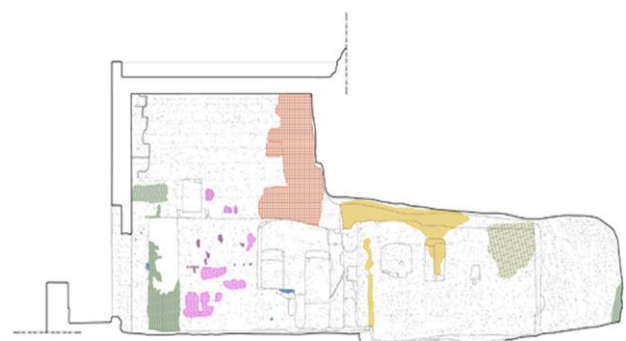
Figure 12. Degradations mapping

- stain: localized color variation of the surface, related to the presence of certain natural components of the material (concentration of pyrite in the marbles) and to extraneous material (water, oxidation products of metallic materials, organic substances);
- chromatic alteration: it manifests itself through a variation of one or more parameters that define the color, with different morphologies by referring to large or localized areas;

- biological patina: thin and homogeneous layer caused by the presence of water, mainly consisting of microorganisms, variable to texture, color and adhesion to the substrate;
- exfoliation: formation of one or more laminar portions, of very small thickness and sub-parallel to each other, said layers. It is primarily caused by moisture.

After analyzing the present pathologies (Fig. 12), we moved to the study of the possible recovery interventions. Considering the morphology of the places and respecting the construction techniques, the renovation aims at a cleaning based on the removal of the products of alteration and deposit affecting the surface of the stone. The cleaning will be made with sorghum brush that will not go to affect the surfaces of good consistency. We will proceed with a whitewash, technique of painting or coloring, semi-one coat of lime milk used frequently in the past to protect surfaces. A key aspect to be taken into account are the closures of the environments, the absence of which results in a complete accessibility which obviously creates environmental and human dangers (Fig. 13). In the restoration project were provided suitable closures which also guarantee an improvement of the internal microclimate and are encouraging the protection of the environments. With regard to the coverage of built environments, having been reconstructed in an intervention of the Seventies, does not present big problems of infiltration. The only points where there is the possibility of infiltration are in correspondence of the graft with the masonry realized only with fittings in mortar. Furthermore, the discrete rainfall, the sunshine and the presence of earthy deposits and dust carried by the wind as the result of processes of de-cohesion of the materials, have favored the growth of natural vegetation on the roofs. Indeed terracotta elements of the mantle are hydrophilic in nature and tend to absorb water and encourage the phenomena of delamination of the material. Due to the degradation conditions of the coverage, we are planned interventions aimed at revision of the mantle, reposition and fixation of dispersed elements, removal of vegetation after application of biocide and liberation of the outlets of drain pipes. The interventions take into account the fact that the covering layer rests on a fill in flakes of stone, tiles and earth which ensures breathability but not watertight seal. From the analysis of the elevation we have highlighted the presence of iron elements for the support of the downpipes for the disposal of rainwater coming from the shell. Therefore it is expected the reintroduction of these ones in correspondence to the channels at valley.

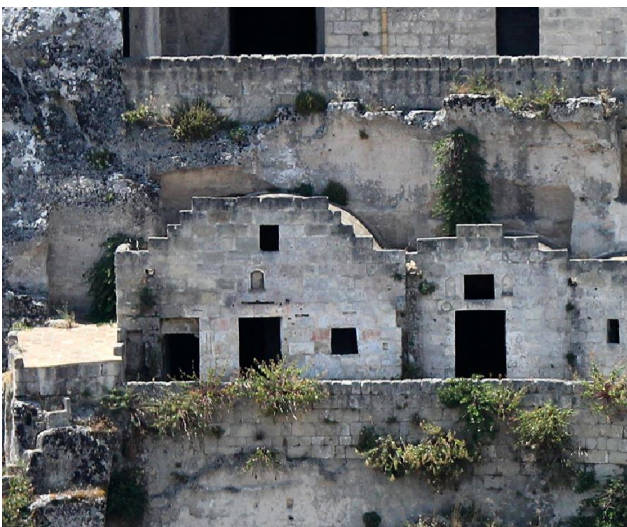
Figure 13. The elevation and the absence of the closures

The degradation factors mainly concern the micro-climatic conditions to which the environments are subjected. The absence of closures makes the internal microclimate particularly influenced by the external one. The mechanisms of alteration of the material are also favored by the porous and tender nature which constitutes the calcareous sandstone. These factors have resulted in the indoor environments degradation phenomena such as:
