Restoration and Rehabilitation of world heritage Site of Chupan Church

Shirin Darvish Rohani
Ph.D student of Urban Planning and Design of Tehran Azad University
shirinrohani@yahoo.com

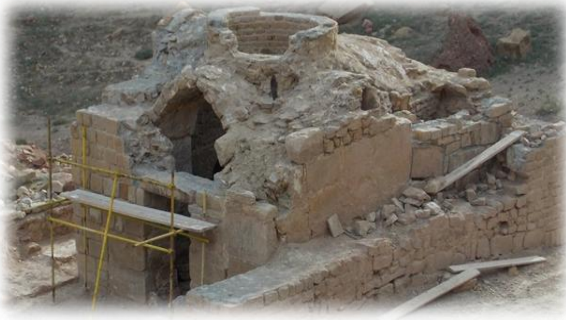
The church chupan from south western façade before 2014

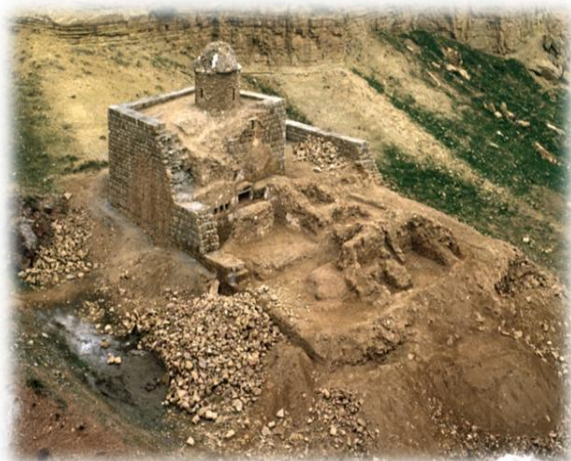
The church is located on a smoothed hillock .the site is enclosed from 3 sides by stone retaining ramparts that each one has different height and even it is clear that the current appearance are built in different periods (because of different restoration in different years).it seems the northern wall had never been completed.

Figure 6. Ramparts of Chupan church.befor restoration of 2014
