HISTORIC PHOTOS AND TLS DATA FUSION FOR THE 3D RECONSTRUCTION OF A MONASTERY ALTAR ENSEMBLE

Klaus Hanke^{a*}, Michael Moser^a, Reinhard Rampold^b

KEY WORDS: Historical Photos, Photogrammetry, 3D Reconstruction, Data Fusion

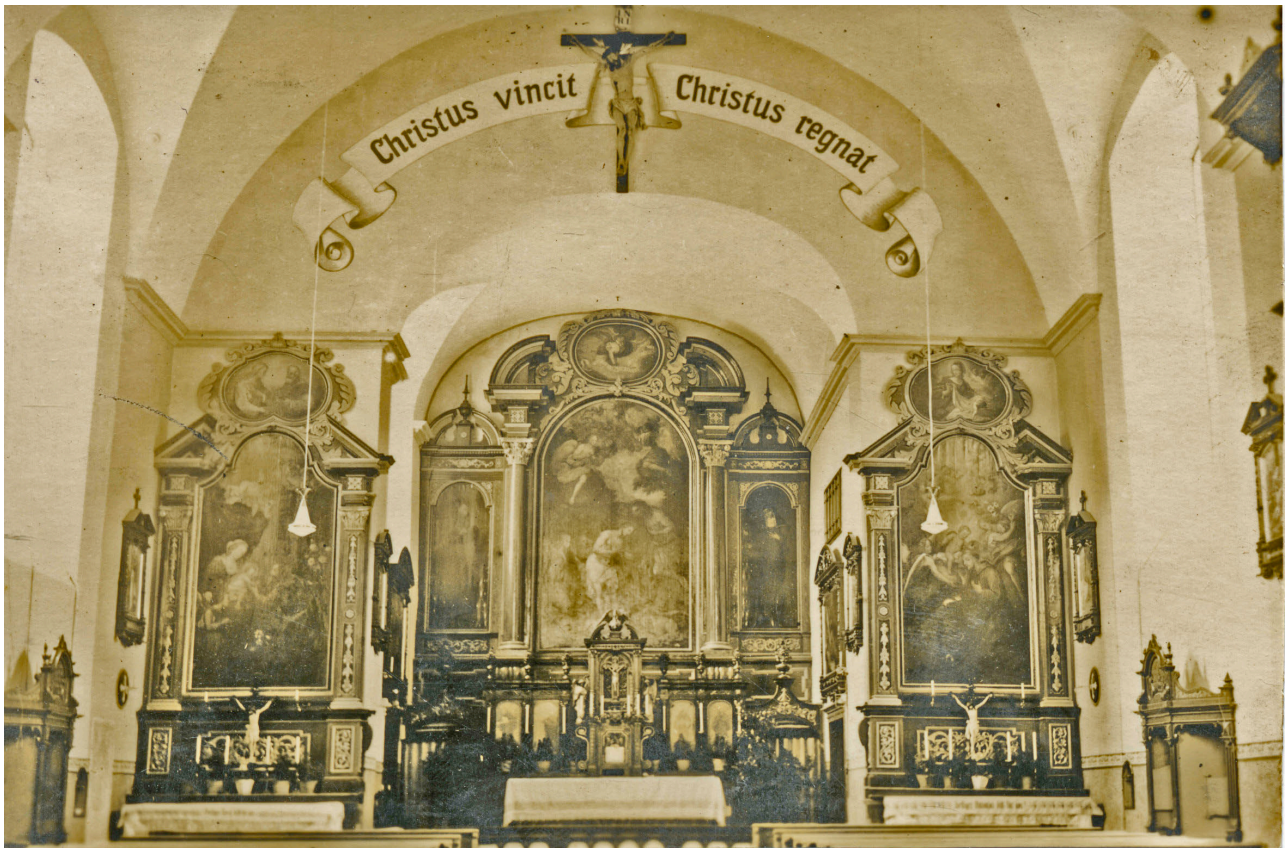
Figure 1: Historical photograph 1 showing the desired altar ensemble as it was before World War II

Despite a thorough search by the Federal Office for Public Monuments, only two historical photos were available. The first photograph (fig. 1) shows the altar area with the side altars and the architectural elements of the interior of the church. Unfortunately, the picture resolution is somewhat low and only the outer limits of the details needed such as the moldings and the decorative elements are well identifiable. This illustration, on the other hand, is well suited for a reconstruction of the internal and external orientation of the photo.

In order to achieve a detailed survey on site, the present altar space was subject to detailed geometrical measurement with a terrestrial laser scanner. This available dataset made it possible subsequently to investigate the recorded geometry of the church interior for common features in the historical images. In this way, a large number of reliable control points for the photogrammetric determination of the interior and exterior orientation of the first historical photograph (Fig. 1) could be achieved.

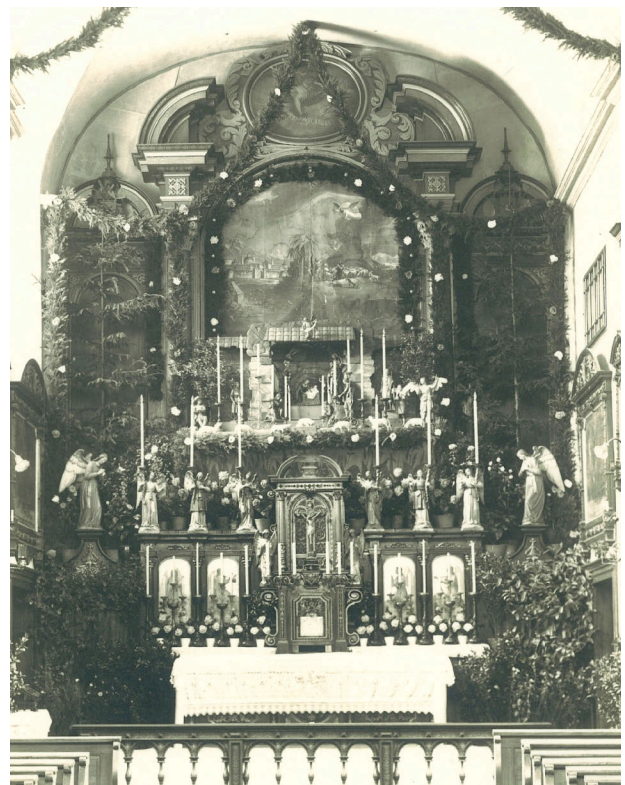
Figure 2: Historical photograph 2 with Christmas decoration

The situation is different with the second photograph (fig. 2) available. Despite some items being covered by garlands that were part of the Christmas decorations displayed on the altar at the time of the photograph, various details are clearly identifiable. However, since this photo shows hardly anything of the interior of the church, there are no common points that permit the determination of the parameters necessary for photogrammetric reconstruction. Other approaches to a solution using secondary geometric conditions such as parallel or orthogonal edges to calculate the orientation of the camera proved to be too complex. A large number of different combinations of secondary conditions would have had to be tested in order to obtain a reasonable result. Nor is it advisable to rectify the image on various levels, since on the one hand the altar is very detailed and of a fine structure, and on the other hand there is no information about the spatial depth of the object.

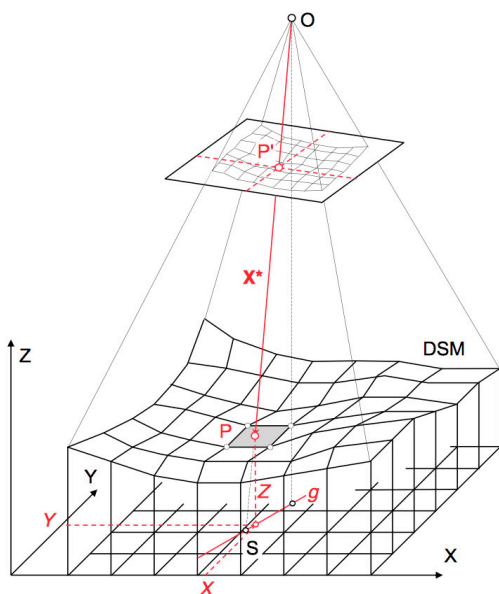
Figure 3: Principle of Monoplotting method
(Hastedt and Luhmann, 2012)

Monoplotting denotes the process of intersection of a spatial image ray with a given surface, e.g. a digital terrain or surface model (DSM). The use of an existing CAD model also allows the inclusion of geometric conditions. If an image is absolutely oriented with respect to the 2,5D or 3D surface, each measured image point defines a direction vector pointing onto the surface. This method made a three-dimensional reconstruction of some parts of the altar at all possible.

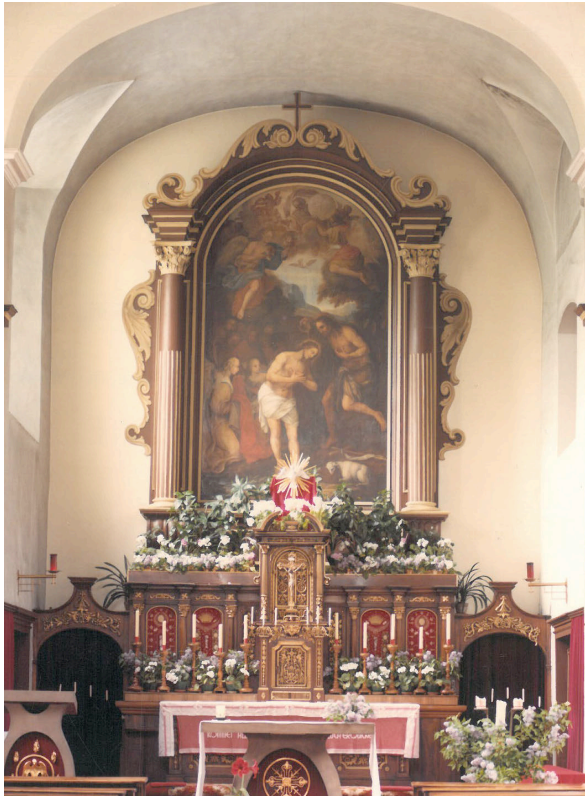
Figure 5: The present situation of the altar ensemble

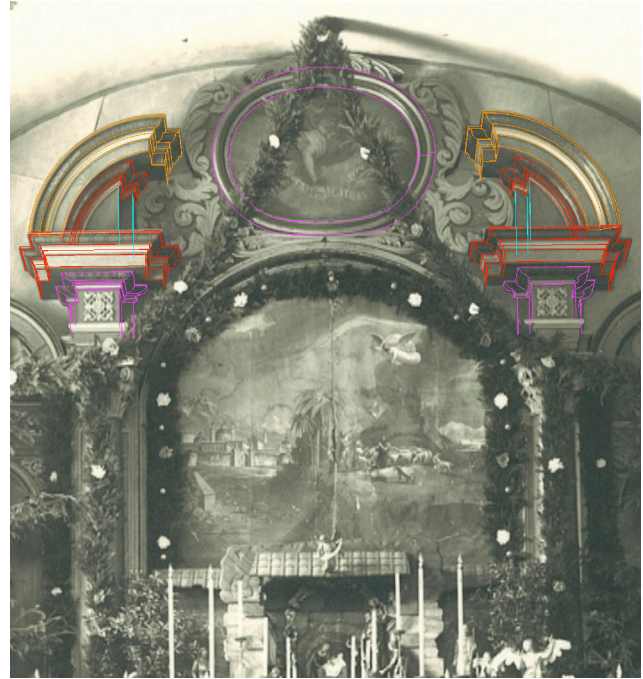
Figure 8: Rigorous audit by back projection of the reconstructed outlines into historical photo 2

These three-dimensional limit lines of the altar elements were the basis for calculating the internal and external orientation of the second historical photograph. After the camera parameters had been determined, it was possible to add the missing details such as moldings and decorative elements. Once the work in the central area had been completed, the side elements of the main altar were then reconstructed. In both illustrations, it is difficult to get the depth of these objects, or they are in part concealed by the Christmas decoration present at the time of the image taken. For this reason, this missing data, such as that of the moldings, was adopted from the central section of the altar. To begin with, the size was adapted on the basis of the external frame of the objects. Then, the missing information was taken over as additional geometrical condition for the reconstruction. Finally, the results were always verified by a back projection of the three-dimensional model into the two historical images.
