SUNKOSHI LANDSLIDE IN NEPAL AND ITS POSSIBLE IMPACT IN INDIA: A REMOTE SENSING BASED APPRAISAL

KEY WORDS: Sunkoshi, Landslide, Dammed lake, Remote Sensing, Kosi, Hydrological analysis

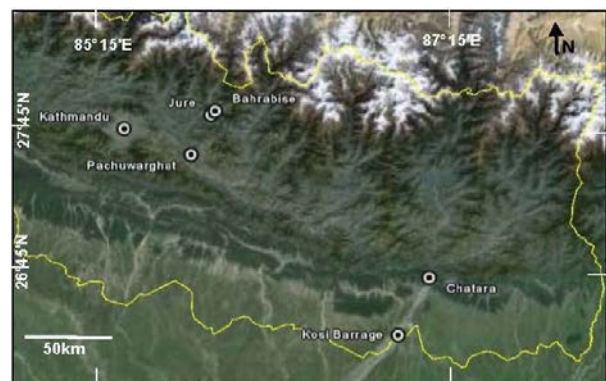
Figure 1. Landslide location (Jure) and gauge stations (Bahrabise, Pachuwarghat and Chatara) along Sunkoshi river. Background satellite image (Source: Google Earth)

A devastating landslide occurred on the early hours of 2nd August 2014 on the right bank of the Sunkoshi river above Jure village, Sindhupalchok district, at a distance of 70 km ENE of Kathmandu, Nepal (Figure 1; SANDRP, 2014). As a result of this Sunkoshi river was blocked at the river meander and it created a large landslide dammed lake (LDL) which extended up to a distance of more than 2 km in the upstream direction and submerged the economic as well as strategic Nepal-China Arniko highway on the right bank, many settlements, 2.5 MW Sunima power project area and most importantly it caused potential threat of landslide lake outburst flood (LLOF). The river Sunkoshi and its tributaries have a history of lake formation due to landslides and subsequent breaching and flooding (Shrestha et al., 2014). The Kosi disaster of 2008 is still fresh in mind when Kosi changed its course after 200 years due to breaching of embankment and flooded large parts of North Bihar that affected 3.3 million people (Sinha, 2009a, 2009b). Therefore, there was a wide spread concern in Nepal and India and as a preventive measure tens of thousands of people were evacuated to safer locations in eight districts along

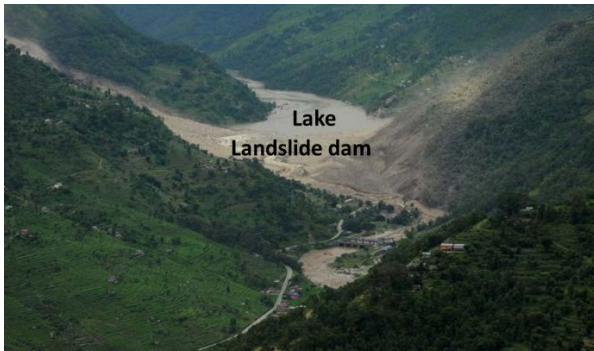
Figure 2. Landslide location (Jure) and landslide dammed lake on Sunkoshi river. View is towards NE (upstream direction). Terraces on the opposite slope are completely covered by landslide mass (Source: www.thedailystar.net).

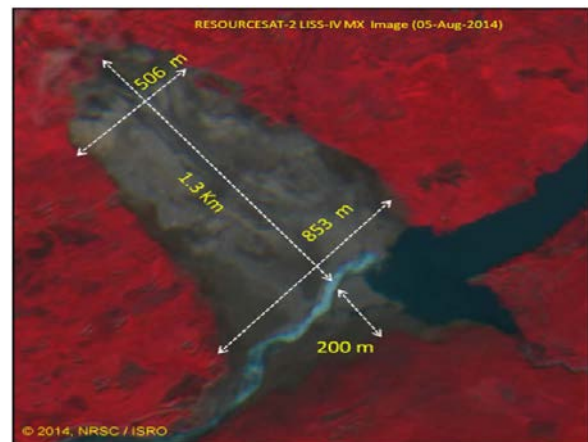
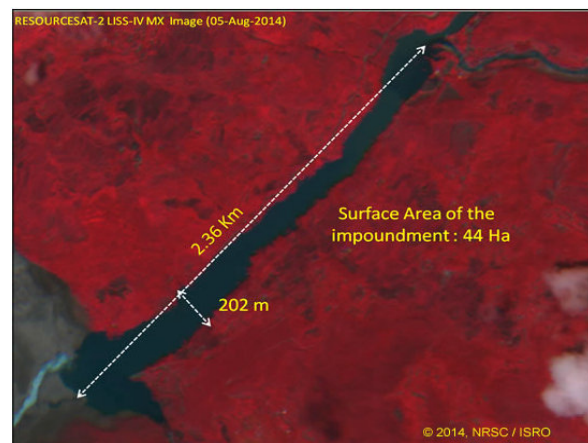
Figure 3a and 3b. Landslide dimensions as observed on IRS Resourcesat-2 LISS-IV satellite data acquired on 5th August 2014 (Source: NRSC)

Satellite data products have been found very useful for landslide mapping and its impact assessment (Mantovani, 1996; Metternicht, 2005). In the present study moderate and high resolution satellite data products were analysed. The landslide ($27^{\circ} 46' 00''$ N, $85^{\circ} 52' 25''$ E) is located on the right bank of a meander of river Sunkoshi at Jure close to village Mankha, between two hydropower sites, 2.5 MW Sunima Hydropower site on upstream and 10.5 MW Sunkoshi Hydropower intake dam on the downstream side at a distance of 1 km (Figure 1 and 2). The major trade and strategic route, i.e., Arniko Highway between Nepal and Tibet passes through the landslide on the right bank and after two kilometres on the upstream side it crosses over to left bank at Bahrabise. It is needless to say that the road has been completely destroyed for a length of 850m-1km in the landslide section and further upstream it is submerged

in landslide lake for a length of about 2 km (Figure 3a and 3b). IRS R2 LISS-IV image acquired on 7th and 12th Sep.2014 show slight change in the dimensions of the landslide and reduction in lake volume due to release of water by controlled blasting (Figure 4a and 4b).

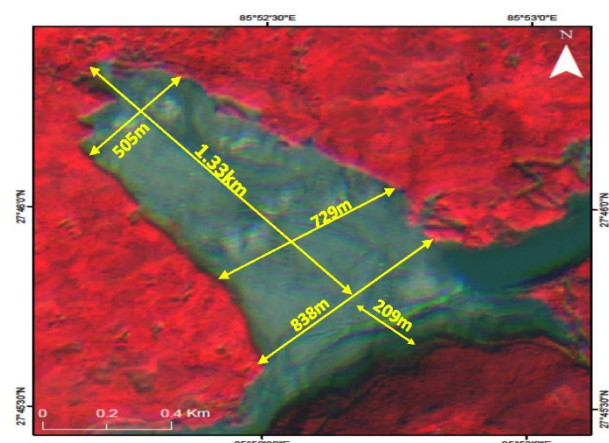
Figure 4a. Landslide dimensions as observed on IRS Resourcesat-2 LISS-IV satellite data acquired on 07th September 2014 (Source: NRSC)

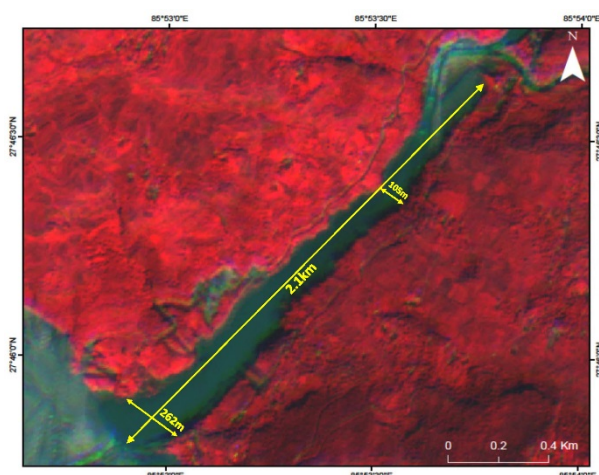
Figure 4b. Landslide dammed lake dimensions as observed on IRS Resourcesat-2 LISS-IV satellite data acquired on 07th September 2014 (Source: NRSC)

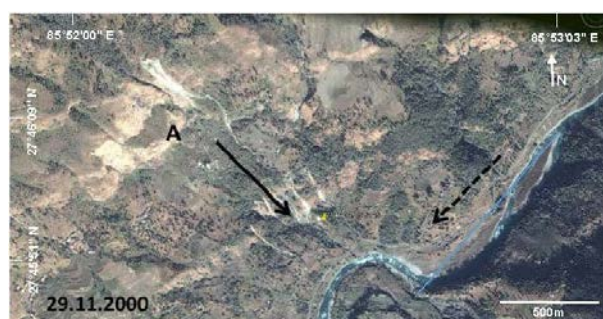
Figure 5. Reactivation of landslide at the same location prior to 2014 event as observed in 2000 (Source: Google Earth). Dotted arrow shows the flow direction of Sunkoshi and solid arrow shows the direction of landslide.

The location of landslide was a very vulnerable location as it is a site of old landslide in a topographic hollow and at the outward side of the river meander where maximum toe/bank erosion is expected. It has been reactivated in the recent past as shown by landslide scar at an elevation of 1300-1350m which is above 500-550m from the river level of 800m as shown on pre-event IRS-LISS-IV data (www.nrsc.gov.in) as well as on World View satellite images (available in Google Earth for the time period 2000 to 2012, Figure 5 and 6). On 2nd August at around 2.30 AM the landslide was again reactivated and completely covered the old slide zone and the crown had extended further upward at least up to an elevation of 1500m. The landslide length is 1.3 km and width is 853m (www.nrsc.gov.in). The landslide debris volume was so huge that it could not be accommodated in the narrow valley of Sunkoshi river, although the river was widest (60-70m) in this part of the course due to meandering. The landslide debris that descended from a height of 1500m on the right bank to river valley at 790-795m and then it moved up on the left bank and covered 4 levels of terraces observed at 796m, 800m, 812m and 823m (Figure 7). Thus, the landslide debris has reached up to a height of 825m from lowest level valley elevation of 790-795m. Therefore, after recovering 33 bodies from debris, 123 people, who were missing and believed to be buried under thick debris, were declared dead and rescue operations were abandoned (www.nepalmountainnews.com).

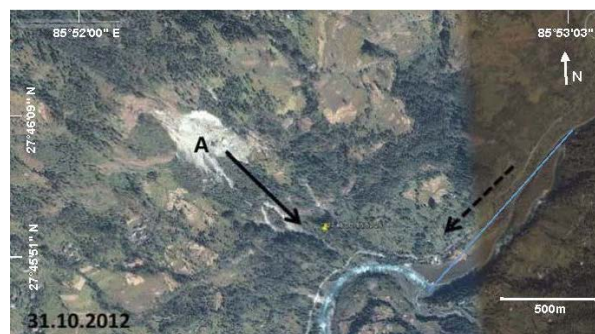
Figure 6. Reactivation of landslide at the same location prior to 2014 event as observed in 2012 (Source: Google Earth). Dotted arrow shows the flow direction of Sunkoshi and solid arrow shows the direction of landslide.

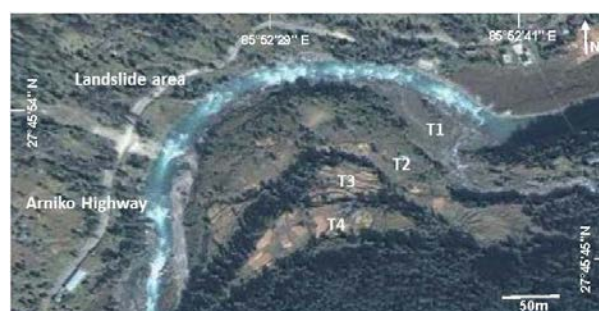
Figure 7. Four levels of terraces as observed on satellite images (Source: Google Earth). All the four levels of terraces were covered by landslide debris on 2nd August up to a height of 30-35m from the river bed.

It is interesting to note that similar to 4 levels of terraces at the landslide location, 2km in the upstream direction on the left bank also 4 levels of terraces are observed at an elevation of 828-830m, 832m, 850m, and 870m. The relative relief difference between the river level and the highest terraces in both the cases is around 30-40m and both have formed on the left bank thus showing the overall hydrodynamic pressure on the right bank at both these locations and the present landslide has occurred in one such location. Movement of landslide masses from one bank to another is not very uncommon, as has been observed during Ukhimath landslide in 1998 in Garhwal Himalaya and Hatian Bala landslide in 2005 in Kashmir region and at many other places worldwide (Champati ray et al., 2009; 2012; Costa and Schuster, 1988; Dunning et al., 2007; Schneider et al., 2013; Yin et al., 2009). In all these cases rivers were blocked and dams were formed like the present case. The most spectacular and oldest of these events was the Gohna Tal landslide (Garhwal Himalaya) that occurred in 1893 and blocked river Birahi which breached first in 1894 and later in 1970 causing devastating floods in Garhwal Himalaya (Champati ray, 2013; Weidinger, 1998).

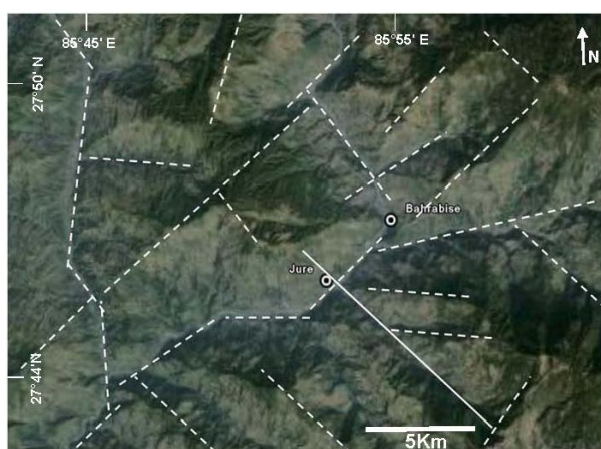
Figure 8b. Major lineaments (dashed lines) of the region and the most prominent lineament in NW-SE direction is through the landslide zone (solid line). Background satellite image (Source: Google Earth).

Geologically this area is underlain by Lesser Himalayan rocks (known as Kunchha Formation, the oldest rock in Lesser Himalaya) consisting dominantly of phyllite, schistose phyllite and quartzite (personal communication: Dr. Dinesh Pathak, Trivuban University). The area lies very close to Main Central Thrust zone and most importantly it is traversed by two sets of prominent joints oriented in NW-SE and NE-SW directions (Figure 8a and b). One such lineament in NW-SE direction passes through the landslide zone showing the overall structural weakness in strata. Overall the slope of the area is around 58-60° and the entire landslide mass can be divided into two zones with one resistant layer in between. On 2nd August 2014, failure was observed on both the portions: the upper portion shows more of rock slide whereas the lower portion shows rock and debris slide.

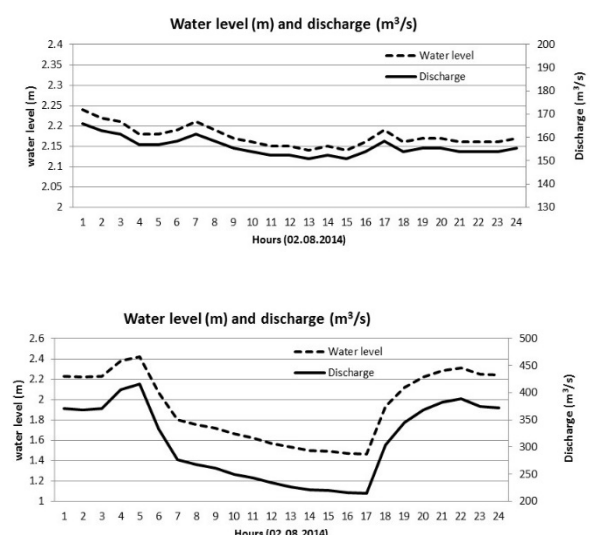
Figure 9. Water level and discharge observations at a) Bahrabise (upstream of landslide) and at b) Pachuwarghat (downstream of landslide) on Sunkoshi. The reduction in discharge indicated blocked Sunkoshi river at landslide dam, which was partially breached by blasting to regain the flow of the river as indicated by rise in water level and discharge (Data source: Nepal Govt.)

Hydrological data, particularly water level and discharge data was analysed for two important stations from both upstream and downstream side of the landslide blockade area. The discharge was approximately around $160\text{m}^3/\text{s}$ on 2nd August 2014 at Bhrate Koshi, Bahrabise on the upstream side at a distance 3.5 km. However, the actual discharge to the landslide lake would be higher due to contribution from two tributaries on the left bank between the measurement site and landslide location. Water level was around 2.2m which rises in tandem with discharge of Sunkoshi that confirms consistent data quality. Due to the landslide dam, a lake was formed and from 5 o'clock to 17 o'clock in the evening, the discharge was reduced from 416.2 to $214.2\text{m}^3/\text{s}$ as measured at Pachuwarghat on Sunkoshi at a distance of 35 km from the landslide. It clearly shows blockade of the Sunkoshi and balance discharge was from tributaries of Sunkoshi between landslide location to Pachuwarghat. From 17.00 hrs onwards, the discharge started increasing along with the water level and by 22.00 hrs it almost regained normal discharge of $400\text{m}^3/\text{s}$ (Figure 9). This increase in flow is attributed to controlled blasting of landslide dam by Nepal Army to allow passage of water from the reservoir. Although there are possibly stream discharge measurement sites close to the landslide, but the area close to the upstream side (belonging to 2.5MW Sunima hydropower project) was damaged due to lake formation and data from immediate downstream i.e. from 10.5 MW Sunkoshi hydropower project was not available. Therefore, data from Bahrabise and Pachuwarghat were analysed. On 3rd August the flow in to the lake remained at around $160\text{m}^3/\text{s}$ at Bahrabise and there was slight drop of discharge at Pachuwarghat at around 17.00 hrs after which it regained to $400\text{m}^3/\text{s}$ (Figure 10). Discharge data at Pachuwarghat was analysed for 8 days (1-8 August), peak flow was observed on 4th, 6th and 8th August at Pachuwarghat (Figure 11). The discharge data at both the upstream and downstream provides very crucial information that needs to be monitored continuously for effective disaster management.

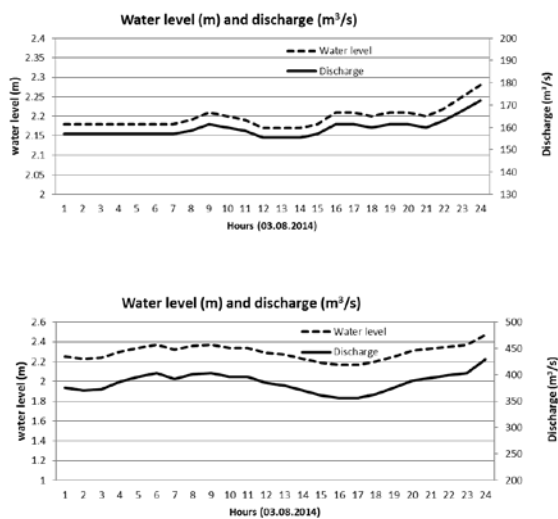
Figure 10. Water level and discharge observations at a) Bahrabise (upstream of landslide) and at b). Panchuwarghat (downstream of landslide) on 3rd August 2014 showing normal flow between two stations except for marginal reduction at around 16-17hrs at Panchuwarghat (Data source: Nepal Govt.).

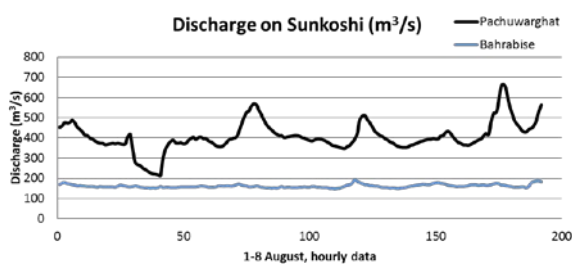
Figure 11. Sunkoshi discharge at Bahrabise (upstream of landslide) and Panchuwarghat (downstream of landslide) during 1-8th August 2014 showing variation between two stations particularly three discharge peaks at Panchuwarghat that could be related to higher flow from the landslide dammed lake. The dip in discharge is attributed to reduced flow on 2nd August due to landslide dammed lake formation (Data source: Nepal Govt.).

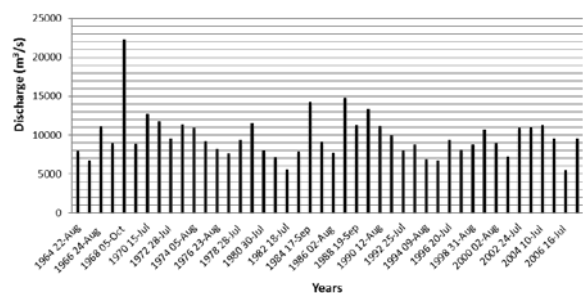
Figure 12. Peak discharge at Kosi Barrage, high values correspond to flood and breaching of embankments. Even at lower value, embankments have breached indicating role of sedimentation in reducing the actual capacity of the reservoir (Data source: NIC, Bihar Govt.)

Indian border lies at a distance of 270 km from the landslide and lake area and the most important hydrological structure, Kosi barrage is clearly at a stake. In the event of sudden release of water due to breach, it can be severely affected. Therefore, all 56 gates were kept open at Kosi barrage and nine districts of north Bihar were advised to be on high alert till 4th August (Times of India, 4th August). The Kosi barrage with a capacity to handle 9,50,000 cusec (26,900 m³/s) had embankment breached at 1,44,000 cusec (4100 m³/s) in 2008 (Sinha, 2009a; 2009b). Therefore, there was a concern and it is important to note that due to siltation and river aggradations, the barrage capacity has reduced since its construction in 1964 (Figure 12; Sinha, 2009a and 2009b). The peak discharge in 1968, 1971, 1980, 1984, 1991 are associated with major flood events, even these

were lower than the highest capacity of Kosi barrage as well as estimated peak flood discharge (Figure 12 and Table 2). Kosi basin has a high sediment yield rate and larger catchment area compared to its alluvial plain, which suggests large volume of sediment is deposited in the relatively small area and as a result river aggradations takes place in downstream areas close to Kosi barrage and adjoining areas (Sinha, 2009a and 2009b; Sinha and Friend, 1994).

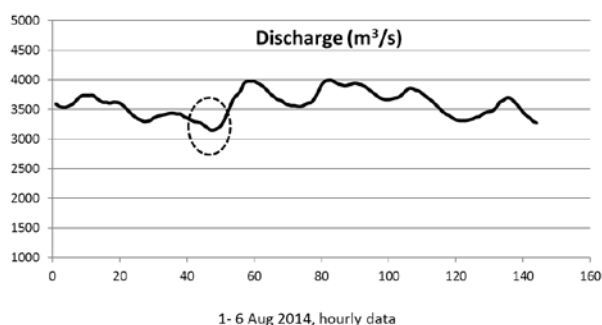
Figure 13. Sunkoshi discharge at Chatara (43 km upstream of Kosi Barrage) during 1-6th August 2014 showing the dip in discharge attributed to reduced flow due to landslide dammed lake formation on 2nd August (Data source: Nepal Govt.). Such data provides actual travel time of flow from the dammed landslide lake to Kosi Barrage.

In order to assess the damage control efforts at Kosi barrage, the immediate upstream data available at Chatara, Nepal was analysed. The discharge of Sunkoshi was between 3000-4000 m³/s during the first week of August 2014 (Figure 13). It shows a reduction in discharge around 17.5 hrs after the reported time of landslide and dam formation (2.30 hrs on 2nd August 2014), which is equivalent to travel time of the water from landslide area to the gauge site at Chatara on Sunkoshi. Considering its distance of 43 km from Kosi barrage, it was expected that the flood water would reach Kosi barrage approximately after 20 hours in the event of breach. Therefore, if the breach time is known then very efficiently preventive measures can be taken as sufficient time would be available to evacuate. However, in the present case as a preventive measure, a large number of people were evacuated, which is a welcome move, but such scientific data can be considered in future to optimise the evacuation plan.
