# INTERNATIONAL CHARTER SUPPORT DURING MAJOR FLOOD DISASTERS IN INDIA

G. Srinivasa Rao\*, C. M. Bhatt, P. G. Diwakar

National Remote Sensing Centre, Indian Space Research Organisation, India - (srinivasarao\_g@nrsc.gov.in)  
National Remote Sensing Centre, Indian Space Research Organisation, India - (bhatt\_cm@nrsc.gov.in)  
National Remote Sensing Centre, Indian Space Research Organisation, India - (pgdiwakar@nrsc.gov.in)

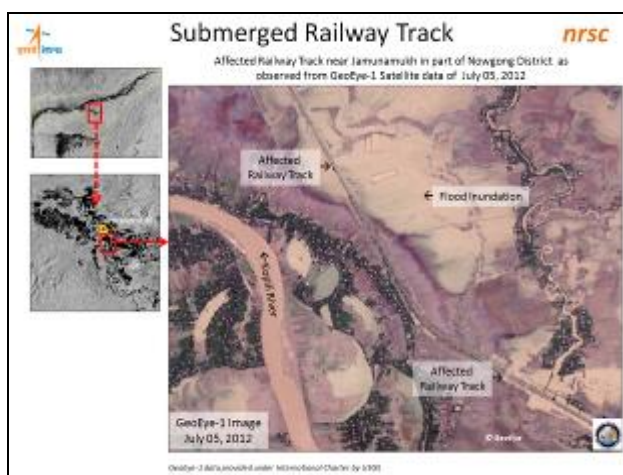
**3.1.5 Affected Railway Tracks:** Significant damages to railway track due to these floods were reported. About 88 km length of railway track in Assam state was observed to be affected by these floods as on July 02, 2012. Figure-4 shows the affected railway track near Jamunamukh in part of Nowgong district as observed from GeoEye-1 data of July 05, 2012.

Figure 4. Affected railway track near Jamunamukh in part of Nowgong district as observed from GeoEye-1 data of July 05, 2012.

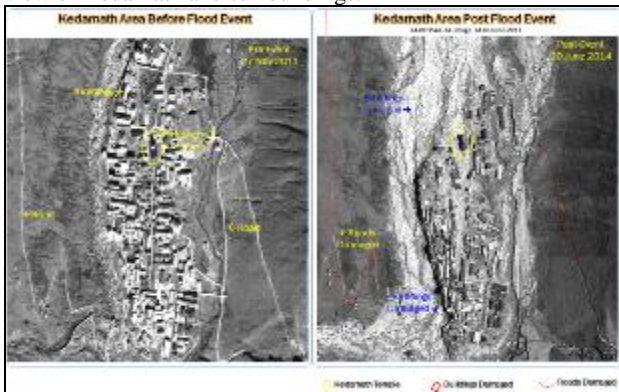
Departments. Figure-7 shows the pre and post flood situation view of Kedarnath and surroundings.

Figure 7. Pre and post damages observed in Kedarnath region.
