THE REPRESENTATION OF CULTURAL HERITAGE FROM TRADITIONAL DRAWING TO 3D SURVEY: THE CASE STUDY OF CASAMARY'S ABBEY

M. Canciani^a, M. Saccone^a, *

WG V/2 - Cultural Heritage Data Acquisition and Processing

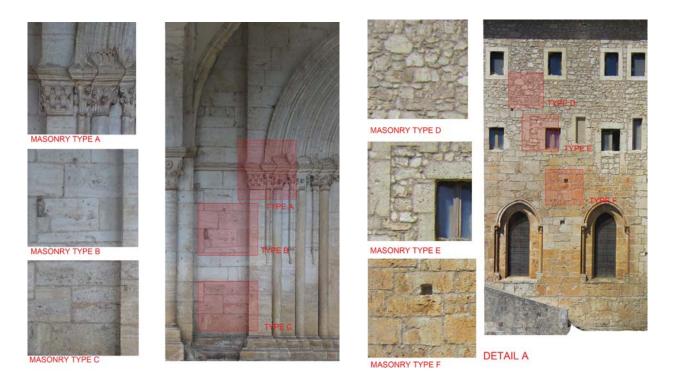
Figure 3a. Masonry Type of the Church

Figure 3b. Masonry Type of the East Façade of the Dormitory

Taking the main facade of the church as an example it denotes in the lower range the use of a rather regular and homogeneous masonry of square blocks of various sizes (Figure 3a, masonry Type C) on which is superimposed at the height of the lintel of

the side doors a masonry (Figure 3a, Type B), consisting of large squared elements of various sizes and different color, probably coming from the counting of pre-existing Roman structures in the area and that testify two subsequent building phases chronologically contiguous.

Even the entrance portal is due to a later phase than that of the wall, being the portal framing set against the vault of the narthex (Figure 3a, masonry Type A).

Looking at the **Eastern front** of complex the variations of wall texture and discontinuities, it is possible to hypothesize a stratigraphy of the specific segment: a first phase involving the construction of the church and the first two levels of building place to the left and the new sacristy to the right (Figure 3b, Type F). In specific detail the variation of the wall texture also allows to read the transformations that occurred at the open in breach windows, then made in a later phase and those buffered belonging to a contemporary phase (Figure 3b, Type E).

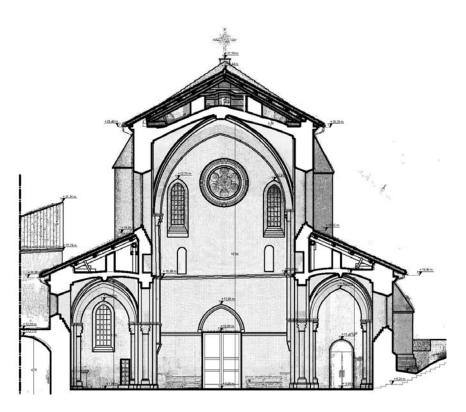
Figure 4b. Cross section, looking at the church counterfaçade

In particular, concerning the **church**, in the drawing of the plant are obvious that the projections of the ribs of the voults do not have a linear path but curvilinear (Figure 4a); the projection of the vaults is not placed vertically respect the base of the south wall pillars and this misalignment is also evident in cross section (Figure 4b). In longitudinal and cross section it is still denotes a marked inclination of the intermediate moulding that denouncing a difference in altitude to witness a change in the structure than the optimum configuration, possibly due to a defect in the original construction.
