EXTRACTION OF FLOODED AREAS DUE THE 2015 KANTO-TOHOKU HEAVY RAINFALL IN JAPAN USING PALSAR-2 IMAGES

F. Yamazaki^{a,*}, W. Liu^a

^a Chiba University, Graduate School of Engineering, Chiba 263-8522, Japan - (yamazaki, wenliu) @tu.chiba-u.ac.jp

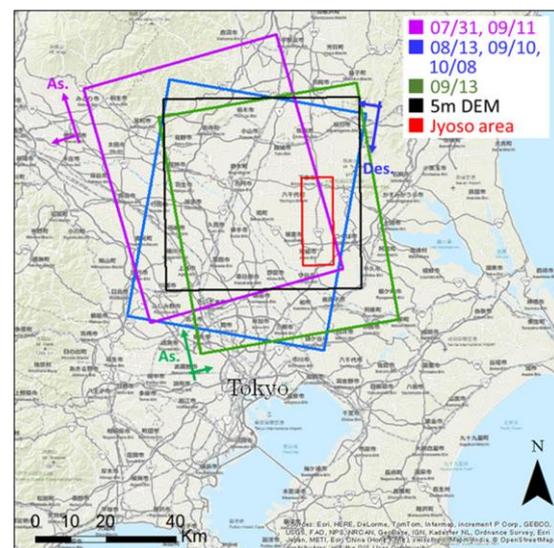
Figure 1. Coverage of PALSAR-2 data in the Kanto region of Japan and the study area (Josso city) in red square

Joso city is located in about 50 km to the north-western direction from the central Tokyo, as shown in Figure 1. The study area is shown by the red square in the figure. In this area, two major rivers, the Kinugawa river (west) and the Okai river (east), flow from the north to the south.

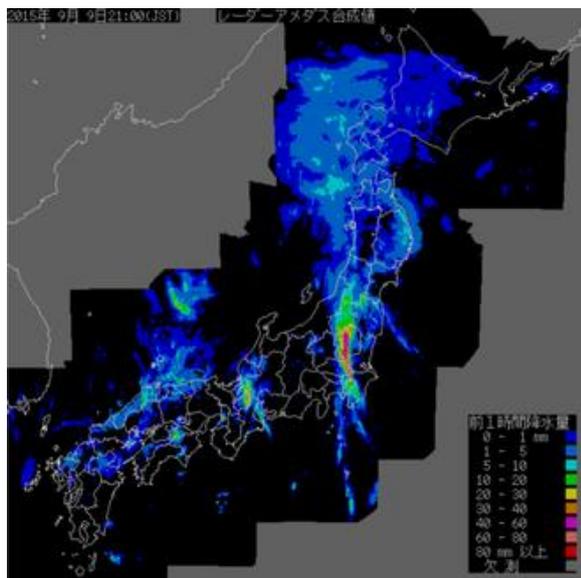
Figure 2. One-hour rainfall distribution map on 21:00, Sept. 9, 2015. A strip of heavy rainfall can be observed along the Kinugawa river catchment (CEReS, 2015)

Affected by two typhoons, a linear heavy-rain cloud stayed for several hours in the upstream of the Kinugawa river, as shown in Figure 2. The maximum cumulative rainfall from September 9 to 11, 2015 exceeded 600 mm in the upstream area, which is the record breaking volume in this region.

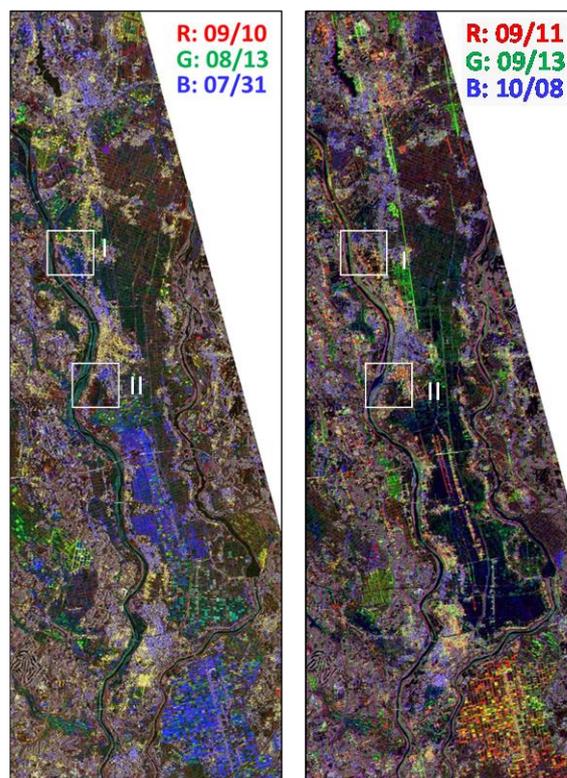
(a) colour composite 1 (b) colour composite 2

Figure 3. Multi-temporal colour composites of PALSAR-2 images for different combinations

The water level of the Kinugawa river in Joso city increased rapidly in the early morning of September 10. An overflow from the river bank was reported by the city government at Wakamiyado district (Square I in Figure 3) at 7:40 am. The flood-water went down in the city from the north to the south. A failure of the river bank finally occurred at 12:50 in the afternoon at Kamimisaka district (square II in Figure 3) and then almost all the area in between the two rivers became under water quickly.

In order to observe the flood situation visually, two colour composite images were made as shown in Figure 3. The left image shows the composite of the two pre-event dates and one when the flood just started. The right image shows the composite of three dates in and after the flood, which depicts the reduction of water in time.

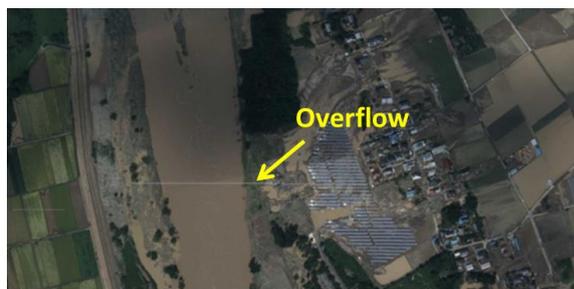
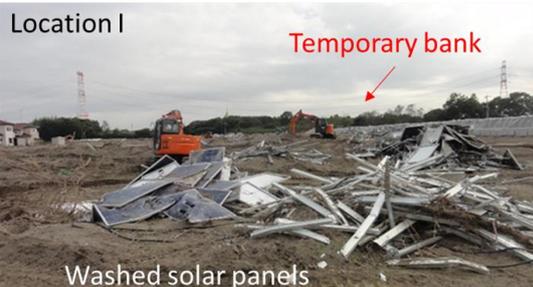
(a) Location I where overflow occurred

Figure 4. Aerial images taken by GSI on September 11, 2015 (up) and ground photos taken by the authors' field survey on October 29, 2015 (down) for the two major damage sites.

The flood situation of Joso city, bounded by the Kinugawa and Okai rivers, was investigated from the multi-temporal PALSAR-2 images. Figure 4 shows aerial images taken on September 11, 2015 (GSI, 2015b) and ground photos taken by our field survey on October 29, 2015 for the sites I and II.

At the site I, the overflowed water washed away solar panels placed inside the river embankments. When we visited the site, a temporary bank was already built and the removal of the damaged panels was on-going. At the site II, the river bank was collapsed for a length of 200 m (MILT, 2015). When we visited the site, emergency restoration using sheet-piles and a temporary embankment has already completed.

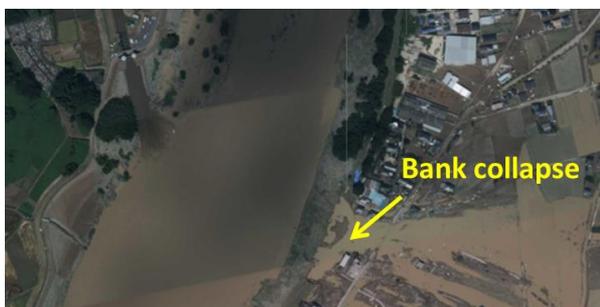
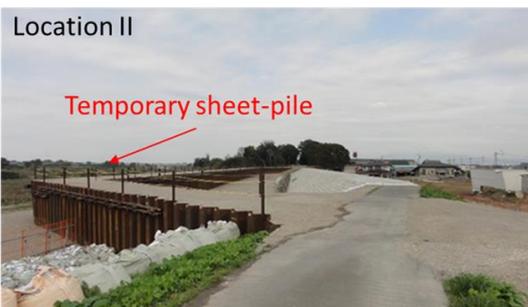
(b) Location II where the bank collapsed

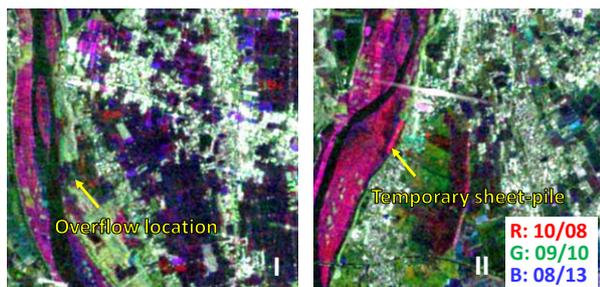
Figure 5. Multi-temporal colour composites of PALSAR-2 images for the two major damage sites

Figure 5 shows the colour composite of three PALSAR-2 images at the sites. The damaged banks and new sheet-piles can be observed in the figure.

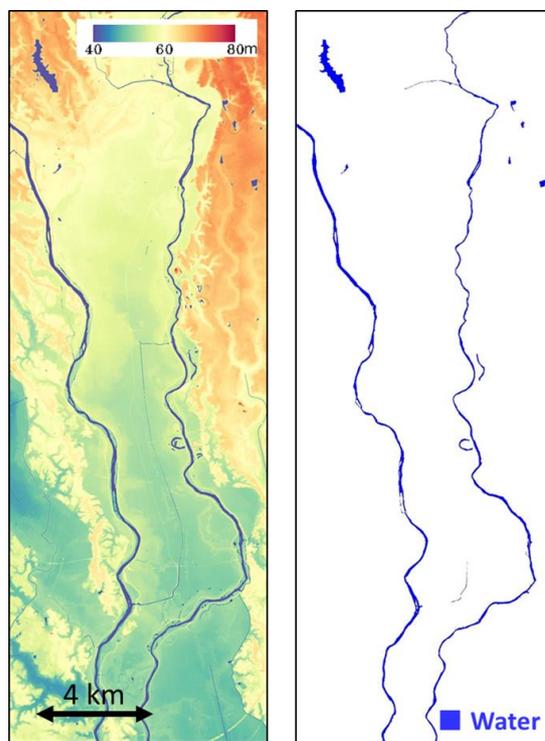
(a) GSI's 5m DEM (b) Water bodies extracted from the 5m DEM

Figure 6. GSI's 5-m DEM (a) used to extract original water bodies and the extracted result (b)

To extract flooded areas, the land-cover classification in the pre-flood time should be considered because there were a lot of water bodies in the study area including rivers, channels, and paddy fields. Figure 6 shows the 5-m DEM (GIS, 2016) and the extracted water areas based on it. These original water areas were determined by the condition that an elevation lower than 41.0 m with an object size larger than 0.01 km².

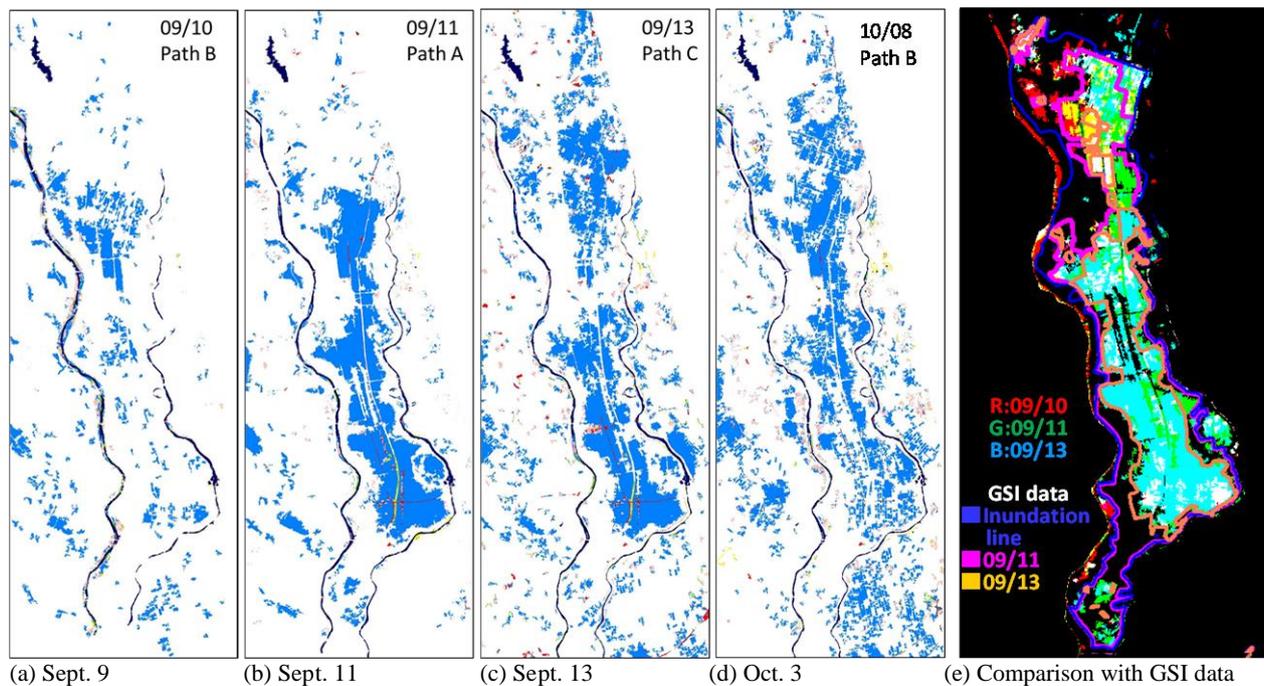
Figure 7. Extracted water areas from the PALSAR-2 images and comparison of the results with the GSI's visual inspection data

The extraction of inundated areas was carried out for the PALSAR-2 images during and after the flood. Figure 7 shows the extracted flooded areas on September 10, 11, 13 and October 8, 2015. The total area of flood-water was the maximum on September 11 in actual observations. But due to the effects of SAR observation conditions, the extracted water distributions from the SAR data were slightly different. Built-up urban areas could not be extracted because radar did not reach to the ground (water) surfaces there. The path C estimated somewhat different water areas because of its right-look condition. Note the paths A and B were left look.

The our extraction results are compared with those by visual inspection of aerial images (GSI, 2015b) in Figure 7 (e), where the GSI's truth data are shown by boundary lines. It is observed that our results agree fairly well with the truth data. There exist differences in observation times, especially for the images on Sept. 11 and 13. On these days, PALSAR-2 images were acquired at night-time while the aerial images at daytime.
