## DOCUMENTATION OF HISTORICAL ARCHITECTURES THROUGH THE COMBINED USE OF DIGITAL SURVEYING TECHNIQUES

**KEY WORDS:** Architectural surveying, laser scanning, digital photogrammetry, thermal imaging, restoration, detached frescos

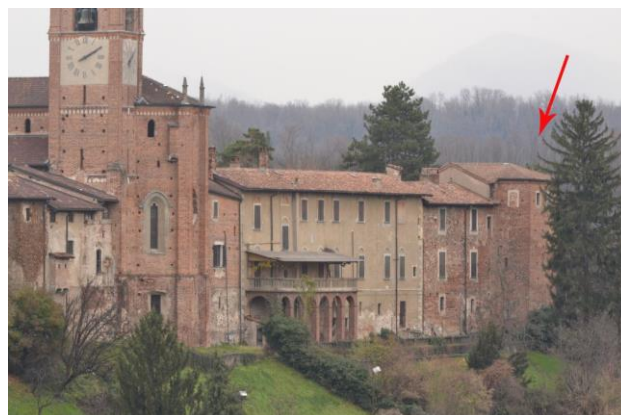
Figure 1: The ancient tower where the Baptistery is located

The Baptistery was realized into a former castle tower, adapting the existing spaces (fig. 1). The exterior aspect is mostly covered by other close structures, except for the back area corresponding to the external front of the tower towards the valley floor. The inner part is composed of only one inner room, separated into two connected spaces of different size: the first one, has a square plan covered by a cross vault, the second one, smaller, has a rectangular plan and is covered by a pointed barrel vault; the two spaces are connected through a small triumphal arch (fig. 2).

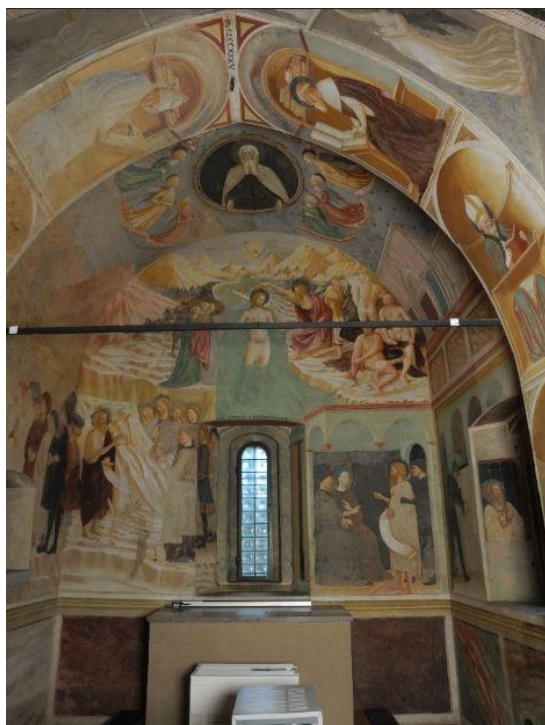
Figure 2: the interior of the Baptistery decorated with Masolino's frescos

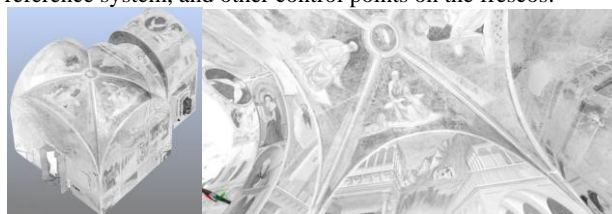
Figure 3: Laser scans of the interior space of Baptistery (grey scale visualization)

Most of the geometric surveying relied on the use of laser scanning. It's been a consolidated technique for the architectural surveying for almost a decade; improvements in technology allowed for more powerful and portable instruments, able to record some millions of points for every scan. A series of scans with colour information were taken inside the Baptistery with a Faro Focus 3D. Registration was carried out with targets obtaining a precision of about  $\pm 2-3$  mm and 220 million points inside the structure ( $8 \times 4 \times 6$  m roughly). Both checkboard and sphere targets were used; the instrument was able to capture also some architectural details, such as window profiles, which are usually more likely to produce a no-data area. Registration was carried out using Scene software, which allows automatic detection of targets (fig. 3).

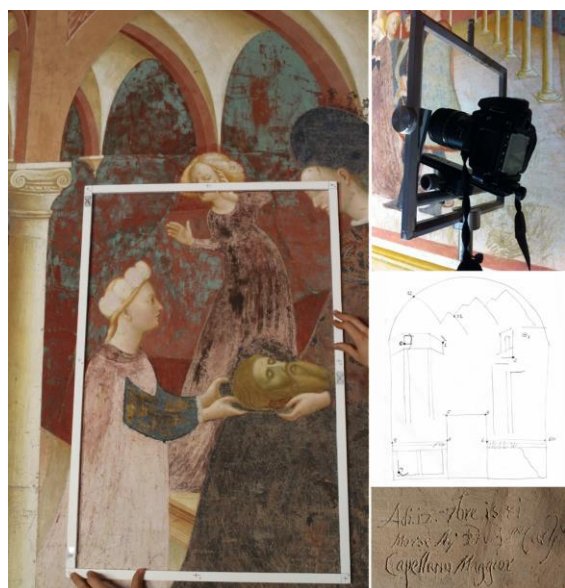
Figure 4: Photographic documentation of graffiti and manual sketches of measurements

acquired, to be used as a base for digital drawings; these sets of images were principally acquired with raking lighting, so as to enhance their visibility and readability. In this case a series of premeasured frames were used to obtain a more accurate georeferencing (fig. 4).

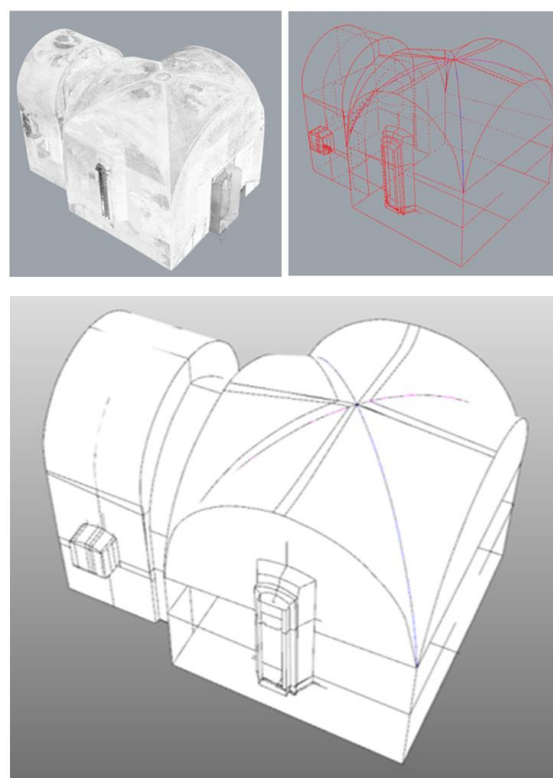
Figure 5: Laser scans (above), generative lines of the structure (middle), 3D model composed by digital surfaces

Data collected on the field were successively processed. Laser scans were used to produce 2D and 3D outputs. Registered cloud points were uploaded into a CAD software where an horizontal slice corresponding to the Baptistery plan was created and retraced. The same scans were also uploaded into Rhinoceros, a modelling software, after their conversion into an interoperable file format.

A specific plug-in (Point Cloud) for point clouds produced by laser scanners was used in order to better manage them. A series of different section lines were traced with polylines alongside the major generative lines of the structure. Thanks to these polylines, the respondent wall surfaces were digitally generated, with a high correspondence with laser scans and real object (fig. 5). For what concerns the photographic documentation, a series of rectified images of single walls were created. Since most of the inner wall are sub-planar surface, operations of rectification aimed to minimize distortions were successful. The different rectified images were successively assembled together in three-dimensions, using topographic measurements as reference and recreating the spatial disposition of walls. Two large portions of the southern wall, where there are most of the ancient graffiti, were also selected for a more detailed documentation. In this case, four different photogrammetric projects were set, two for each wall with different lighting conditions. The image blocks were processed with Agisoft PhotoScan Pro (fig. 6).

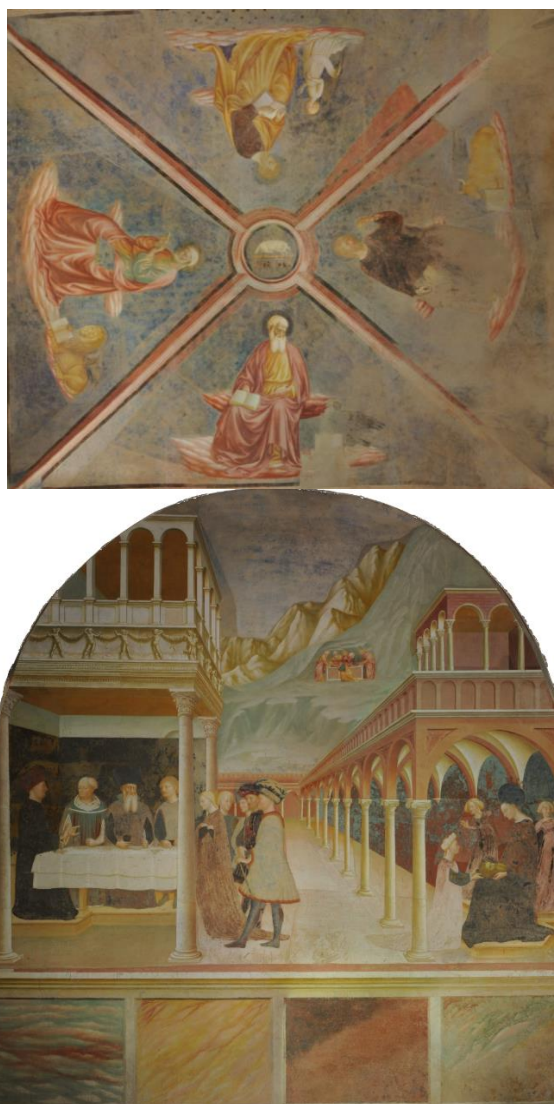
Figure 6: Orthophotos of the main vault (left) and of southern wall (right)

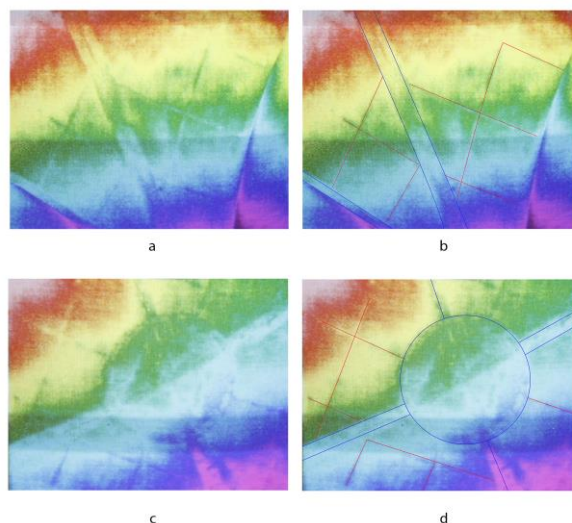
Figure 7: Enhancement of hidden lattice as support for detached frescos

Some important results were obtained analysing the thermal images of the main vault of the Baptistery. Today, only few visible clues suggest that the entire decoration was detached and then put in place again: for instance, a small rim is detectable along the external edge of vault frescos, where there is the connection with vertical walls. Thermal images revealed more than what can be currently see: near infrared sensor clearly shows geometrical lines which do not belong to any decorative or architectural element. This pattern is a hidden structure underneath the frescos and must be the rigid frame

where the canvas with detached frescos are fixed. The structure appears as a regular grid of squared elements, possibly made out of metal or wood (fig. 7).

The regular pattern is interrupted only along the arrises of the vault. In this area, larger profiles are visible, probably because here is where the different vault surfaces joint and where the frame is probably fixed to the vault itself. Similar larger profiles are visible on the external edges. A decorated band is present on the profiles of both arrises and external edges, but the features visible on the thermal images should not belong to frescos, because no other decorations, such as the Evangelists' figures, are detected.

It is likely that the framework elements have similar sizes to decorations, maybe a method to better hide their presence. Another interesting part is the central part of the vault, where there is a circular decoration with an *Agnus Dei* depicted. The circular edge is still visible also on the thermal images, and this could suggest the presence of another hidden structure, where the vault is almost flat.
