# DISCUSSION ON RESTORATION DESIGN OF LANDSCAPE SITE BASED ON 3D-TERRESTRIAL LASER SCANNING : A CASE STUDY OF QIWANG HALL IN SUMMER PALACE, BEIJING, CHINA

**KEY WORDS:** 3D- terrestrial laser scanning, Heritage Conservation, the Summer Palace, Qiwan Hall, Restoration design

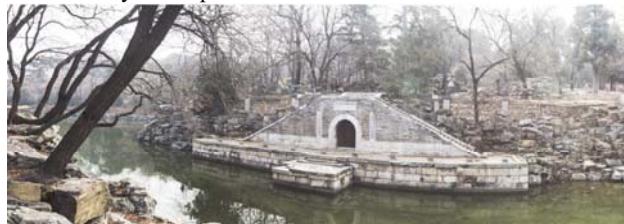
Figure 2 Current Situation of Qiwang Hall

present, only historic sites remain in Qiwang Hall Garden (Figure 2) and the Hall for Watching Cloud Rising (Figure 3).

From the south bank of the north river in the summer palace, you can enter the Qiwang Hall Garden through the steps left on both sides of the gate. It can also reach the interior of the garden directly through the stacking stone culvert stairs inside the gate. There are four exits in the culvert, hidden in the rockery of the south side of Hanxiang Pavilion (a pavilion by the river in Qiwang Hall Garden). The overall topography is gradually rising from north to south so that even in the southern courtyard of the Qiwang Hall Garden, people can also look across the scenery in the north bank. The Qiwang Hall Garden consists of 6 buildings connected by a corridor. The whole garden is divided into three courtyards in the north, south, and west by the buildings and corridors. The northern boundary of the garden is a corridor connected with the southern wall. The east, west and south sides of the garden are surrounded by low-lying earth hills. The caves formed by stacked stones on the south side of the courtyard are one of the land entrances of the Qiwang Hall Garden. At the entrance to the “cave”, a “curved path” is created, and the terrain in the park gradually decreases from south to north, making the entire garden hidden in the cascade of mountains and the environment is quiet. There are several ancient cypress trees in the west side courtyard. The winding road of rockery and the ancient cypress trees echo the horizontal inscribed board and couplets written by the emperor Qianlong at the gate of the river bank, reflecting the overall aesthetic interest of the garden. On the south-western part of the west side courtyard, there is a hole in the wall and a stone step below. It is another entrance to the Qiwang Hall Garden, which leads directly to the park.

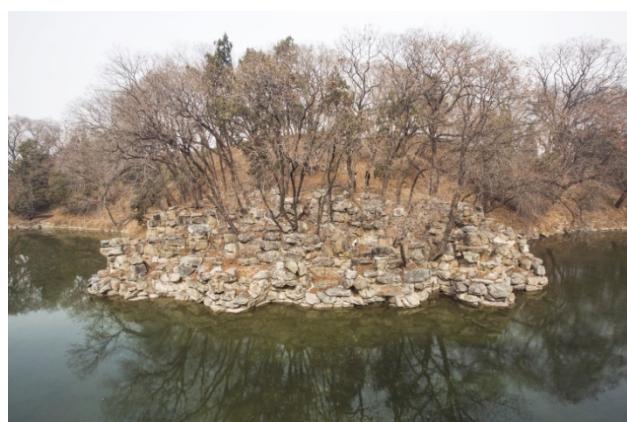
Figure 3. Current situation of the Hall for Watching Cloud Rising

On the other side of Qiwang Hall Garden, the Hall for Watching Cloud Rising is built on top of a rockery stack, which can be reached by stone steps on both sides of the east and west. It has no dock, and the north side is the outer boundary of the entire Summer Palace, with low accessibility. Therefore, it is speculated that it was originally created as a viewing place for Qiwang Hall on the other side of the river, rather than a place to visit. The remains of the path, apron, and paving bricks are still visible in the garden. There are two ancient cypress trees on either side of the main hall.

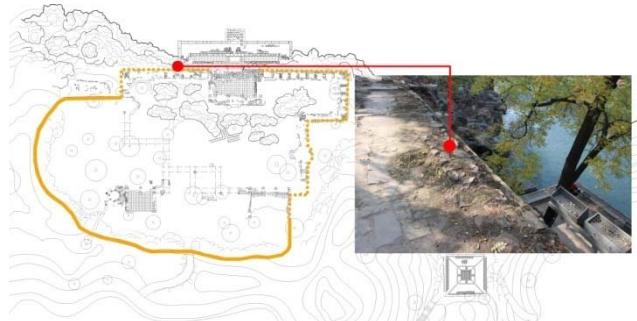
Figure 4. Traces of the wall of the Qiwang Hall Garden

For example, we can judge the entire garden through the traces of the wall base outside the corridor, which further confirms that the space intention of the garden in the Imperial Garden in Qianlong period is inward-looking (Figure 4). Taking a pavilion in the Qiwang Hall Garden as an example, we can easily obtain the building's plane information due to the rich information retained in the site, such as the location of the wall (Figure 5).

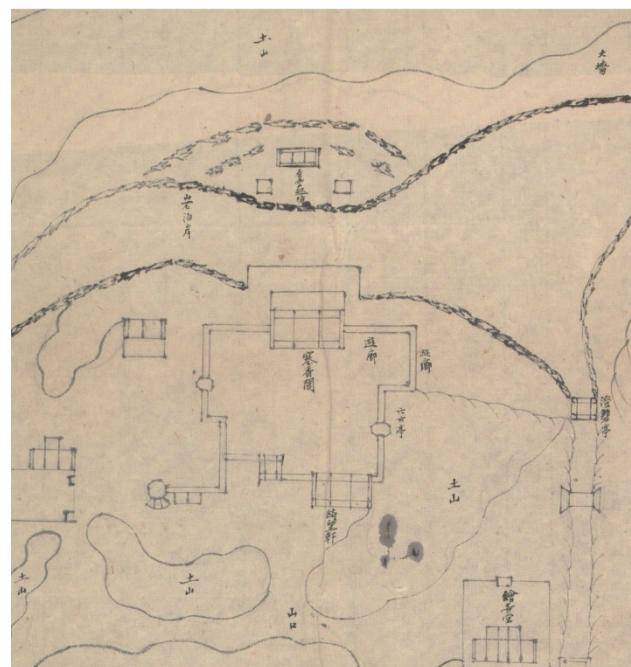
Figure 6. The survey map of Qiwang Hall Garden from the Yangshi Lei Chart (National Library of China, 2018)

There is no record of size information in the survey maps of the Qingyi Garden, which show the plane form of the building and the overall pattern of the Qiwang Hall Garden (Figure 6a). The survey map of Qiwang Hall has recorded its door position and its bay, depth, column height, stylobate height and other size information (Figure 6b). Both flat and dimensional data are important evidence for subsequent recovery designs.

The Yangshi Lei Chart is the architectural drawings, models, engineering practices and documents made by the Qing dynasty architect Lei family when they participated in the design process of royal architecture. It covers the survey site map, architectural design sketch, final drawing, construction process map, etc. There are currently 7 pieces of Yangshi Lei Chart related to Qiwang Hall Garden that have been survived. Six of them are the survey map of Qingyi Garden. One of them is the survey map of Qiwang Hall.

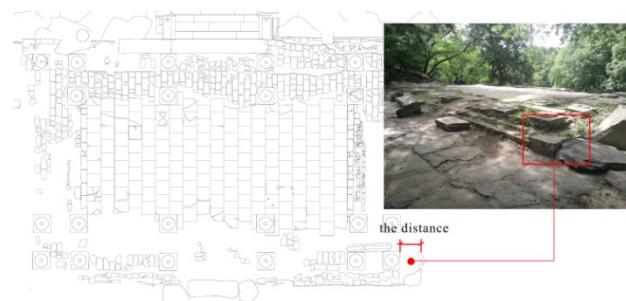
Figure 8. The Shanchu of Hanxiang Pavilion

There are several roof forms in Chinese traditional architecture, such as overhanging gable roof and hip and gable roof, etc. After conducting a large number of investigations and restoration studies related to the Royal Garden of the Qing Dynasty, the research team found that the size of the Shanchu (the distance between the foundation of the building and the eaves column) has a certain connection with the roof. Shanchu of the flush-gable-roof building is the smallest, followed by buildings with an overhanging gable roof. The Shanchu of the gable-and-hip-roof building and the hip-roof building is larger. However, in traditional Chinese architecture, the hip-roof building rarely appears in landscape architecture. According to these characteristics, we can judge the roof form of the building from the foundation left at the site. For example, it was found in the field survey that the size of the Shanchu of Hanxiang Pavilion was very large (Figure 8), so it was likely to have the gable-and-hip roof. The gable-and-hip-roof buildings in Chinese garden usually adopt the form of round ridge roof. Such cases are common in other gardens of the same period, so we can conclude that the roof of Hanxiang Pavilion is the gable-and-hip roof with a round ridge.

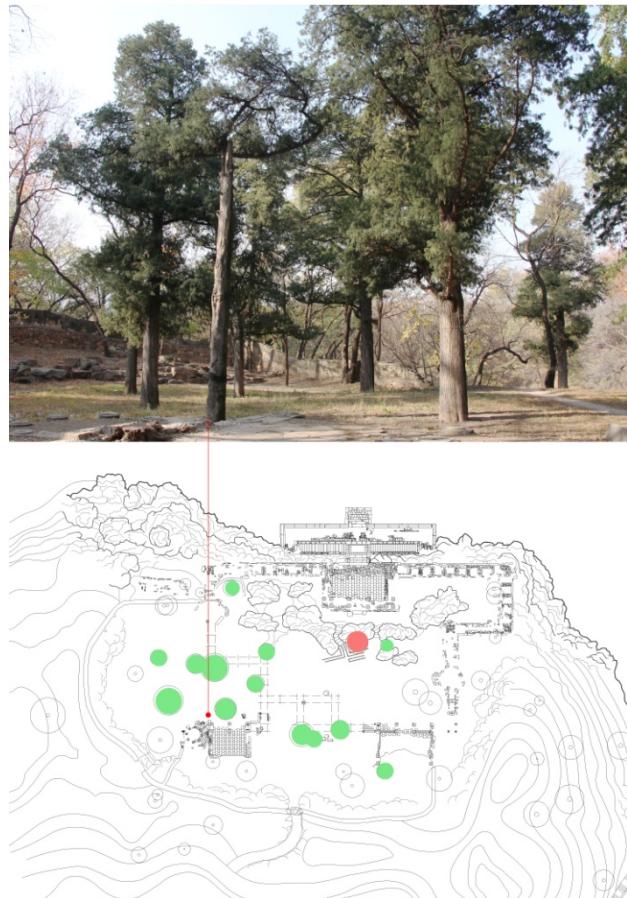
Figure 9. The old trees in the Qiwang Hall Garden

In addition to the ancient trees with clear historical records, the previous relatively common identification method of ancient trees was to measure the diameter at breast height (DBH). The ancient tree of more than 300 years is designated as the first grade, and is represented by the red card "Axxxx". It is measured by the DBH, which varies according to the species of

the tree. The cypress is 60cm and the pine is 70cm. The ancient trees between 100 and 300 years are classified as second grades and are indicated by the green card "Bxxxx". The cypress has a DBH of about 30 to 60 cm and the pine is 40 to 70 cm. In the site survey, we found that there are a total of 13 second-grade old cypresses with green cards and one first-grade old pine with red cards in the Qiwang Hall Garden (Figure 9). There were two first-grade old cypresses with red cards in front of the Hall for Watching Cloud Rising. However, the DBH of trees is greatly affected by other factors such as climate, so the age of ancient trees cannot be accurately calculated. The error of this identification method is large, and can not determine whether these ancient trees were in the garden at that time. From Emperor Qianlong's poems, we can know that there are ancient cypress trees in the courtyard on the west side where Cuilai Pavilion is located. There is no doubt about it. But whether or not these cypress trees are what we're seeing now needs to be supported by relatively precise techniques.

Tree ring identification method can be adopted on the premise of not affecting the growth of trees. The core of the tree to be measured is drilled with a growth cone. Dry, fix and sand the core sample. Tree rings can be interpreted by artificial or tree ring analyzer, and the tree age can be inferred according to the number of rings. In this way, we can get a relatively accurate tree age to help us judge the location of garden plants at that time. Plants are an indispensable part of a garden but compared with stacking stones in a garden, plants are alive, so it is

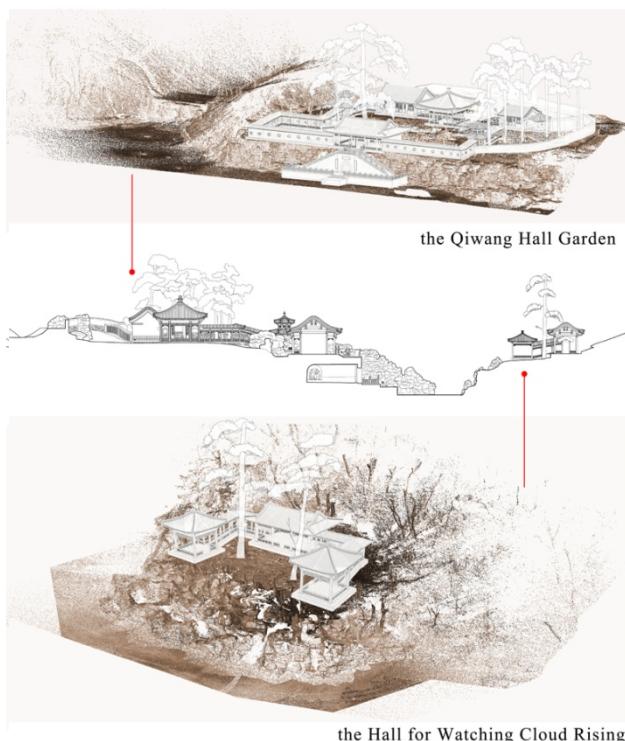
Figure 10. Landscape restoration based on TLS

Based on the above restoring materials and methods, preliminary restoring results are obtained (Figure 10). As there are no historical photographs of Qiwang Hall Garden and the Hall for Watching Cloud Rising at present, the images in the current restoration results are reasonable speculation, as an exploratory study of the original landscape. This is a relatively scientific result.

As mentioned above, the overall image of the building can be roughly deduced by referring to the architectural images of the same period and the relationship between the various components of the royal building in the Qing Dynasty when the site components such as the architectural plane are known. However, the creation of Chinese classical gardens is not all the product of stereotypes. Chinese gardens are very flexible and free, and the architecture sometimes bears the owner's own design ideas, which are different from the official practice.

For some special cases, we cannot find similar architectural forms in the same period such as the Cuilai Pavilion. Therefore, the form of the roof was speculated through architectural methods, and a form that most conforms to the artistic conception of the garden at that time was selected.
