3D DIGITAL AND PHYSICAL RECONSTRUCTION OF A COLLAPSED DOME USING SFM TECHNIQUES FROM HISTORICAL IMAGES

C. Beltrami¹, D. Cavezzali², F. Chiabrando³, A. Iaccarino Idelson⁴, G. Patrucco^{3*}, F. Rinaudo³

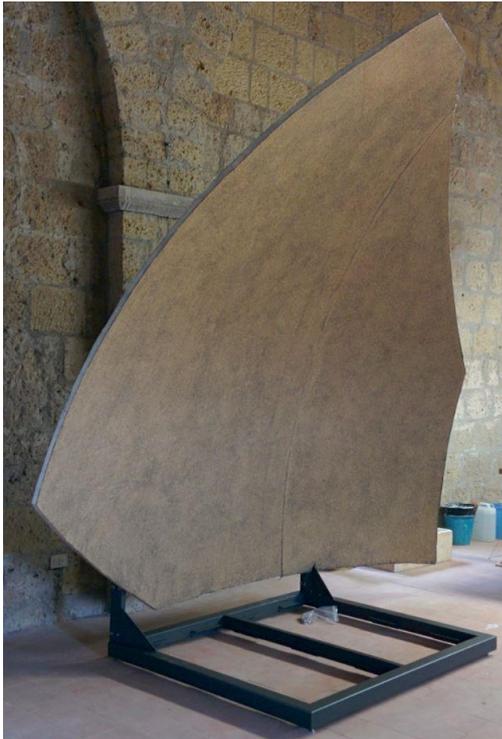
Figure 12. The support panel and structure.

The panels were built with a layered sandwich structure, Carbon fibre/epoxy – end grain balsa wood - Carbon fibre/epoxy. Each layer is soft and flexible during the construction and, while the epoxy resin completes its curing, needs to be held in place within a vacuum envelope on the surface of the counterform. In this case, a portion of sphere shaped with hot wire from large blocks of polystyrene.

The sandwich structure provides the required rigidity of the wide panels, independently from the display stands in steel, thanks to the choice of the carbon (416 g/m²) and of the thickness of the balsa core material (20 mm). On the rear of the cutting line, a broad molded rabbet plate was built with a lay-up of 8 layers of carbon, to be used for securing all the way the joining area with bolts. The structures were built by Equilibrarte srl under the direction of Antonio Iaccarino Idelson and Carlo Serino. In the following Figure 12 the final result is shown.

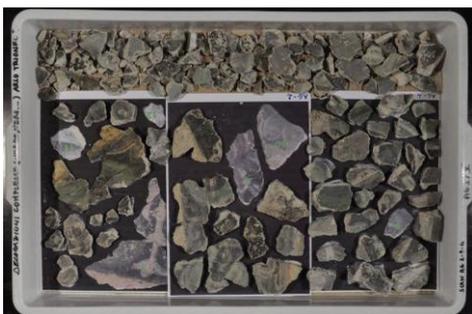
Figure 13. Example of classified fragments.

After the earthquake of 1971, the fragments of the fresco collected from the area of the apse of the Church of S. Pietro in Tuscania have been subjected to a long and meticulous preliminary examination. During this preliminary study every fragment has been cleaned, consolidated and carefully observed in order to be classified and stored in accordance with chromatic, consistency and conservation status criteria (Figure 13).

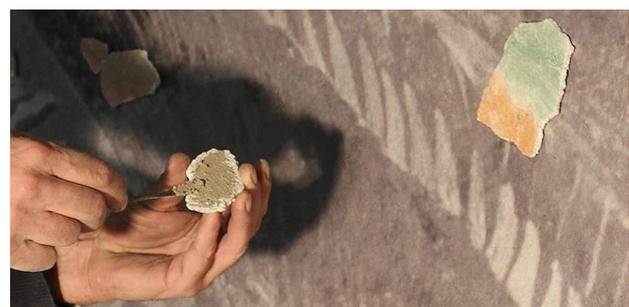
Figure 14. On the left: assembling of the fragments on the support structure.

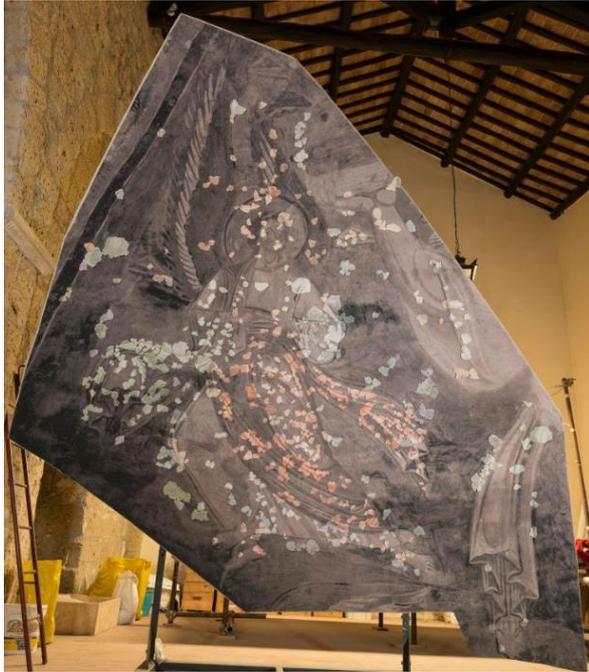
Figure 15. The support structure built by the restorers on which it is possible to see the remaining pieces of the original fresco.
