LANDSLIDE DEFORMATION MONITORING BY THREE-CAMERA IMAGING SYSTEM

KEY WORDS: Unmanned helicopter, Landslide monitoring, Three-camera imaging system

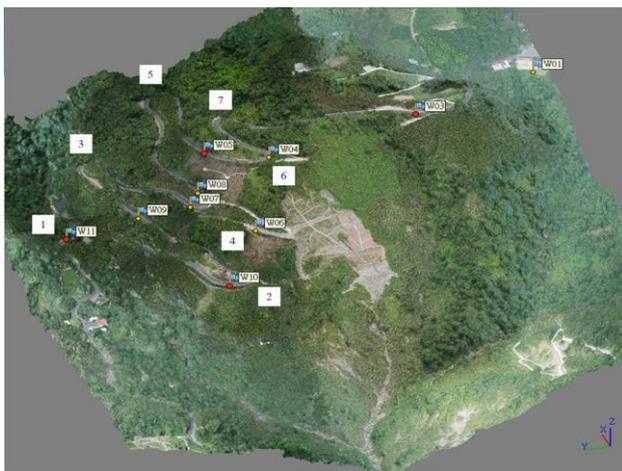
WuWanZai is locate at Tai-Road #18, i.e. A-Li-San Road, 42K-44K of Chia-Yi County, Taiwan. As shown in Figure 1, it situates at mountainous area with terrain variation more than 400 meters, thus the road was construct with five curves to reduce the slope. Due to its geological stability is low, a landslide had induced by a heavy rainfall event and cause the road collapsed with 150 meters long 10 years ago. Thus, two more curves had created to avoid the landslide area. Though the Fifth Maintenance Office of Directorate General of Highways, Taiwan had built eight underwater collection wells to reduce the water pressure in order to stop the land displacement, it is still necessary to continuously monitoring its deformation to maintain the road safety.

Figure 1. WuWanZai in 3D view with the location of GCPs/CKPs together with road curve number.

As shown in Figure 1, the distribution of road and landslide are separate at two sides. The ground control points (GCPs) and independent checkpoints (CKPs) can only be arranged along the roadside. To cope with non-well distributed control issue, the adopted unmanned helicopter is also equipped with PPK (post-processed kinematic) to obtain controls in the air. The positional accuracy of PPK is about 20 cm, which may not accurate enough, but better than no control.

For co-registration purpose, we established 11 GNSS stations by static continuous observation with 3-4 hours. Four of them highlighted in red are marked as GCPs and the others are treat as CKPs. Their distribution are depict in Figure 1 as well. The GCPs' locations are chosen as outermost as possible to avoid land deformation effect. Their positions have been survey by two times, i.e. March 31 and July 31, with four months difference. Within this period, two heavy rainfall events with accumulated rainfall about 140 mm had occurred and induced landslide. Except for W6, which is located very close to the landslide area, has significant horizontal and vertical displacements of 6.18 cm and 12.4 cm, respectively. The displacement of the others points are all under random noisy level and considered as no movement.

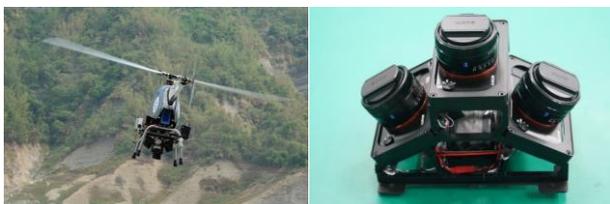
Figure 2 and Table 1 illustrates the appearance and specification of the proposed unmanned helicopter and three-camera imaging system. One advantage of unmanned helicopter is it can take-off and landing in a vertical way, like a multi-rotatory UAV, which

is suitable for mountain environment. Meanwhile, it has longer endurance time, i.e. 30 minutes, higher payload capacity, compare to a low cost multi-rotatory UAV. It has variable flying speed, i.e. from 0m/s until 30 m/s, which is also suitable for large area mapping like a fixed-wing UAV. In this study, we also design its flight path to follow the terrain variation with similar altitude (e.g. 75 and 200 meters above ground) in order to acquire similar image scale as well as high spatial resolution, i.e. GSD is about 1-3 cm.

Figure 2. The adopted unmanned helicopter and three-camera imaging system.

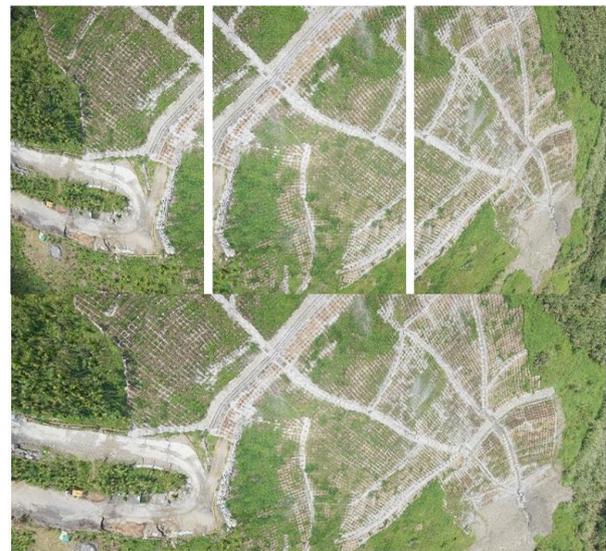
A raw image-stitching algorithm (Rau et al., 2016 & Jhan et al., 2018) was developed and applied to the acquired three-camera images before aerial triangulation. The reasons to use a three-camera imaging system for data collection is its 100 degree of FOV that can cover a rather larger area to reduce the required flight time and improve the successful rate during aerial triangulation, particularly for repetitive texture and less texture area. An example of three raw images and its stitched result are display in Figure 3.

Figure 3. Sample of three-camera raw images and the stitched result.

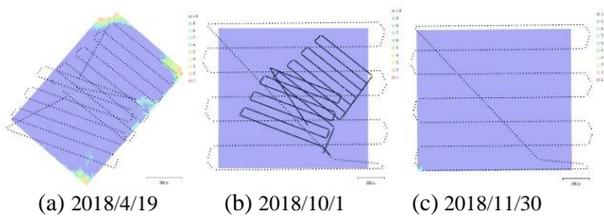
Figure 4. Flight tracks and photo positions.

In this study, we collect UAV images from April 19 until Nov. 31, in total six dataset were obtain. After applying the developed image-stitching algorithm, we conduct aerial triangulation using Agisoft PhotoscanPro© (renamed as Metashape© since 2019). Table 2 demonstrates the statistics of accuracy analysis results. We design three flight-tracks to cover the whole study area. However, as shown in Table 2, April 19 has only two flights and June 30 has only one flight, due to failures of image acquisition, such as images are blurred, cloudy or too dark, etc. The other dates have three flight-paths same as Oct. 1st. The flying altitude above ground with 75 meters is to focus on the road and landslide areas with GSD ~1cm, while the 200 meters altitude is to cover the whole study site with GSD ~3cm.

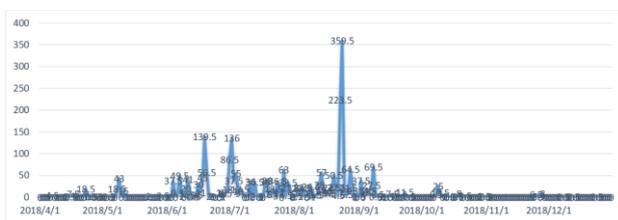
Figure 5 illustrates the daily precipitation plot between April 1st and Dec. 30th, 2018. It can be find that two heavy rainfalls occurred at June 20th and July 2nd with daily precipitation about 140 mm. Meanwhile, another heavy rainfall happened at Oct. 23rd and Oct. 24th had introduced a daily precipitation of 360 mm. These three major rainfall events had affect the landslide area seriously and caused significant deformation and shallow landslide. Detail analyses results will be discuss later.

Figure 5. Daily precipitation during the study period

In this study, we conducted two times of static GNSS observation, i.e. March 13 and July 31, for 3-4 hours at 11 stations. According to Figure 5, we notice that between those two dates, there are two heavy rainfalls events. Figure 6 and Figure 7 demonstrate their displacement in horizontal and vertical directions, respectively. From those two figures, comparing W6 with other stations, W6 has significant horizontal and vertical displacement. Since W6 is located very close to the landslide area and due to two heavy rainfall events that had induced land deformation, this phenomena is reasonable.

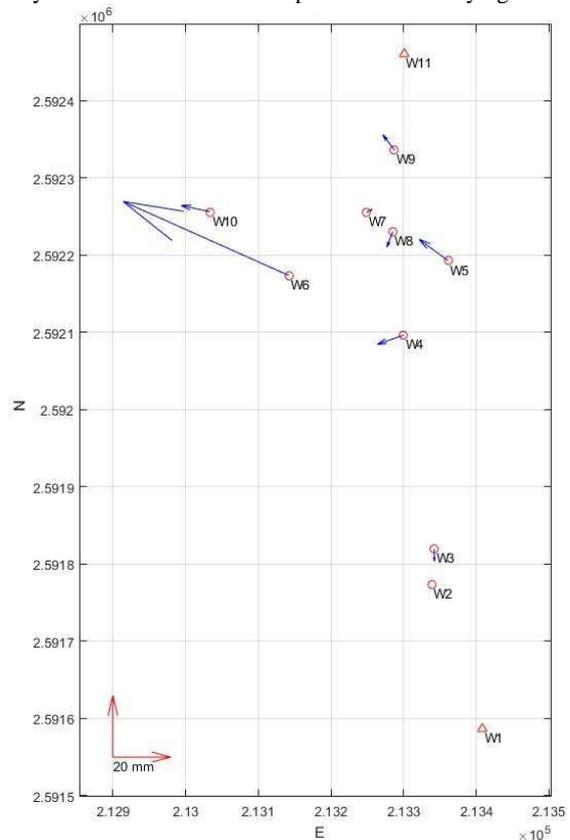
Figure 6. Horizontal displacement vector.

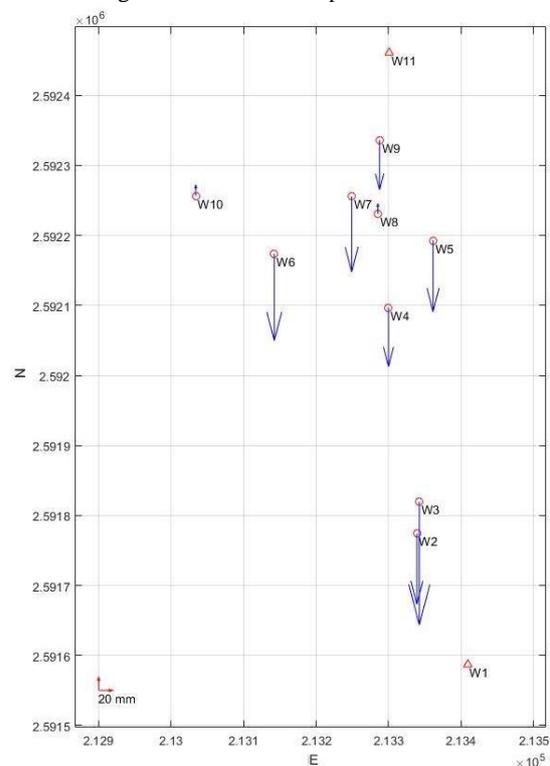
Figure 7. Vertical displacement vector.

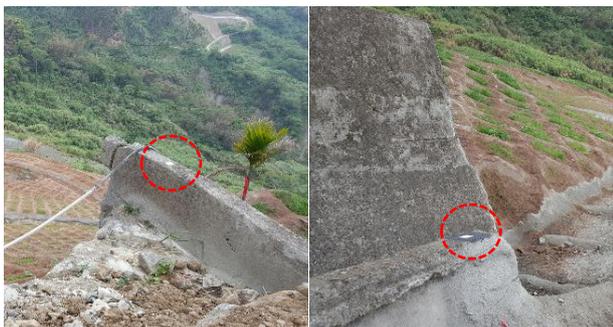
Since the setup and measurement of GNSS stations is time consuming, this study also establish 100 photogrammetric targets along the roadside. Two examples near the landslide area are illustrate at Figure 8. They are paint in white with black background to increase the contrast for easy identify and manual measurement on the original image. After aerial triangulation,

their positions can then be obtain by space intersection. Comparing two periods of results, we can conduct displacement analysis as well to increase the point-based surveying results.

Figure 8. Photogrammetric target examples (MTP63 & MTP64)

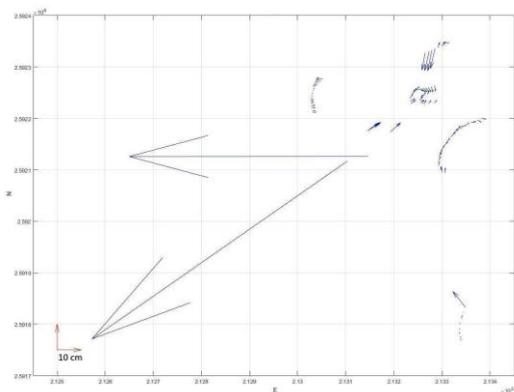
In this paper, two measurement results obtained from April 19 and June 30 are compare. Their displacement vectors are plot at Figure 9 and Figure 10 for horizontal and vertical directions, respectively. In which, one may observe two points that have very large displacement on both directions. They are named MTP63 and MTP64 as shown in Figure 8. Because of heavy rainfall and their locations are close to the landslide area, we obtain a horizontal displacement with 1.27 m and 0.99 m together with 0.89 m and 0.6 m of vertical offset. The other photogrammetric points also have small displacement, but not significant. This example demonstrate that utilizing photogrammetric method can compensate for the drawback of GNSS stations with lower cost.

Figure 9. Horizontal displacement of photogrammetric points.

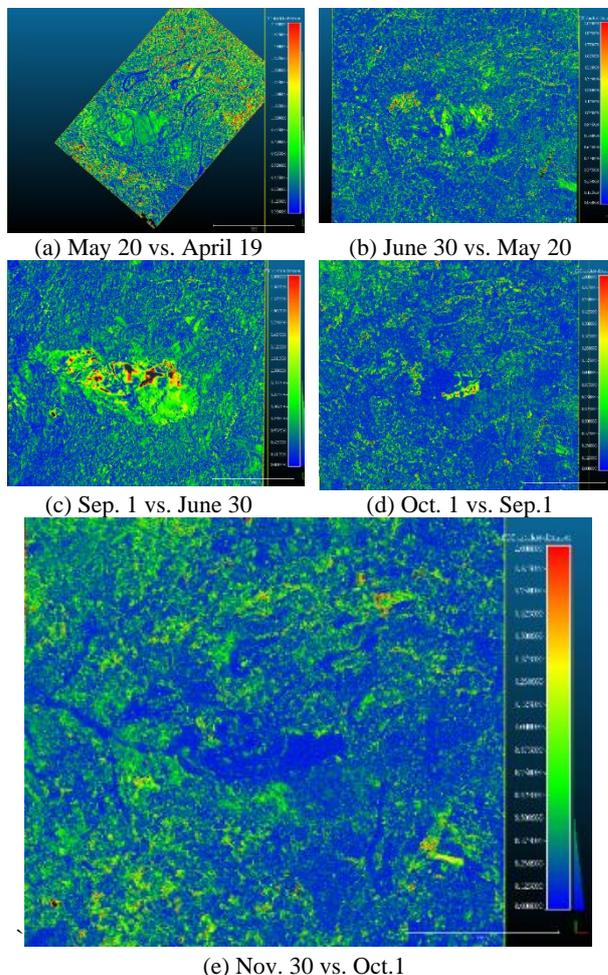
By using point-based measurement, we cannot realize the land deformation of the whole landslide area. We thus calculate the cloud-to-cloud (C2C) distance between two neighbored point clouds through CloudCompare© software to investigate the land deformation situations. Figure 11 shows five C2C plots for the whole six dataset in pseudo colour. The colour legend located at the right hand side depict the red colour has the maximum distance while the blue colour is the minimum one, i.e. 0 meter. The maximum distance for Figure 11(c) is 5 meters, while the other four plots are 2 meters.

First, we can observe the vegetation areas, particularly trees and miscanthus grass, have caused larger C2C distance. Because the trees is erroneous in image matching and the miscanthus grass may grow up quickly in one month, we may ignore the vegetation areas. Second, the road looks no change at all, as its surface is hard without movement. It has been prove by photogrammetric point's measurement. The dense image matching also perform very well at road surface. Finally, for landslide area, we can find out there is no land deformation from Figure 11 (a) & (e), due to no heavy rainfall had occurred between two neighbored data acquisition dates. The other three plots have shown larger C2C distance, particularly for Figure 11(c) due the largest rain fall happened at Aug. 23-24. It shows that the land movement is larger than 5 meters.

Figure 11. Point-to-point distance between two neighbored point clouds illustrated in pseudo colour.

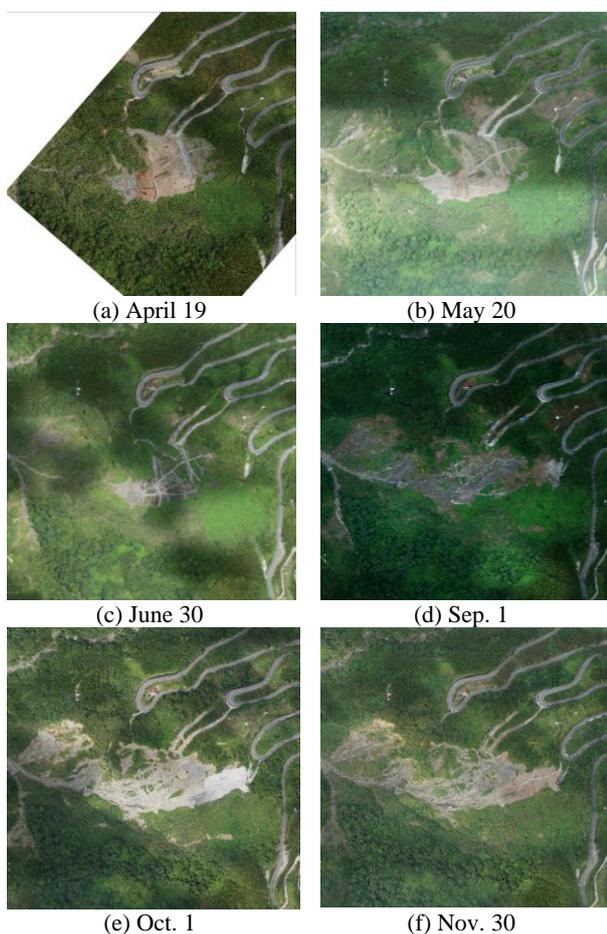
The ortho-image is generally used for inspecting the land cover types. Figure 12 demonstrates six ortho-images generated by the acquired UAV images. It is easy to identify the green colour of vegetation area, brown colour of bare ground or landslide, and grey-white colour of man-made constructions or road. By look into all ortho-images in Figure 12, we notice a significant change between (c) and (d), i.e. between June 30 and Sep. 1st, due to the largest rainfall happened at Aug. 23-24. Figure 13 also illustrates four in-situ close-range photos for comparisons. Comparing Figure 13(a) & (b), we can find out the slope protection construction has distorted due to the first rainfall event, i.e. June 20. This land deformation phenomena can be identify from Figure 11(b), but not easy to be found at Figure 12(c). Later after Aug.23-24 rainfall, the slope protection construction has almost destroyed, which can be saw from both C2C plot and ortho-image. Please notice that a new slope protection construction was built at the east side of the landslide area. It can be find from Figure 13(d), within the red dashed-ellipsoid, as well.

Figure 12.Ortho-image of each date.

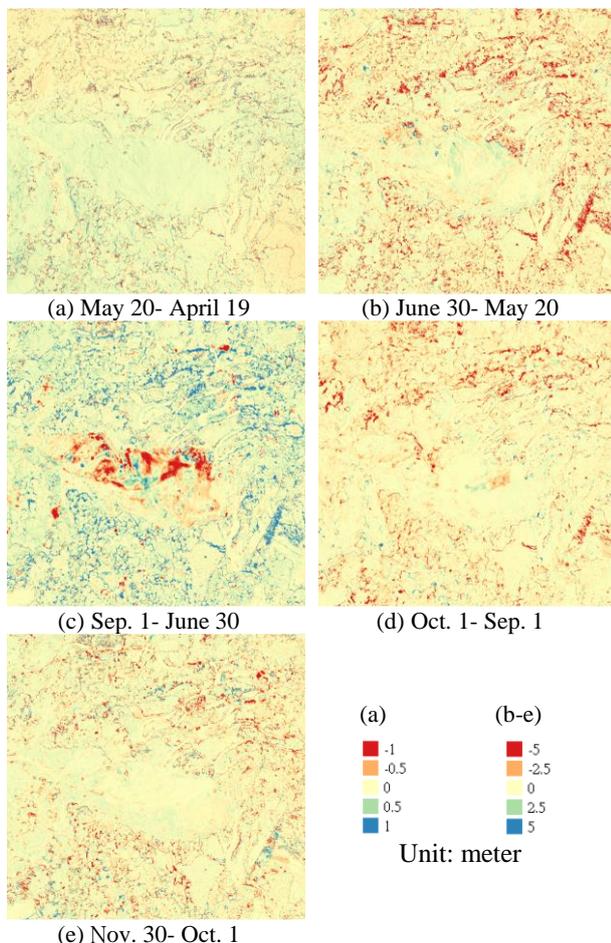
Figure 14 demonstrates the DSM elevation difference in pseudo colour. Please notice that the colour legend of Figure 14 (a) is different to Figure 14 (b-e). The DSM is generated by point cloud but contains only elevation information. Thus observing the DSM elevation difference, the land deformation phenomena are consistent with the C2C results shown in Figure 11. However, from DSM elevation difference, we can also obtain the earth's volume change and produce soil erosion and deposition map by digitization on the raster. On the other hand, it is difficult to obtain a vector map from C2C results.

Figure 14. DSM elevation difference between two neighbour dates.
