STRUCTURAL ANALYSIS OF WOOD BEAMS BY NON-DESTRUCTIVE METHODS IN RESTORATION WORKS OF THE CATHEDRAL OF MORELIA, MEXICO

Commission II, WG II / 8

KEY WORDS: Humidity content, density, wave velocity, stress waves, dynamic modulus, structural rigidity (stiffness)

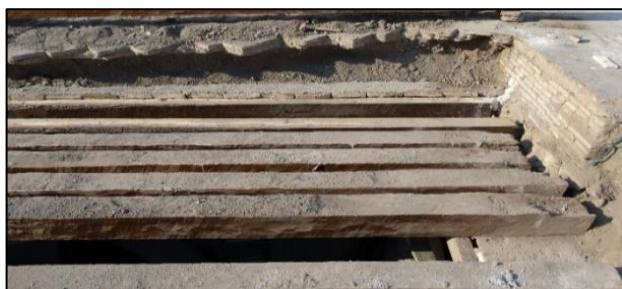
Figure 2. Old beams of the roof framework

The old beams were exposed on three sides to the environment of an interior ceiling and it is estimated that their service period was 50 years. Significant deterioration was visible in the ends that were embedded (Figure 3), therefore, the observations were made in the central segment with wood free of deterioration.

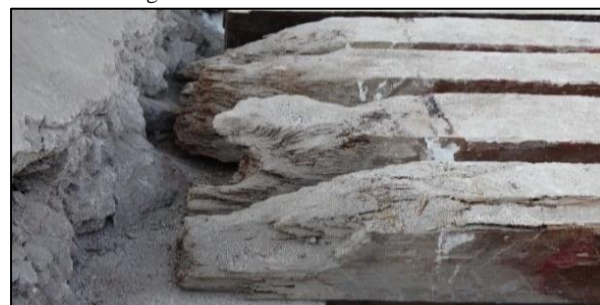
Figure 3. Deterioration in the ends of the beams
