ASSESSMENT OF EARTHQUAKE-INDUCED DAMAGE LEVEL ON BUILDINGS: ANALYSIS OF TWO DIFFERENT SURVEY METHODS FOR A CASE STUDY

KEY WORDS: Seismic Damage, Natural Hazard, Seismic Assessment, UAVs, Post-catastrophe surveying

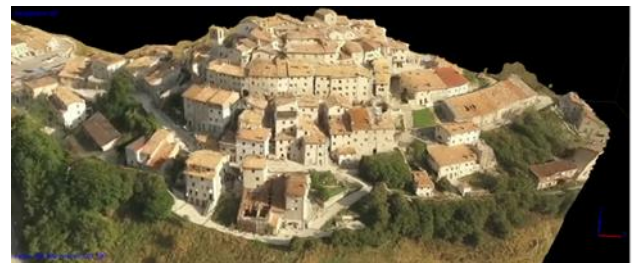
Figure 2. 3D model of Castelluccio before the earthquake

Since the damage on buildings after the earthquake of August 24th was very low, the model obtained through the elaboration of data from the first video was used to study the layout of the village before the strongest and most disruptive shock of October. Through the comparison of the two 3D study models obtained (Figure 2 and 3), and by deriving the entity of partial and total collapses, a DDE map was constructed.

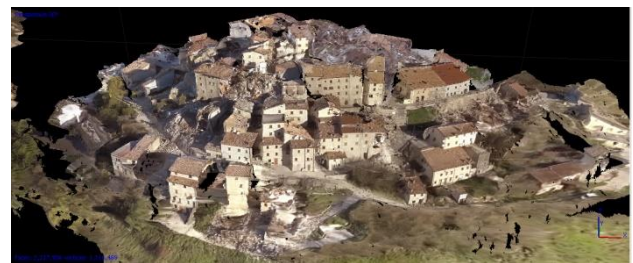
Figure 3. 3D model of Castelluccio after the earthquake

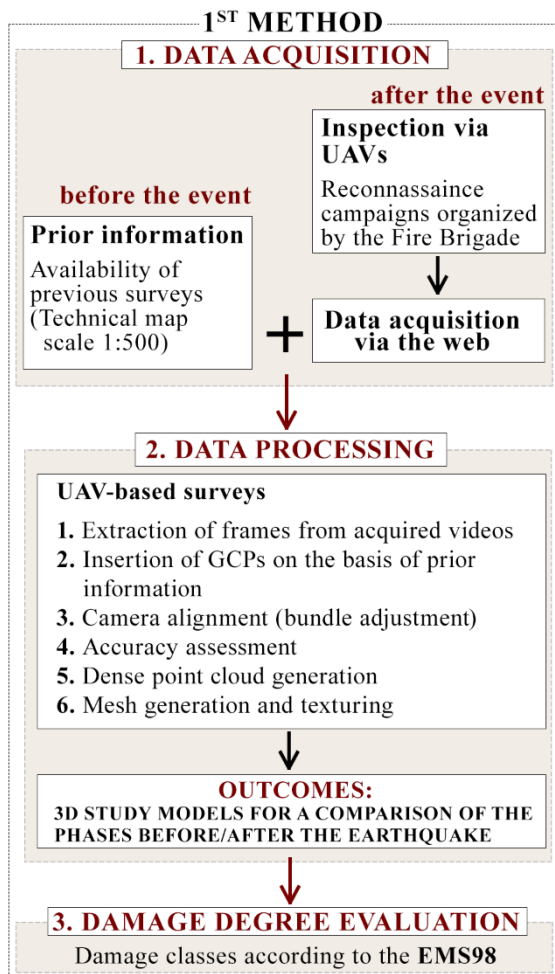
Figure 4. Workflow for DDE map for the 1st method

The workflow of the process for this first DDE method is synthesized in Figure 4 and is described in detail below:

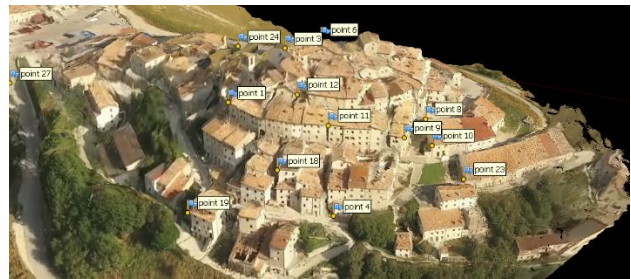
Figure 5. Position of GCPs in the pre-earthquake model

Furthermore, for a correct orientation and a proper scale of the 3D model, an adequate number of Ground-Control Points (GCPs) was added (Figure 5 and 6). Particularly, due to the availability of the technical map of Castelluccio dated back to 2004, it was possible to assign known coordinates to the GCPs. This expedient allowed to enhance and implement the accuracy of the model and to obtain a geo-referenced survey, based on the prior information available on the area.

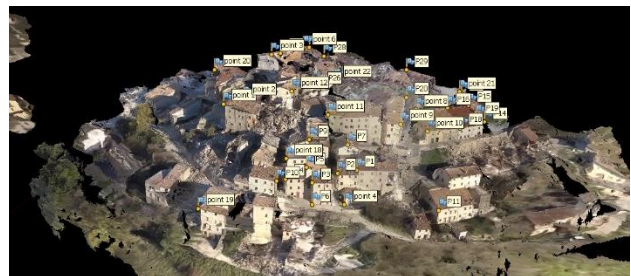
Figure 6. Position of GCPs in the post-earthquake model

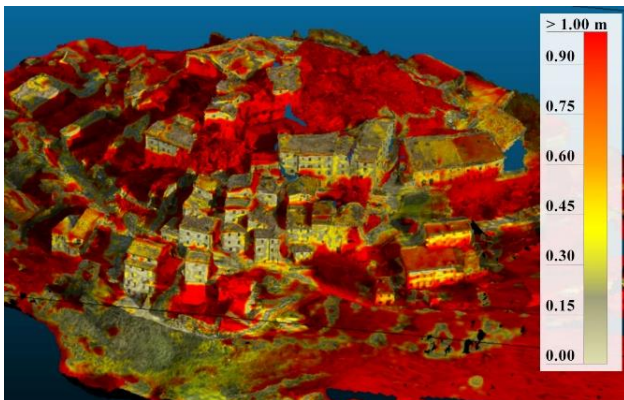
Fig. 7 Cloud-to-mesh comparison: computed distances

The outcomes of the computation are shown in Figure 7 (below): distances between the two models higher than 0.9 m allow to identify collapsed buildings; distances between 0.4 and 0.89 m correspond to intermediate levels of damage; distances lower than 0.4 m are in compliance with the error of representation of the technical map and identify no damage. By observing this graphical comparison, a map assessing the level of damage was constructed; in particular, each building was classified based on the distinction provided by the European Macro-seismic Intensity Scale EMS98 [Grünthal, 1998], defining six damage levels, from level DL0 (no damage) up to DL5 (total collapse) (Figure 8, below). It has to be noted that, since kind of survey is based on videos that were not specifically and originally recorded for

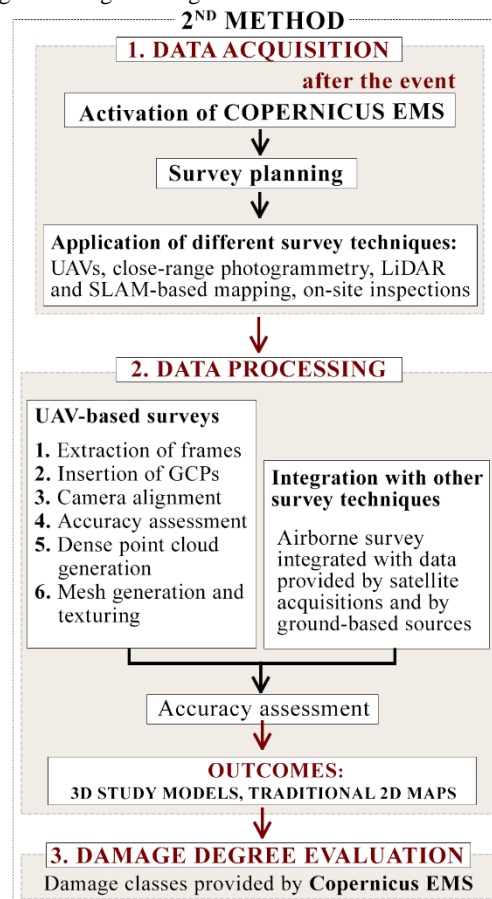
Figure 9. Workflow for the DDE map for the 2nd method.

The workflow for the DDE (Figure 9), in this case, presented many differences from the one illustrated in Figure 4:

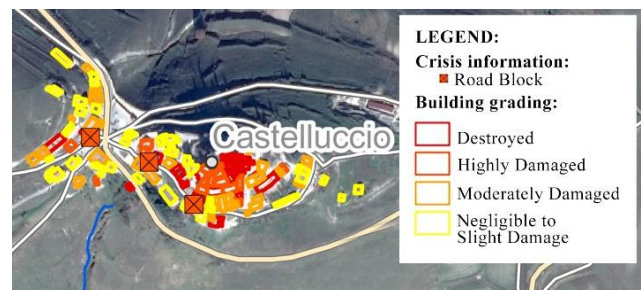
Figure 10. Copernicus EMS (© 2016 European Union), [EMSR190] Castelluccio Grading Overview Monit 01

The outcome of the EMS activation procedure is a damage level map (Figure 10) that is of course more accurate and precise than the one obtained through the application of the first method proposed, since it is the result of a study based on different survey acquisition systems. The map in this case classifies four different levels of damage on the buildings of the village, distinguishing

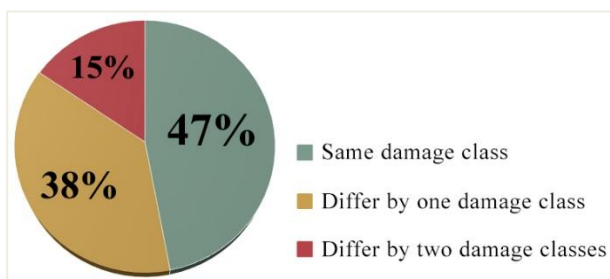
Figure 12. Comparison, in terms of surface occupied by buildings, between the two DDE methods

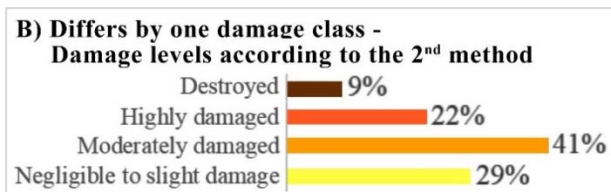
Figure 14. Difference by one damage class between the two DDEs: percentage of buildings that had a certain damage class according to the assessment of the 2nd method.

Looking at Figure 14 (below), anyway, it is possible to observe that the cases in which the DDE differed by one damage class are for the 41% the cases in which the buildings -according to the more accurate procedure of DDE based on the second method, were classified as "moderately damaged" and for the 29% the cases in which the buildings were classified as "negligible to slight damage".

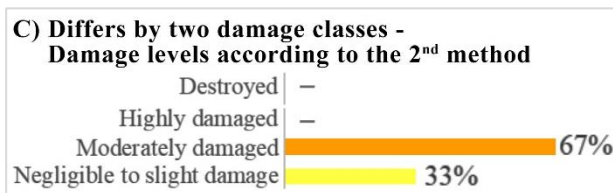
Figure 15. Difference by two damage classes between the two DDEs: percentage of buildings that had a certain damage class according to the assessment of the 2nd method.

Analogously, Figure 15 shows the cases in which the DDE differed by two damage classes: in these cases, according to the more reliable second method, the 67% of the buildings were assessed as "moderately damaged", and the 33% as "negligible to slight damage".
