MONITORING OF DEFORMATION OF THE FOGUANG TEMPLE'S EAST MAIN HALL UNDER THE CONCEPT OF PREVENTIVE CONSERVATION

YUMIN LI, RONG ZHANG

Culture Heritage Conservation Center of Beijing Guowenyan CO.,LTD
Beijing, China -37318215@qq.com

KEY WORDS: Preventive Conservation, Monitoring of Deformation, The East Main Hall

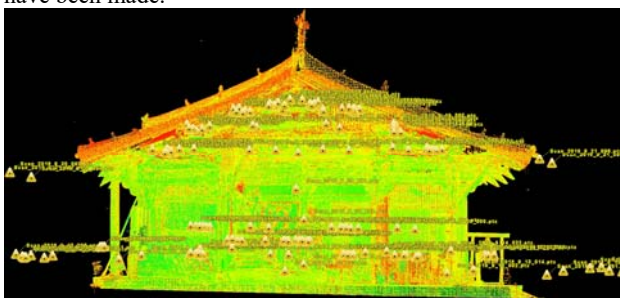
Fig.3 Point cloud model of the east main hall

On the basis of the precision control network, the 3D scanning equipment is used to obtain the complete 3D information of the interior and exterior of the hall and the exposed beams and horizontal wood. 173 scanning measurements of the stations have been made.

The multi-station point cloud forms a complete 3D point cloud model through data collation. The scanning error of the point cloud is 0.3 mm.

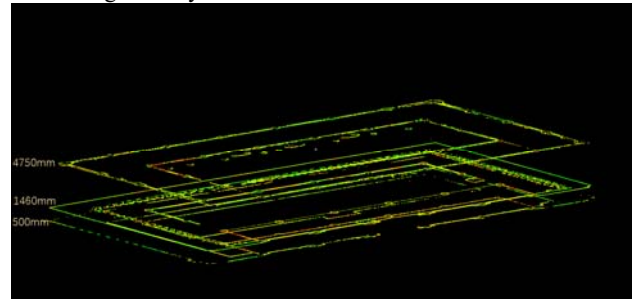
Fig.4 3 layers slice of point cloud

article are the relative measurement values based on this reference point). According to the data analysis in 2005, the plane measurements of the column cap and base were first carried out. Based on the 3D point cloud data, 3D laser scanning point cloud slices about 50 mm thick were cut at an elevation of 500 mm (front peripheral column, base of hypostyle column), 1460 mm (base of posterior inner column), and 4750 mm (column cap). Each column slice is fitted to a circle, and the center-to-center gap is measured to obtain the width and depth dimensions at the height of each layer. Compared to the 2005 data, it is possible to find the changes to the direction of width and depth of the column network in the hall during the 13 years.

Excluding the errors caused by different measuring equipment and staff at the two measurements, and the inevitable measurement error, it is found that the trend of change to each column is basically the same in the direction of width, and the changes in the rear peripheral column and the posterior inner column are greater than that of other columns; in the direction of depth, the outermost columns in the first row see great changes, resulting in a great change in the depth.

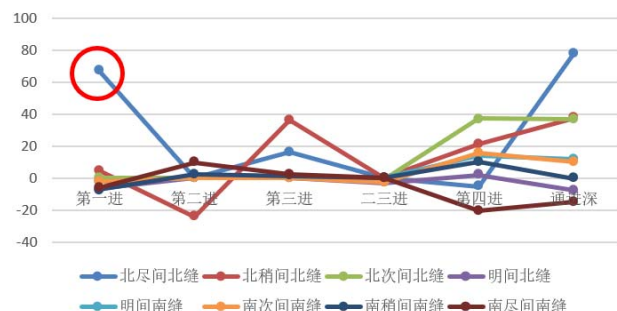
Fig.5 Coordinate of the top center of the column is abnormal.

The working group measured the deviation of the column cap and compared it to the data in 2005. From the numerical point of view, this column continues to expand southward and westward on the basis of the value in 2006, which may cause the growing westward deviation of the column cap in the south. The reason for the increase requires further study. Further, the eastern deviation of the southwest corner column is reduced compared to that in 2006, which is also a prominent change. We also measured the elevation of the column cap, and compared it with the value in 2006. There is a significant reduction in the front inner groove column in the north gable (see table 1 and fig 5). Therefore, based on the current monitoring values, the columns at the south and north corners of the front eaves see great changes, which is one of the focuses for our subsequent monitoring and analysis.
