INFRARED THERMAL IMAGING AS A NON-DESTRUCTIVE INVESTIGATION METHOD FOR BUILDING ARCHAEOLOGICAL PURPOSES

A. Luib¹

¹ KDWT, Centre for Heritage Conservation Studies and Technologies, University of Bamberg, Germany
anna.luib@uni-bamberg.de

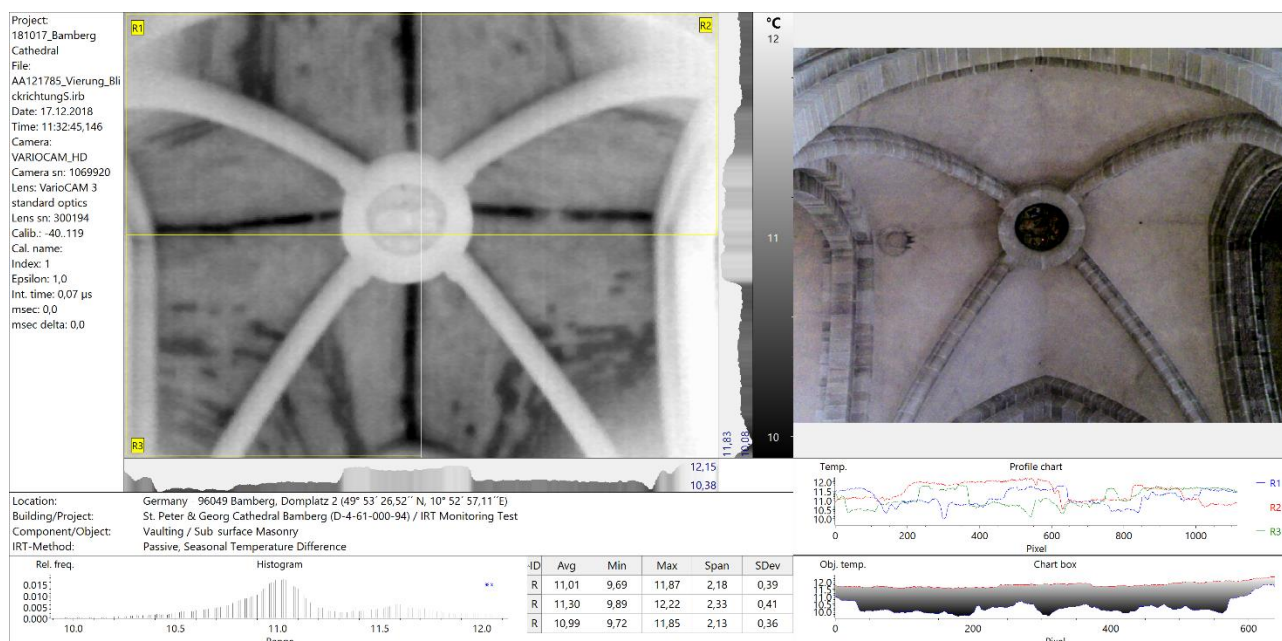
Figure 5: Greyscale visualisation and radiometric measurements of the vaulting structure over crossing of transept and aisle, depicting masonry construction, variations in fabric, stone sizes and pattern.

The vaulting structure over the crossing of transept and aisle corresponds to that of a cross-ribbed vault with pointed arches, bounded by similar transverse ribs on all four sides. (Fig. 5) The diagonal ribs cross in a circularly edged oculus. Both longitudinal and lateral ridge lines finish at the oculus as well. While the vaulting webs are plastered and painted, the oculus, diagonal and transverse ribs remain untreated. Their radiometric examination clearly depicts varying masonry and mortar joint features. The ridge lines show significant alterations in stone size and fabric and the thermal emission of those stone lines clearly differentiates them from the enclosing vault severe stones, hinting at different thermal properties and therefore stone material.

Variations in heat capacity directly correlate to stone fabric in this case. Displaying a very distinct thermal behaviour, the masonry elements used must belong to different stone types. Deductions from this information enables further Building Archaeological conclusions: As their positioning corresponds closely to the vaulting's ridge line, they apparently correspond to a superordinate constructive purpose. Further evidence visible in the thermogram is the larger size of those ridge line stones and their continuous and regular positioning. This is possibly due to the historic construction process. The ridge line stones could have been part of a stabilising sub-structure for the web's vaulting process. Additional investigations on their material properties could provide more detailed information on their structural relevance. Furthermore, the changing stone fabric towards the vault's gussets is noticeable. Following down the cross-ribs, each

of the four gussets appears significantly darker and therefore colder or thermally inert regions in the thermogram.

These regions encompass the size of single stones or the masonry bonds of several stones with radiometrically detectable joint runs. Such distinct thermal capacity clearly hints at alterations in stone material. In contrast to the stone bonds in the ridge line, those thermally prominent in the gussets do not display a coherent distribution or thermal bond. Comparing each gusset, their number, position and allocation varies from gusset to gusset. However, all the stone alterations only reach halfway up the rib line towards the oculus. This might be a result of both the vaulting's construction process and the stones' constructive purpose as possible bracing elements of the gussets. All things considered, the configuration of masonry and joints visualised in the thermogram allows differentiated conclusions on the vaulting process.

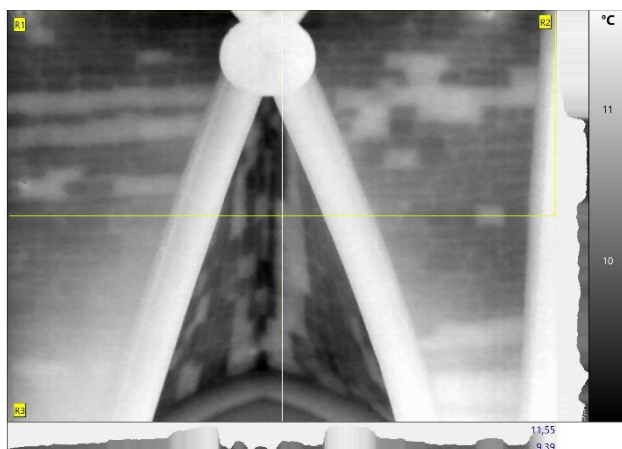
Figure 8: Thermogram of the southern transept's vaulting with heterogeneous masonry pattern.

The thermogram of the southern transept's vaulting displays another variation in the masonry structure. (Fig.8) Their configuration corresponds to a rectangular layout half the size of the crossings square, vaulted with cross-ribs. Due to their narrower proportions, the pointed arches are higher, and their ridgelines more distinctly built.

The masonry bonds differ from web to web. All of them appear to be quite heterogeneous with large parts of the thermally more inert stone type and irregularly positioned stone variations that appear brighter and therefore less inert in the thermograms.

Compared to vaults examined previously, the transept vaultings display a broad variation of stone sizes. The more inert stone type mainly comprises smaller forms with A few larger components running along individual joint lines. The larger, less inert stone types sometimes form rows, predominantly next to the gussets and ridgeline. In this case, superordinate constructive purposes could be the reason for their layout.
