# MODERN PROCESSING CAPABILITIES OF ANALOG DATA FROM DOCUMENTATION OF THE GREAT OMAYYAD MOSQUE IN ALEPPO, SYRIA, DAMAGED IN CIVIL WAR

**KEY WORDS:** Syria, documentation, Aleppo, Great Omayyad mosque, analogue photos, IBMR

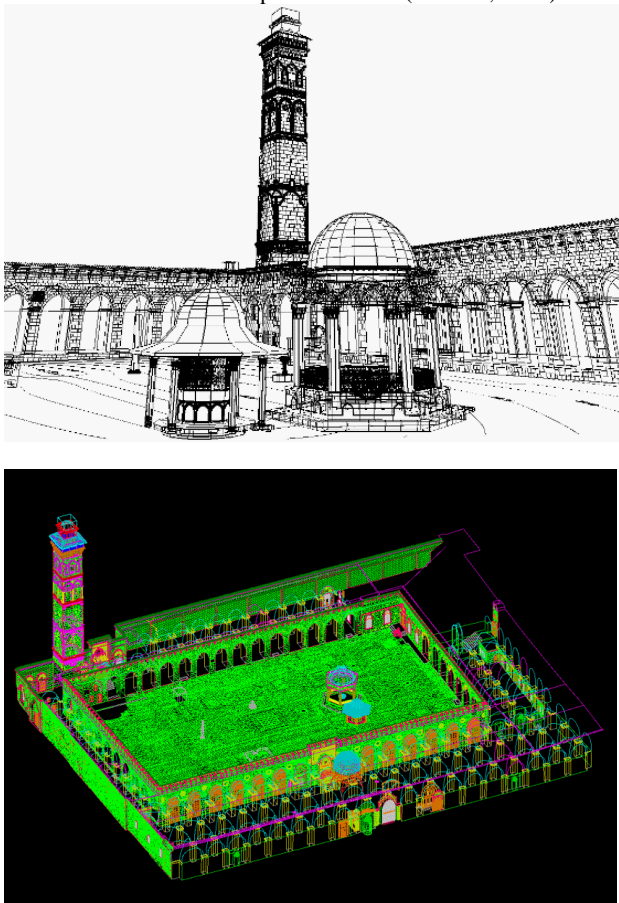
Figure 1. Perspective view on fountains (vector model) and complex documentation in vector form

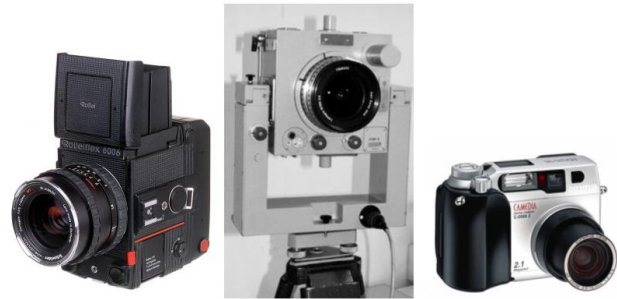
Figure 2. Used cameras in 1999: RolleiMetric 6006, UMK Zeiss 1318/10 and Olympus Camedia 2000

UMK 10/1318 (b/w planfilm 13x18 cm), the RolleiMetric system (colour or b/w roll film 6cm) and for basic documentation digital camera Olympus with 2Mpix resolution. All measurements (control points, object points etc.) were measured with a total station (Pavelka, Matoušková, 2015). The Great Omayyad Mosque in Aleppo in Syria is included in the list of the world monuments of UNESCO. With an age of about 1000 years and a dimension of about 100x60m, it is a very valuable object. For 3D measurement, the combination of classical geodetic measurement and photogrammetry was used. About 600 signalized control points and about 3000 object points with accuracy of less than 1cm were measured from a geodetic network. About 300 photos were taken for single image and stereo processing. Softcopy photogrammetry was used with help of GIS and CAD. The complex data set with processing is about 20GB large. B/w plan-films and roll-films were developed directly in the hotel's provisional spaces (the hotel bathroom was used as a darkroom; it was necessary to have photogrammetric material before the end of the short measurement mission in Aleppo due to the low budget). As has been said, analogue images were later scanned on professional scanners such as the Nikon CoolPix (roll film) and Zeiss Intergraph (plan-films). Complex data processing – the creation of the vector model in CAD (Bentley Microstion) and photogrammetric processing to photoplans was performed in three months and was completed in 2000 (Pavelka, 2000).

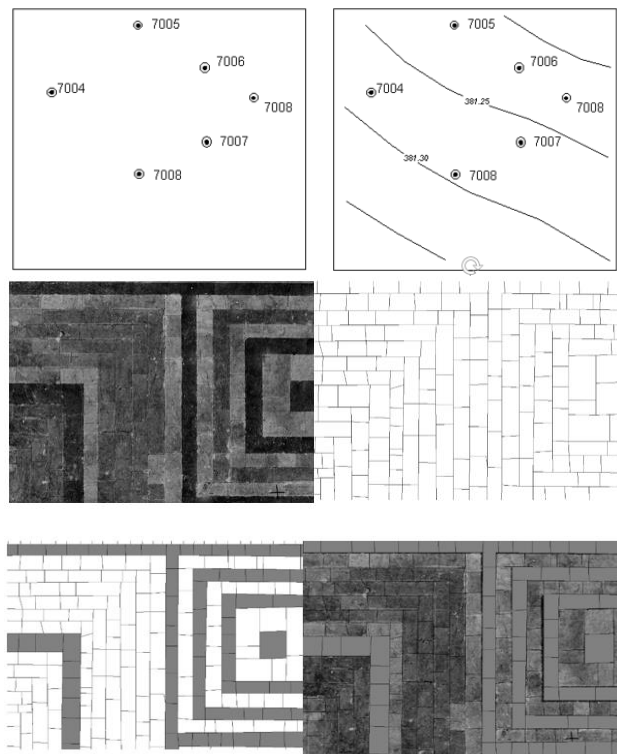
- 1<sup>st</sup> layer: control and object points (geodetic measurement)
- 2<sup>nd</sup> layer: photoplan (photogrammetric measurement and processing)
- 3<sup>rd</sup> layer: vector processing (photogrammetry and CAD)
- 4<sup>th</sup> layer: rendering (CAD)
- 5<sup>th</sup> layer: digital elevation model (DEM, raster or vector – isolines)
- 6<sup>th</sup> layer: material classification

Figure 4. Mosque Inner Court - the example of layers in GIS

For the inner court, a small GIS has been created. Every layer give an information about this part of mosque.

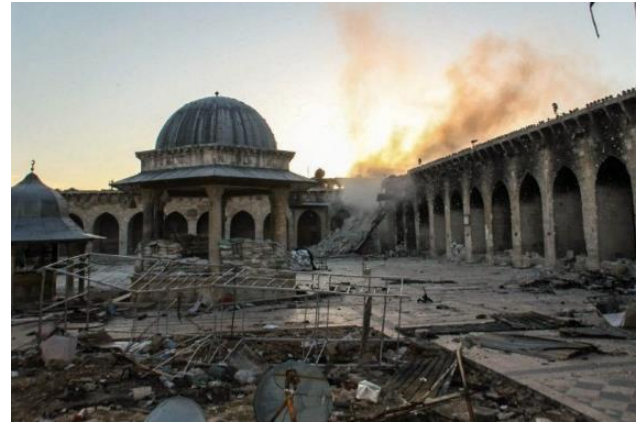
Figure 6. Destroyed minaret, 2013

The Minaret was not processed to a model or point cloud due to a lack of overlapped images. Fortunately, it was very well-modelled by G. Fangi (Fangi, 2013).

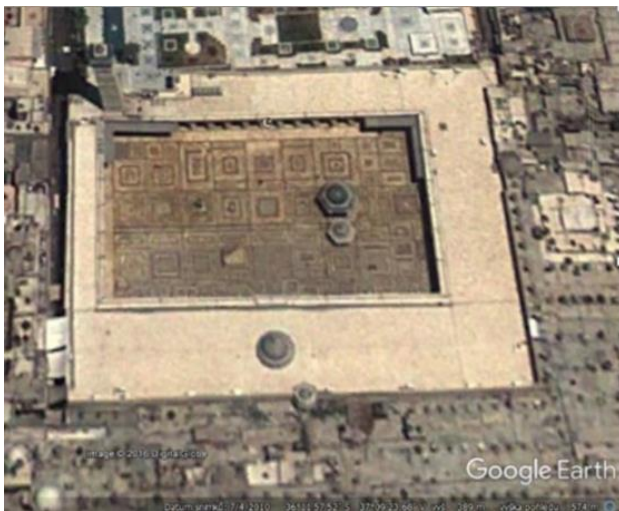
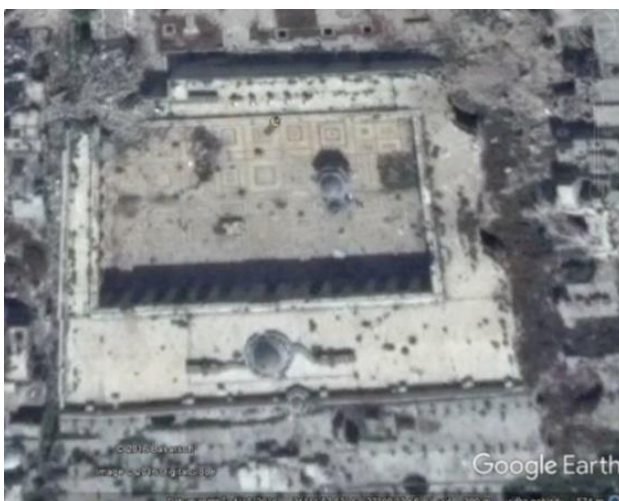
Figure 5. Great Omayyad mosque on GoogleEarth 2010 and 2016

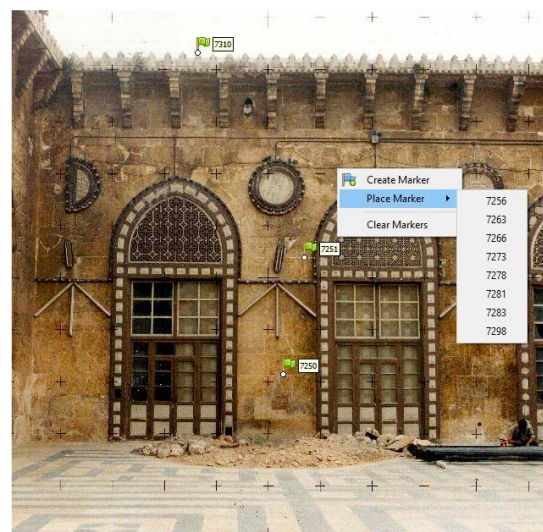
Figure 7. Original color photo from RolleiMetric 6006 camera with marked control points

After many years, data processing has been dramatically changed just like the situation in Syria. In 2017, we searched for archive data from 1999 and attempted a new, modern processing using the digital technology IBMR (image based modeling and rendering). From the first point of view it seemed to be a simple task. After reviewing the data, it was noted that the data had a different quality and was primarily obtained for single-image photogrammetry with minimal overlap between photographs. It meant that it was not possible to use IBMR technology, which needs a big overlap between images. Fortunately, the individual parts were photographed by different cameras (UMK 1818, RolleiMetric 80mm and Olympus digital camera) from different positions. In the case of the facades, a good database of overlapped photographs was collected, which was possible to process in Agisoft Photoscan. As a result, a true orthophoto with a pixel size of approximately 3-5mm and a textured point cloud such as a 3D meshed model were produced. For orthophoto, control points were used (Tab.2), which helped create real model and Improved computation of image orientations. Some original sketches of control points were found, while others were derived from the vector model (Pavelka, Rezníček, 2011).

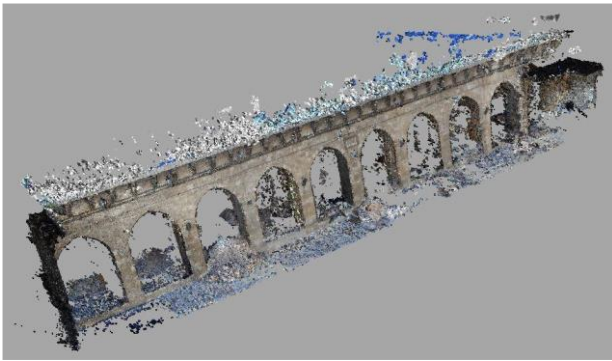
Figure 8. Sparse point cloud

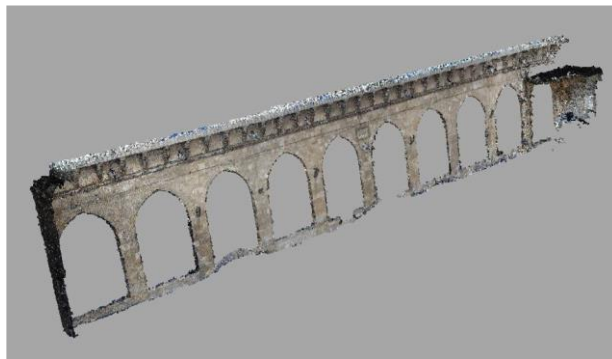
Figure 9. Cleaned point cloud

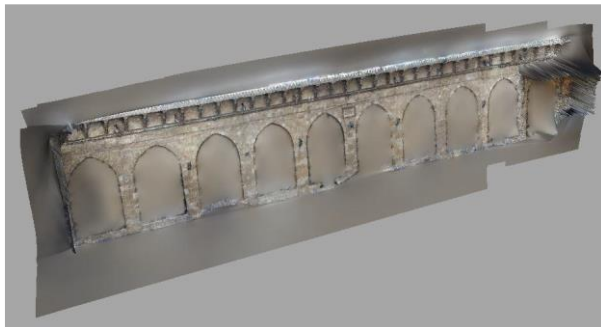
Figure 10. Meshed model of west facade

After many attempts, all the images from the internal facades and the northern main entrance to the mosque were processed. There was a set of overlapped photos from three camera types; of course, the best results were achieved by using photos from the precise photogrammetric camera UMK, but these images were only b/w. After the processing of the sparse point cloud, it was necessary to erase a lot of incorrect points. After this, a good result was created for the facades such as the mesh model. After the masking of unwanted parts (peoples, things, and shadows) the true orthophoto and textured models were computed (Pavelka, Bílá, 2013).

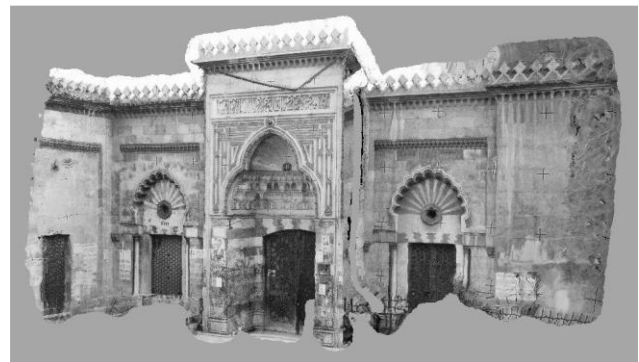
Figure 11. North entrance, textured mesh 3D model

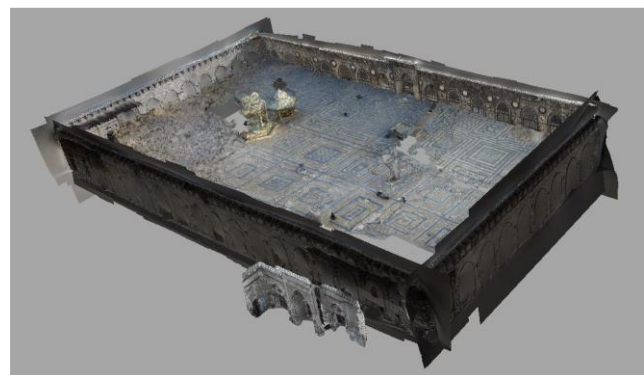
Figure 12. Complex processing of historical photographs to 3D model; inner court is after many attempt still deformed

In the case of the inner court, there was a problem occurred with the preserved images. Only 22 photographs from the RolleiMetric camera were used, taken on black/white film with bad radiometric quality (unfortunately located in the inner court were many people and very dark shadows) and 26 color images taken with the Olympus camera. In the case of Olympus images, these images have only 2MPix geometric resolution and every image has a different internal orientation due to the zoom (these images were taken for documentation only due to low resolution). Photos were taken from the roof and from the minaret, but not good enough for IBMR technology. It meant that they were taken with a very oblique direction, with a low overlap, and in many cases against each other. In this case, the IBMR application gave very poor results or was terminated. With the RolleiMetric camera, we had calibration protocol, but it was necessary to manually make a transformation on all 121 crosses and scanned images of different sizes to crop to the same size (using outer crosses). By photos taken by with the Olympus camera, we didn't have any calibration when zoom was used. Photomodeler software was chosen as appropriate for processing and for reverse calibration computing. Hundreds of control points were used without appropriate results. Apparently it's because images with poor geometry, no quality calibration, and significantly different cameras were used. In this case, the system is very free and contains too many unknowns.

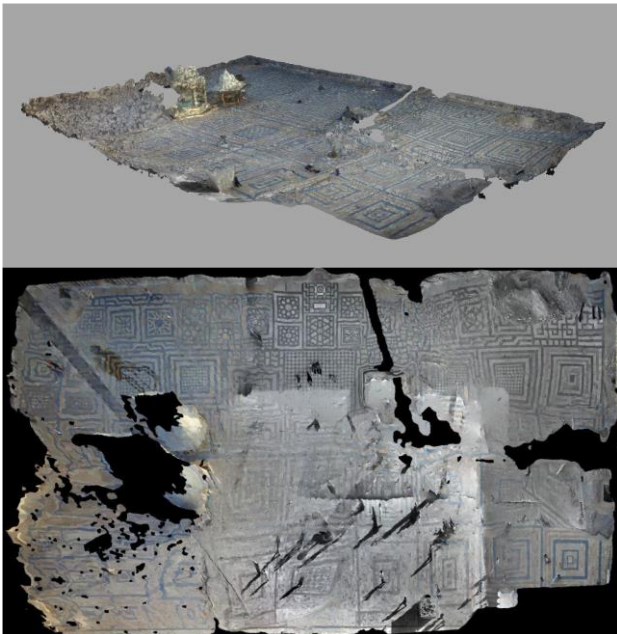
Figure 13. Distorted model of inner court

After many attempts, we didn't get any good results. Intermediate results were distorted or failed to create a complex model. Results of reverse calibration were often meaningless.

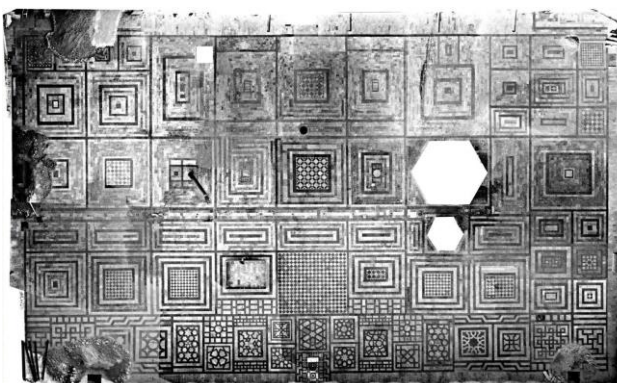
Figure 14. Original photoplan from 1999 created by single image technology with control points
