TERRESTRIAL LASER SCANNER AND FAST CHARACTERIZATION OF SUPERFICIAL LESIONS IN ARCHITECTURAL DIAGNOSIS

KEY WORDS: terrestrial laser scanner, pathology, defensive towers, masonry, Camarles Tower.

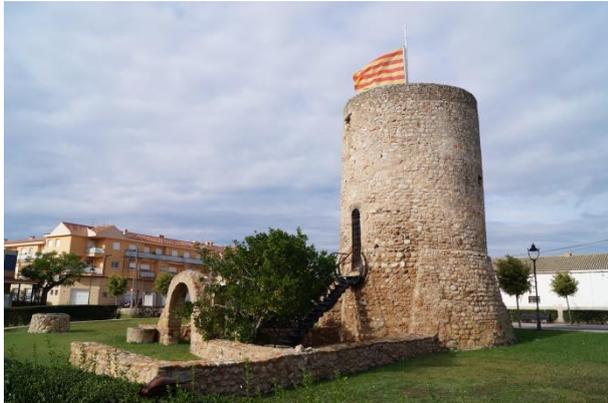
Figure 1. The Tower of Camarles

The case studied is a medieval Tower located in the town of Camarles (Figure 1), in the South of Catalunya (Spain). It was built over an Islamic defensive fortification between thirteenth and fourteenth centuries. It has circular floor plan and a massive structure of stone masonry which was surrounded by other buildings until de decade of 80s, when it was performed a restoration process which involved the removal of these structures and the adaptation of the tower for visitors.

On general terms, the tower consists on a cylindrical body and a conical base of 3.9 m high, with a circumference radius of 4.21 in the lowest part, and 3.22 in the highest part, where meets with the cylindrical body, with a total height of 9.5 m and an average radius of 3.22 m.

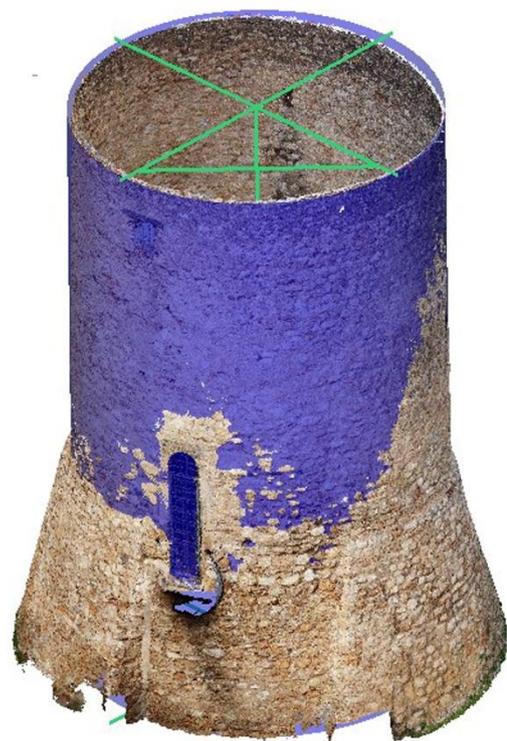
Figure 2. Visualization of the point cloud of the Tower with the standard primitives and the deduction of the central vertex.

First, the structure was divided in two parts: the conical base and the cylindrical body (2.639.866 points and 4.742.608 points respectively), and the corresponding closest standard primitives were defined for each one. It must be taken into account that the results of an analysis of a real object regarding standard primitives needs interpretation. It is recommended to contrast the results with complementary information to define the conclusions of the study. Following, the centroid of every primitive shape (cone and cylinder) (Figure 2) was obtained. Finally, it was defined a common vertical vertex through the two primitives' centroids to obtain an unfolded elevation of the tower.

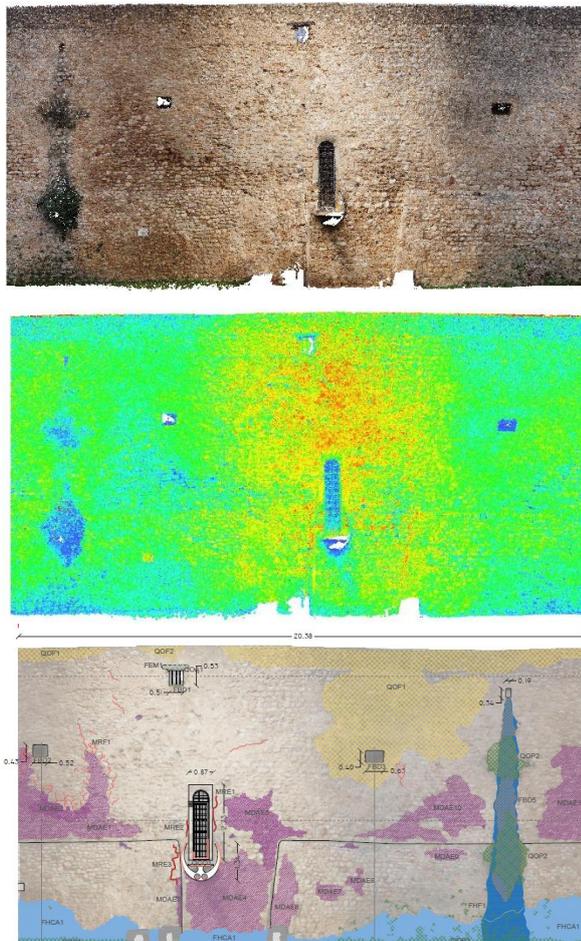
Figure 3. Unfolded elevation of the Tower's surface. a) Texture, b) Inspection map, c) Lesions identification.

The assessment of the surface is performed through different documents. First of all, the unfolded elevation of the textured surface with a known scale, gives a valuable survey of the tower, which allows visualizing clearly on a single image the different degradation processes as loss of material and other superficial issues (Figure 3a). Of course, this image is descriptive, not analytic, and needs interpretation.

Following, it is defined an Inspection visualization of the elevation. The 3D Reshaper command allows inspecting the slopes of a mesh or a point cloud (on that case, a point cloud). An inspection value will be associated to each point of the cloud or vertex according to the angle between the local normal of the surface and the horizontal. The view obtained highlights differential areas where the materials (mainly the lime mortar), are eroded or dirty (Figure 3b). These elevations allow the easy detection of eroded areas, which are represented through Autocad (Figure 3c).

The textured unfolded elevation allows representing the complete surface of the Tower on a single image with metric scale. The Inspection map complements the information, and highlights the different textures that can be identified on the wall. Based on these two documents, it is easy to identify and accurately draw the main issues related to erosion, dirt and also changes on the lime mortar (qualitatively), since several restorations are overlapped on the wall. Further research on that sense will deepen on the automation of that process, and also on the use of other data from the survey, as reflectance maps.

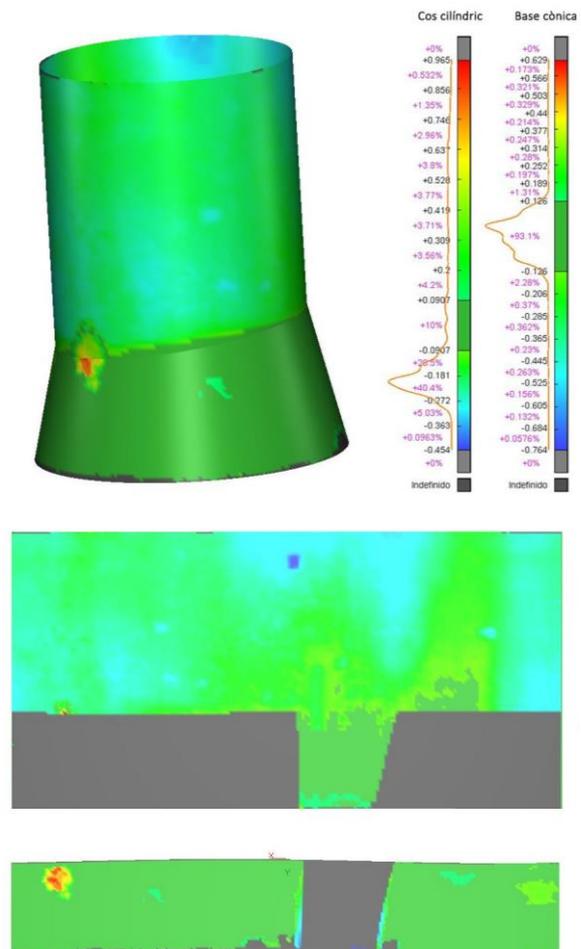
Figure 4. Scalar map of distances between Tower point cloud and standard primitives.

The analysis of the tower shape is performed by the comparison of the point cloud and standard primitives (Table 1). It gives a general view of the irregularities and the areas which are out of plumb. At the cone we obtain a 0.105 mm of standard deviation, meanwhile, in the cylinder this value is 0.0402 mm (Figure 4).

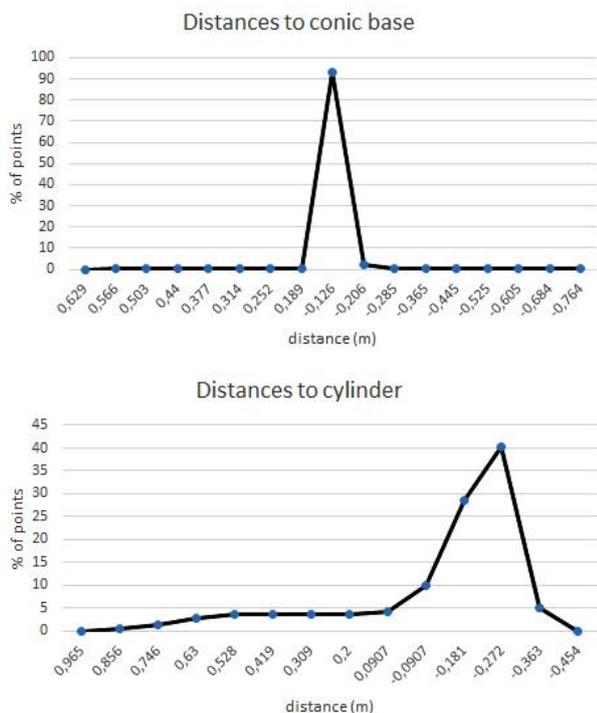
Figure 5. Summary of the histograms for the comparison with standard primitives.

In the case of the conic base, most of the percentage of points are irrelevant, since the (93.10%) of points are located at a range of (± 0.126 mm), which means that the shape of the base is very regular and close to a perfect cone. In the case of the cylindrical body, the main range of distances is $[-0.181; -0.272]$ with a (40.40%) of points (Figure 5).

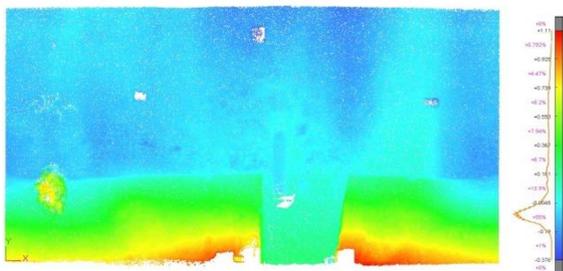
Figure 6. Scalar map of distances between Tower and vertical plane of reference.

In addition, the unfolded elevation is compared with a plane of reference, located in the lower left corner of the entrance door, in order to verify the verticality of the walls all over the surface (Figure 6). Results shows that predominant range of distances I [-0.0045; -0.19] (55%) (Figure 7).

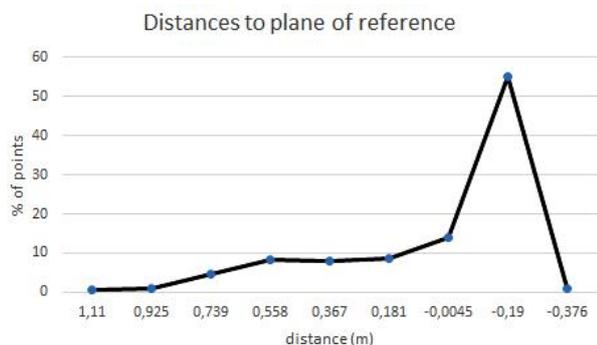
Figure 7. Summary of the histogram for the comparison with a comparison vertical plane.

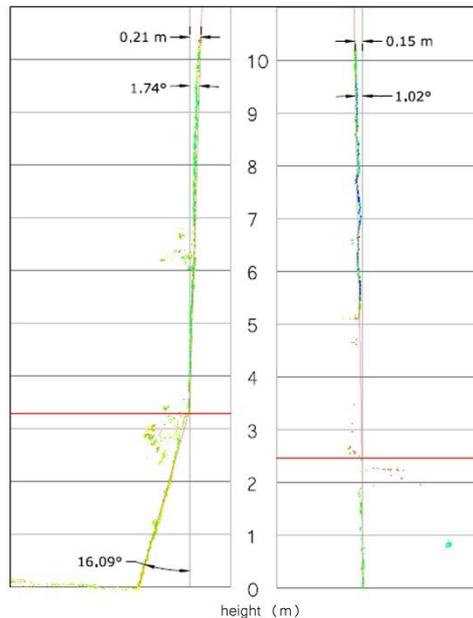
Figure 8. Points of the cross section.

Complementary, a cross section is laid out to verify previous results and to visualize the deviation of the wall on a specific cross line (Figure 8). The section plane is defined as the normal plane to the door opening (cutting through the middle of the door). It shows that the tower tend to shrink on its upper part. The main movements are located on the top are (0.21 m) and (0.15 m), with angles of 1.74° and 1.02° respectively.
