INTEGRATION OF SURVEYING TECHNIQUES TO DETECT THE IDEAL SHAPE OF A DOME: THE CASE OF THE ESCUELAS PÍAS CHURCH IN VALENCIA

KEY WORDS: Laser scanner, Cultural heritage, Thermal camera, 3D modelling

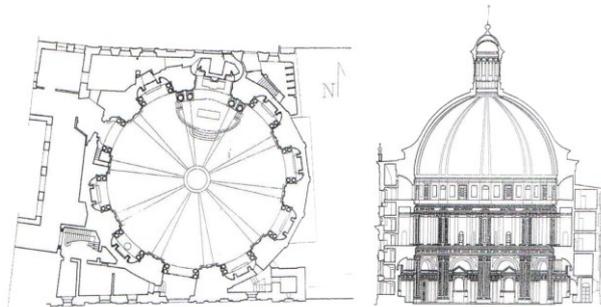
Figure 2. Plan and elevation of the Escuelas Pías Church (Verdú, 1996)

This church, with its imposing height of 48 m, is dominated by a large hemispherical dome of about 24 m in diameter, surmounted by a lantern with a fairing. The dome rests on ten large trapezoid section pillars and ten subsidiary spaces occupied by several radial chapels (Figure 2).

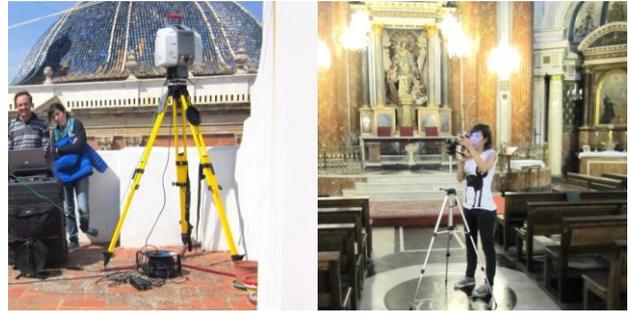
Figure 3. The survey with laser scanner and thermal camera

The surveying operations were carried out with two terrestrial laser scanners, one reflex camera and a thermal camera (Figure 3). For the indoor survey of the Escuelas Pías Church, the FARO Focus3D S 120, one of the smallest and lightweight 3D laser scanners, was used.

The external survey was carried out using a Leica Scan Station. A survey with a thermal camera was also carried out. The IR shots were used to detect hidden cracks, above all in the dome.

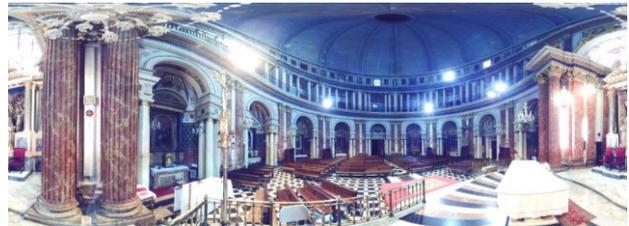
Figure 4. A panoramic view of laser scanner acquisitions

To measure accurately the whole church inside and outside, 40 scans were acquired, with a 0.07°/point resolution at a rate of 120,000 points/s. Figure 4 shows a panoramic view of one of the laser scanner acquisitions on the main altar.

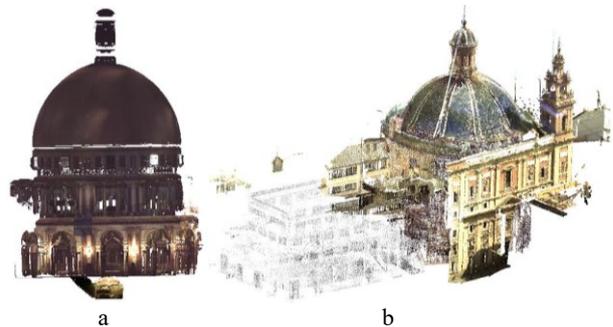
Figure 5. Aligned scans: a) view from inside; b) view from outside

Spherical targets with a diameter of 14 cm were distributed across the church and at various heights in order to facilitate the alignment/registration of scans in post-processing. The union of the registered point clouds is shown in Figure 5, either from inside and outside, summing up more than XX million points.

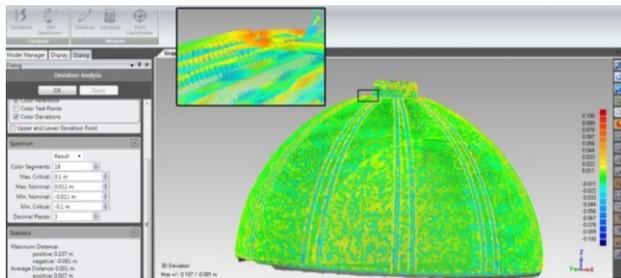
Figure 6. Comparison between model and point cloud

To evaluate the registration performance, meshes were obtained from the registered point clouds. 3DReshaper® software was used for meshing. The comparison between the model and the point cloud, for all three clouds aligned with the three different software packages, was made in Geomagic Studio® software (Figure 6).

The regular intrados dome of the church was used as a testing area. The different points-deviations model results are presented in Table 1.

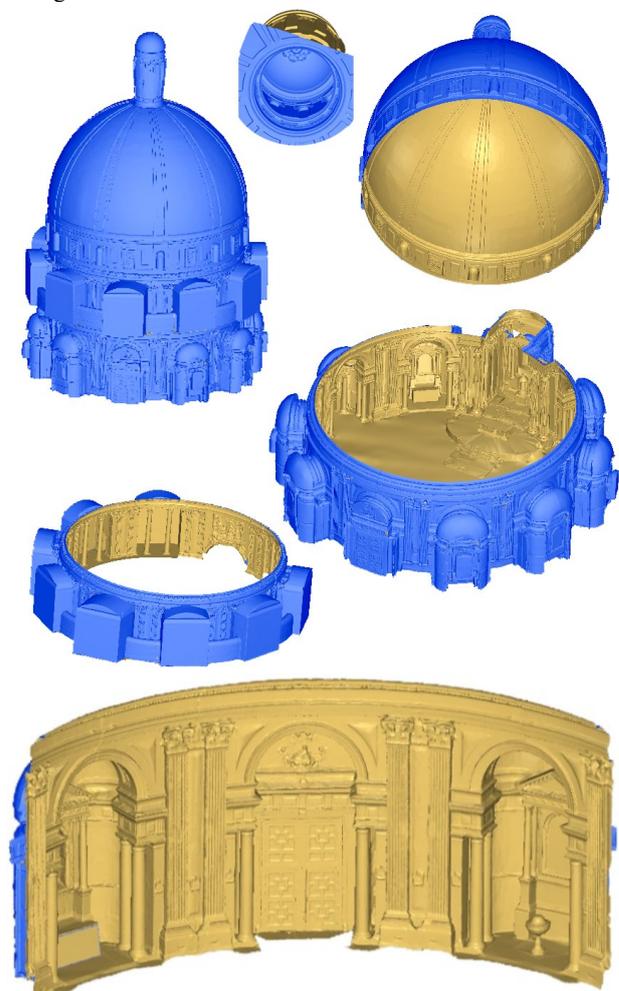
Figure 7. The 3D mesh of the Escuelas Pías Church

In Figure 7, we can observe some details of the 3D mesh of the church at different levels. The cracks on a dome slice and the corresponding thermal image are shown in Figure 8. Figure 9 represents the 3D model textured with the thermal image. The deviations between ideal and actual surface are shown in Figure

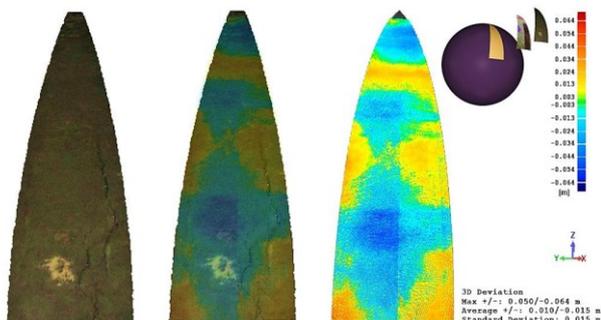
Figure 10. The deviations between the ideal and actual surface

10. It is worth observing that the maximum 3D deviations are about 5 cm (positive) and 6 cm (negative); the average deviations are about 1 cm, while the standard deviation is 1.5 cm. These values are compatible with the techniques used for the construction.

The best fitting dome shape is obtained by considering a Bohemian vault. This hypothesis is confirmed by the 3D deviations between the actual and the ideal shape. It is highly interesting to highlight that the deviation between the real surface (best fitting ideal surface) and an ideal Bohemian vault (slice of the dome) is at a maximum near the cracks, where these are present.

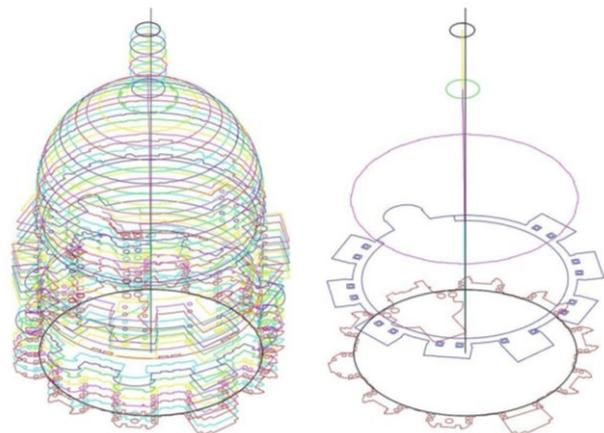
Figure 11. Axonometric view: the thin black line is vertical in the bottom centre

To find the axis of the church, horizontal sections were obtained on the 3D model every meter; the centroids of the sections were then found. The most likely axis should be the line that interpolates all centroids (Figure 11).

The axis found with the above-described procedure shows a deviation of about 0.44 degrees with respect to the vertical (from the floor to the top of the dome). The centroids move in the direction of the transept to the left for an observer looking at the principal altar. The floor of the church has a slope of about 0.137 degrees in the same direction. Since the biaxial compensator of both laser scanners used for the survey has a precision of 0.015 degrees, the slope of the floor can be stated that is real. Given that the deviation of the axis is to some degree greater than the slope of the floor, we could make the following hypotheses: (a) the whole church suffered a subsidence after its realization, (b) due to small errors during the building construction, the central axis was not vertical also at the end of its realization.

Another question still open is related to the floor and the axis of drum, dome and lantern. The low slope, present in the floor, is not directed towards the main altar, but it has an orthogonal direction, so it is unlikely that it was foreseen in the original project. The axis of the church should give some information useful for hypothesizing the causes of the floor slope.
