APPLICATION OF THE STEEP SLOPE RISK ASSESSMENT USING THREE DIMENSIONAL INFORMATION DATA

KEY WORDS: Terrestrial LiDAR, Three dimension, spatial information data, Natural disaster, Steep slope

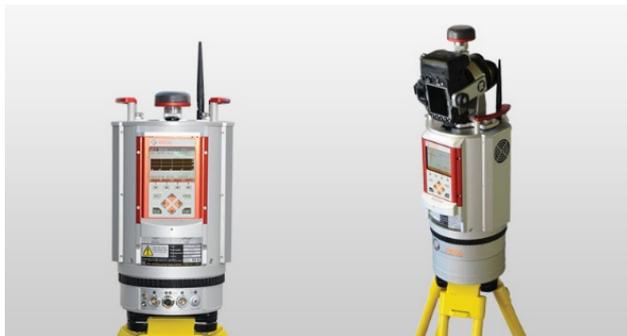
Figure 3. VZ-2000 terrestrial LiDAR

The terrestrial LiDAR is a measuring instrument that can acquire precise point cloud data using reflected values after reaching an object by launching a laser. The equipment used in this study is RIEGL's VZ-2000(Figure 3). The VZ-2000 is equipped with the latest wavelength technology, and is a laser scanning device that can acquire coordinates through GPS mounting. In addition, it can measure at a faster scan speed than other measurement equipment, and has high accuracy, high precision and full automatic processing performance. And real-time geo-referencing technology does not require a separate survey. Other specifications of the equipment are shown in Table 3.

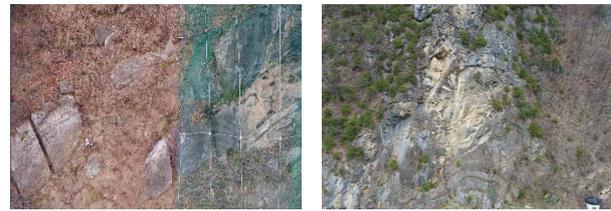
Figure 7. Jeongseon-gun steep slope falling rock prevention and rock

Unlike steep slopes of Pyeongchang-gun, steep slope of Jeongseon-gun were equipped with falling rock prevention walls and retaining walls and weathering has progressed significantly in some sections of rocks. The presence of the old valley seen in the field was confirmed in the LiDAR data, and a lot of fell rocks were actually scattered around it (Figure 8).
