# URBAN INFRASTRUCTURE AND BUILDINGS IN RUINS: DAMAGE SEVERITY MAPPING OF NEIGHBORHOODS AFFECTED BY THE JUNE 2018 WINDSTORM IN BAUCHI

Bauchi for the first time in history experienced a horrific windstorm that lasted for not more than 2 hours, but destroyed more than 20 lives and thousands urban infrastructure. This study examines the monumental damage on buildings and structures as a result of the June, 2018 windstorm disaster event in Bauchi. Handheld GPS was used in taking the location information 1662 structures affected by the windstorm. GIS was used in assessing the spatial pattern and as well mapping the extent of the damage. The results of the Average Nearest Neighbor indicate a clustered pattern with the index (ANN ratio) at 0.30 less than 1%. Similarly, the study reveals that most of the affected structures are residential land use with of 91.2% identified as damaged while the least is the recreational land use with only 0.3% structures identified as damaged by the disaster. On a district level, Jahun is the worst affected district with a total of 46.6% damaged buildings and structures. Finally, variability in annual peak wind gust trend in the last decade suggests the ev

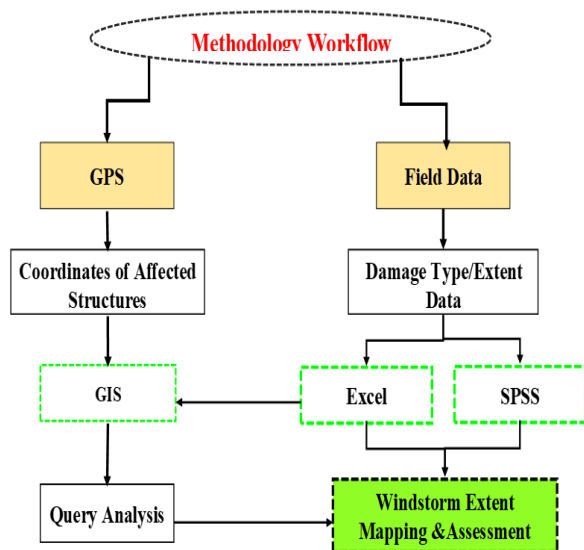
Figure 2. Methodology Workflow

In the course of the study, a census of permanent structures damaged by the 16 July, 2018 windstorm in six of the seven districts of Bauchi metropolis was taken. A visual survey was conducted and coordinates of affected structures recorded using GARMIN GPSmap 78SC device. Information on Land use type, damage extent and type were also taken during the visual survey for the purpose of damage classification. The ward heads and youth volunteers from the affected neighborhoods assisted in identification of the wind-affected structures.

This approach was used in order to ensure wider spatial coverage and all-inclusive assessment of the affected structures in the study area. The survey was conducted within three months after the disaster event. A coordinates of the wind – affected structures were taken with their respective damage information. Only the location information of affected permanent buildings and structures were considered for this study. Others, such as temporary structures, street furniture and other urban appurtenances, no less affected by the storm, are not included in the survey.

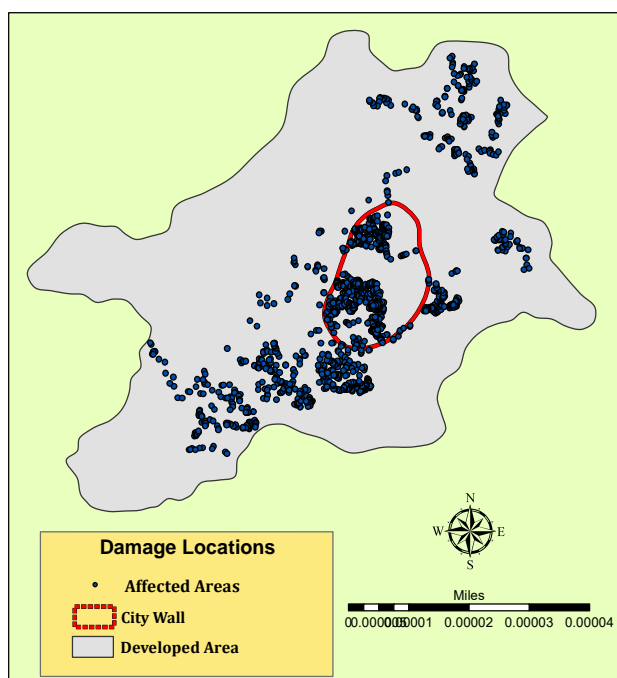
Figure 3. Damage Locations

assessment are shown in figure 3, 4 and 5, revealing damage locations, types and severity respectively. Similarly, table 2 reveals the damage classifications.

Similarly, areas with rough topography (Kandahar and some part of Jahun) were also severely affected by the windstorm. However, in most of the areas surveyed, the magnitude of damage is proportionate to the degree of development within a given area. The results of the Average Nearest Neighbor (ANN) exhibit a clustered pattern with the index (ANN ratio) at 0.30 less than 1% (see Table 1). This is largely due to the fact that most of the affected structures are within the Bauchi city wall (old Bauchi), and consist of majorly informal settlements.

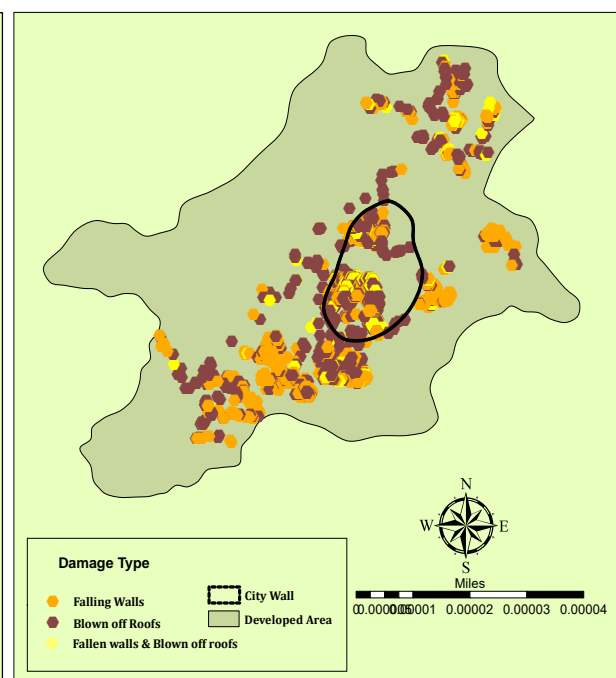
Figure 4. Damage Types

The windstorm event has done several damages to buildings and structures. A total of 51% structures got their roofs damaged during the event. Similarly, 36.5% of the affected structures were identified with fallen walls while 12.5% were identified with both blown off roofs and fallen walls (see Table 2). Similarly, areas with rough topography (Kandahar and some part of Jahun) were also severely affected by the windstorm. However, for most of the areas studied, the magnitude of damage is proportionate to the degree of development within a given area.

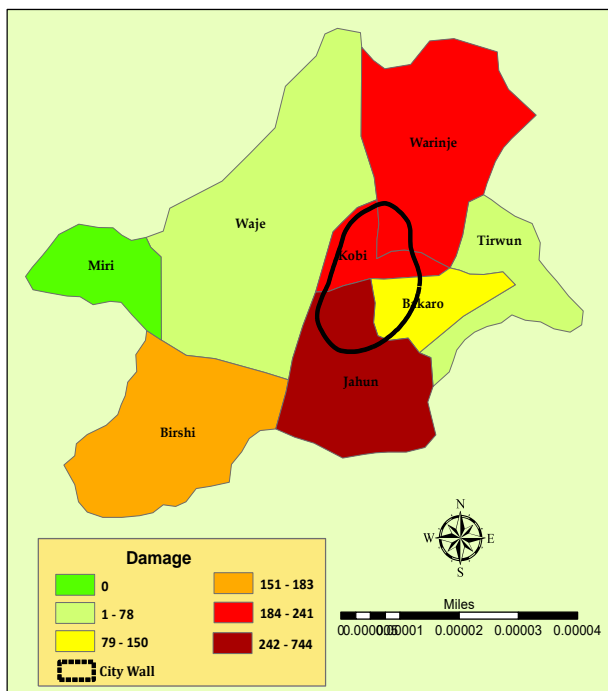
Figure 5. Damage Severity

The study found that the effects of the windstorm vary greatly according to land use type, the housing design pattern, as well as the topographical nature of a given area. On the land use type, residential land use is the worst affected with 91% structures having at least one type of damage or the other from fallen walls, blown off roofs or both damages. But, only 0.3% of all affected structures were identified as recreational land use (see Table 2). Consequently, Areas with little or no elements of planning were severely affected, especially those areas within the compacted settlements of old Bauchi.

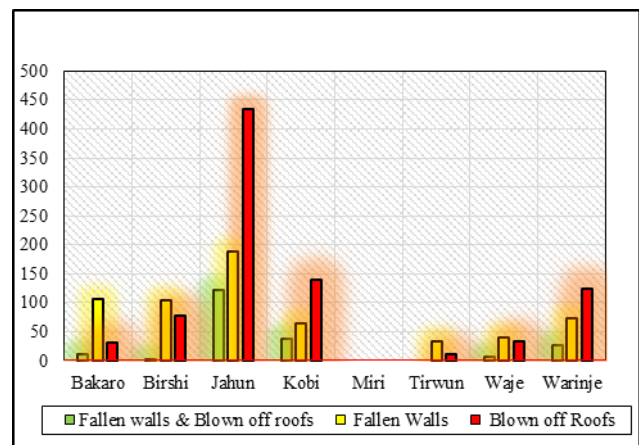
Figure 6. Damage Type by District

The results in figure 6 shows that Jahun district is the worst hit by the windstorm event. This is due to the fact that the type of developments in Jahun is predominantly residential buildings with greater portion of it found within the old settlement of

Bauchi. Other reasons for this high damage could be the settlement pattern which is characterized as compacted with little or no conscious planning inputs as compared to Waje and Tirwun districts which have elements of conscious planning.

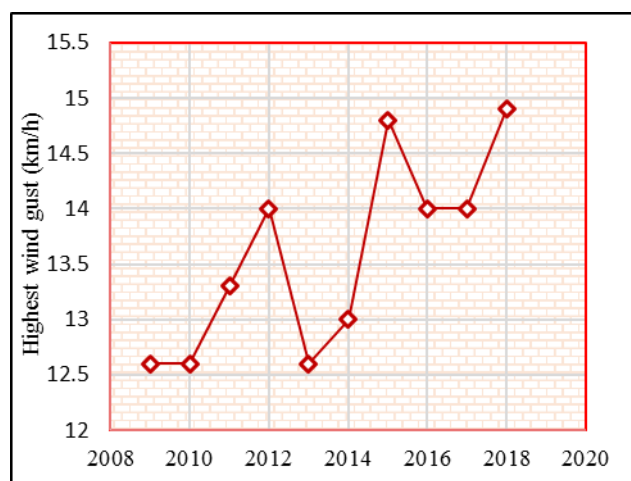
Figure 11. Annual Peak Wind Gust. Source: (NIMET 2018)

The wind gust trend in figure 11 showed an increasing frequency over the last decade. This is an indication of climate change footprints in Bauchi. Climate change effects are severe (ACCES, 2010), especially when the trend of meteorological parameters of a given area keeps varying over time. The occurrence of the June, 2018 windstorm in Bauchi underscores the implications of climate associated hazards, especially given the magnitude of destructions of lives and properties in less than two-hour duration of the event.

The graph in figure 11 shows the annual peak wind gust over the last decade. In the first five years, the average annual Peak wing gust was 13km/h but has increased to 14.1km/h in the last five years with 2015 and 2018 having the highest annual peak of 14.8 and 14.9 respectively.
