THE IMPORTANCE OF DIGITAL METHODS IN PRESERVATION OF CULTURAL HERITAGE THE EXAMPLE OF ZIRNIKLI MANSION

T. Kan¹, G. Buyuksalih¹, Y.Kaya¹, A.P.Baskaraca¹

KEY WORDS: *Documentation of Cultural Heritage, 3D Laser Scanning, CAD Drawing, Restitution, Restoration*

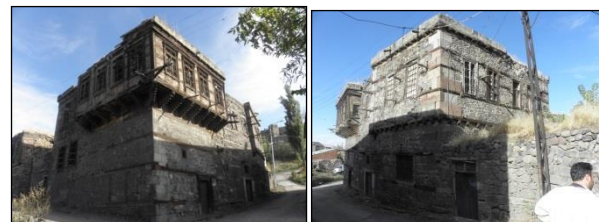
Figure 2. The Selamlık (on the left) and haremlik (on the right) sections of the mansion

The structure is a large mansion with overhangs and two floors (single floor above the ground) and having two sections consisting of haremlik (women's part) and selamlık (men's part). The main room of selamlık corbelled on both facade brought depth to the streets. On the both floors, rubble masonry has been used, partially bricks have been included in the facade of first floor. New additions were made to the structure over time depending on the necessity. These additions were developed at the back of the selamlık and haremlik sections. Additional sections consist of the those which are included in the houses of Erzurum. In brief, this is a mansion where three houses are combined.

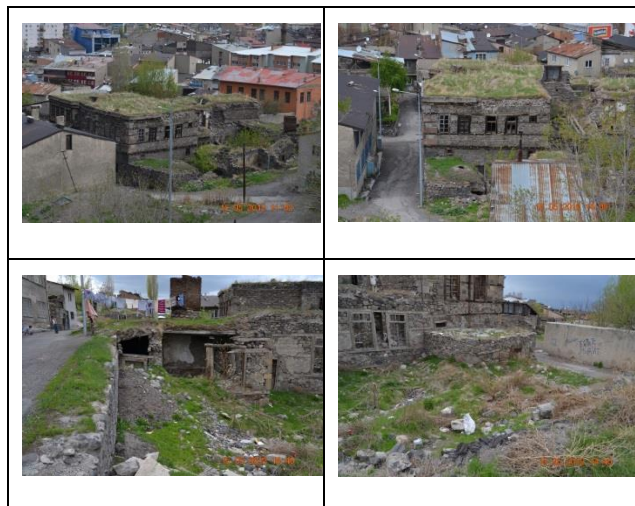
Figure 3. General Condition of the Mansion

It is the mansion situated in the texture around Erzurum Castle, built in 1739 and the oldest example of the houses of Erzurum, having been survived until today. It is located at the address of Mirza Mehmet Mahallesi Seyyid Efendi Sokak. A part of the structure has survived. It is a mansion with two floors. The mansions were the houses built by wealthy people and planned as haremlik and selamlık (see fig. 2); the rooms, tandoori houses and other sections of which were arranged delicately (Yılmaz, 2010). The structure is located in the parcels numbered 1, 2, 3, the island numbered 515 between the streets of Hüseyin Efendi, Sait Efendi and Çeşme (Figs. 3 and 4).

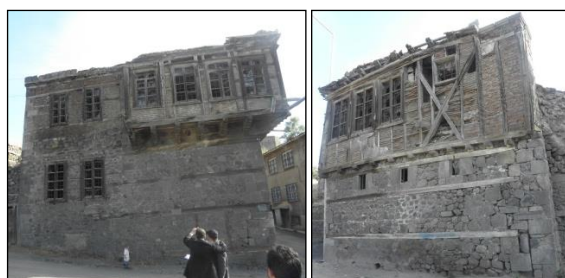
Figure 4. Usage of timbers and bricks

The floors are separated from each other through wooden floor stringers. These stringers are composed of bonding timbers horizontally running on the timber beams. They have given briskness to the facade as eaves corbels. The eaves are overflowing. These overflowing sections are the timber beams used on the ceiling. The stone gagoye placed on the facades of a typical house of Erzurum is also used in this structure. The wooden elements extending outwards from the facade, which are frequently seen in a typical house of Erzurum also appear in this structure. The length of these elements called "kont" anchored on the wall is 1-1.5m. These konts placed on the bonding timbers serve as a scaffold during the renovation of the structure (Fig. 4).

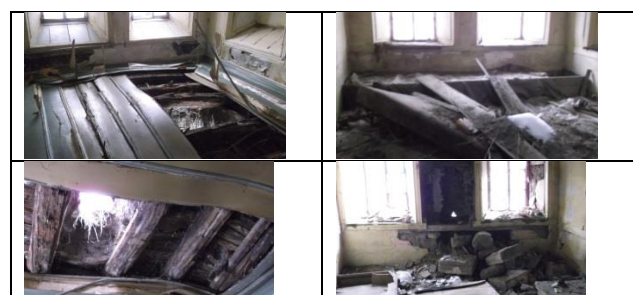
Figure 5. Structural Status of the house during scanning phase

Scanning process of the structure located on an area of about 1195 m², 800 m² of which is ruined was quite challenging (Fig. 5). It was started in March, 2012, and completed within 1 week due to the cold weather conditions. In the measurements, 3D laser scanning and conventional methods have been used together.

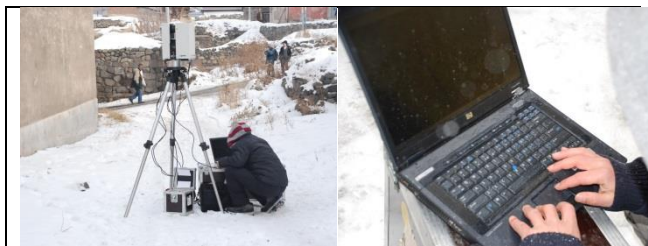
Figure 6. Field Works

The laser scanning team consisting of 3 persons gathered data of the house by performing 19 sessions inside and 16 sessions

outside, a group of 4 architects measured the doors, windows, profiles, etc. details (Fig. 6).

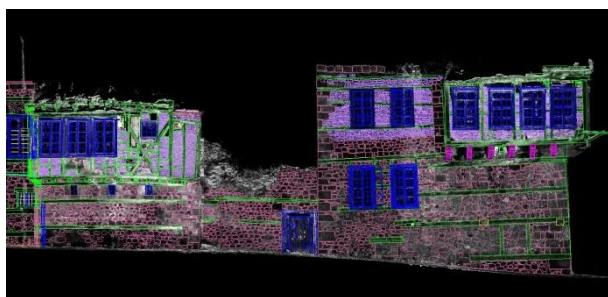
Figure 7. 3D CAD Drawings by ZMap Software.

ZMap program from MenciSoftware, Italy has been implemented for 3D or 2D CAD drawings from laser point cloud data. However, final CAD drawings were in 2D because it was required like this by the architectural council. These 2D drawings are prepared for plans, sections and views and exported to Autocad format of DXF or DWG (Fig. 7). Such a workflow for CAD drawings was also presented by Dursun et al. (2008) and Kersten et al. (2009).

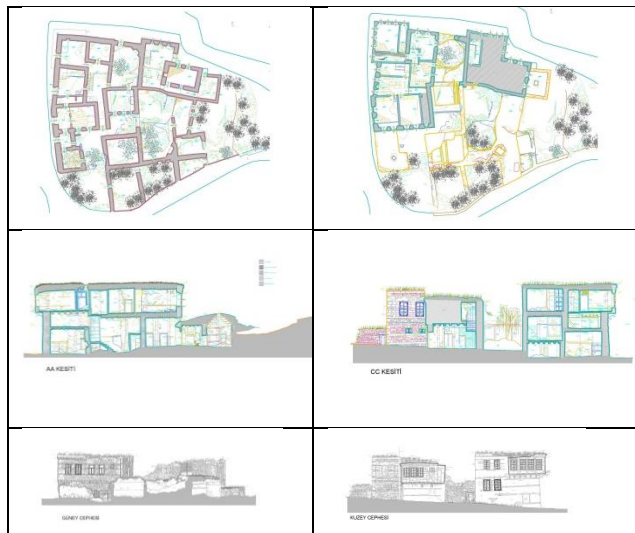
Figure 8. 2D CAD Drawings

In the survey, the materials of the structure have also been defined in addition to its architecture. The definition of the authentic materials of the structure casts light on the parts to be preserved authentically in the restoration project. In the survey report attached to the survey drawings, usage with the spatial deformations and deformations resulting from the climatic factors or improper interference are specified in the context of preservation of the authenticity and integrity of the structure (Fig.8).

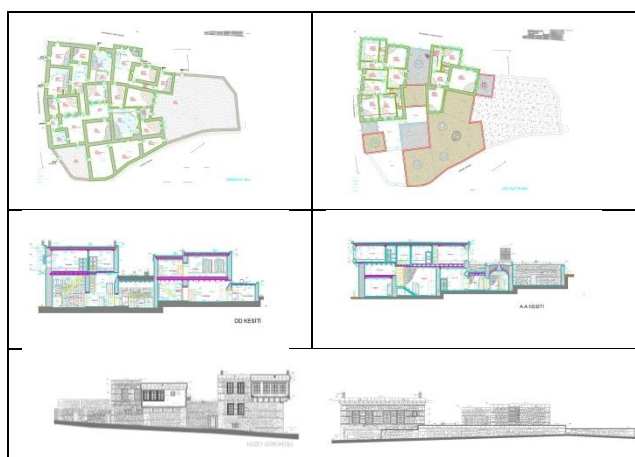
Figure 9. 2D Restitution Drawings

The data gathered from the survey analysis in Zırnıklı Mansion have made it possible to reveal the authentic parts of the structure and to identify the additions. The parts which had collapsed were able to be set as coordinated through the 3D laser technology and an authentic planning scheme could be read (Fig. 9).

The restitution project has been designed by conservation and completion of the authentic parts of the structure, 2D CAD drawings and reports have been prepared.

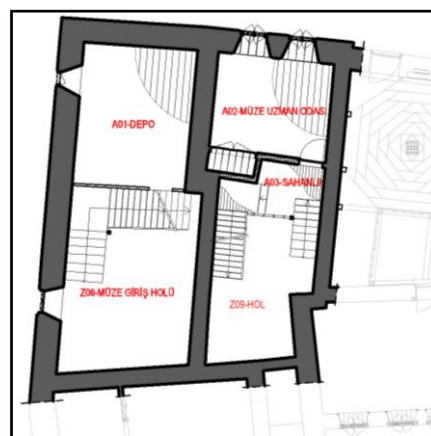
Figure 13. Restoration Project- Spaces of Museum Section

The exhibition hall upstairs is accessed through the wooden stairs, the first 5 steps are stone, from the Museum Z09 Hall. It has been decided to use the space entered from the stairs platform (A03) as an Experts' Room. The space is entered with a single-leaf wooden door from the platform. There is a wooden alcove in the space. The space is illuminated by 2 windows opening to the northern facade. They are double-skin, woodwork and with grab rails. The windows widen inwards. The ceiling of the space made of wooden lath (Figure 13).

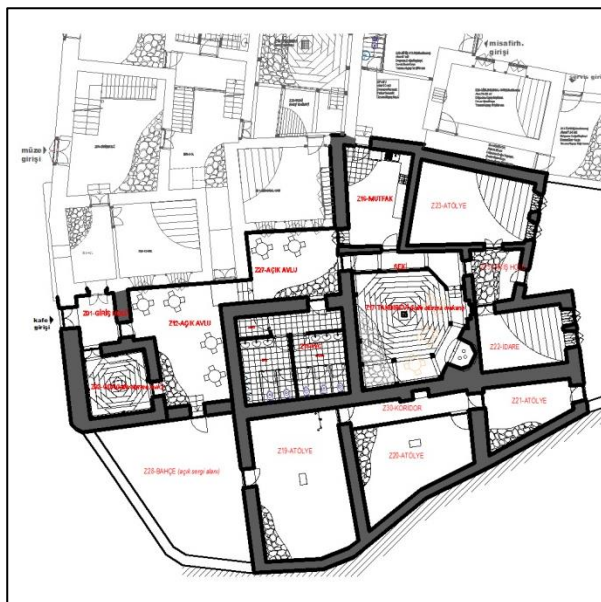
Figure 15. Restoration Project- Spaces of Museum Section

The section in the south of the structure has been given the function of Public Training Center. These spaces have been designed as the workshops where the people of the region would be trained so as to contribute to the individual, familial and local economy. A cafeteria has been arranged in this function. It has been thought that this cafeteria would provide service for both the visitors of the museum and and the people participating in the workshops (Fig. 15).

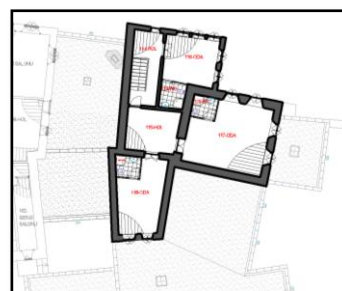
Figure 17. Restoration Project- Spaces of Guesthouse Section (1st floor)

It has been designed as an accommodation area of the guesthouse on the first floor of the structure (Fig. 17).

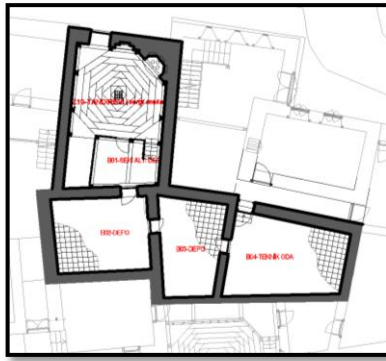
Figure 18. Restoration Project-Basement Floor

There are 3 spaces on the basement floor of the structure. These spaces are accessible underneath the platform in the tandoori house in the museum and from the corridor of the guesthouse. It has been thought that 2 of these spaces would be used as storehouses and the other as a technical room (Fig. 18).

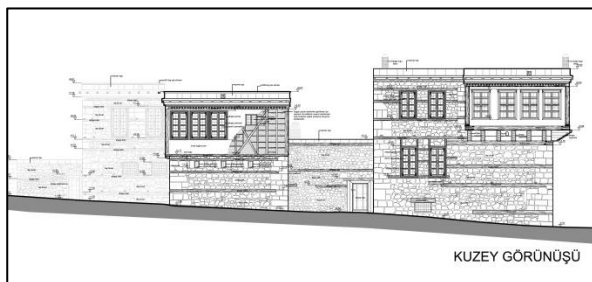
Figure 19. Northern View (Restoration Project)

The external walls of the structure have been rebuilt with the original materials (rubble stone and bonding timber) in original dimensions. The facade of the structure has been ended with the ashlar wall coping. Gargoyles have been placed on necessary parts of facade.

The doors and windows have been arranged in line with the original details. At the entrance of the structure, the "Z" type double-leaf wooden door which is typical in the Traditional Houses of Erzurum has been used. Also, a light double-leaf wooden door called "TIRHIC" seen at the front of the outer doors in the traditional domestic architecture of Erzurum has been used. Brickwork parts have been plastered and stone parts have been left unplastered (Figs. 19, 20,21,22).

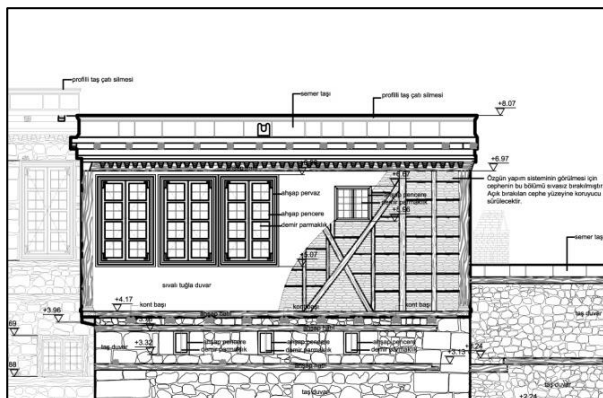
Figure 20. Northern View - Facade Detail (Restoration Project)

A part of the northern facade has been left unplastered for the original construction system to be seen. A preservative will be put on the facade left open (Fig. 20).
