## THE MAXXI MUSEUM IN ROME: AN INTEGRATED SURVEY EXPERIENCE FOR THE RESTORATION OF CONTEMPORARY ARCHITECTURE

A. Versaci<sup>a</sup>, A. Cardaci<sup>b</sup>

**KEY WORDS:** Contemporary architecture, reinforced concrete, conservation, 3D laser scanning

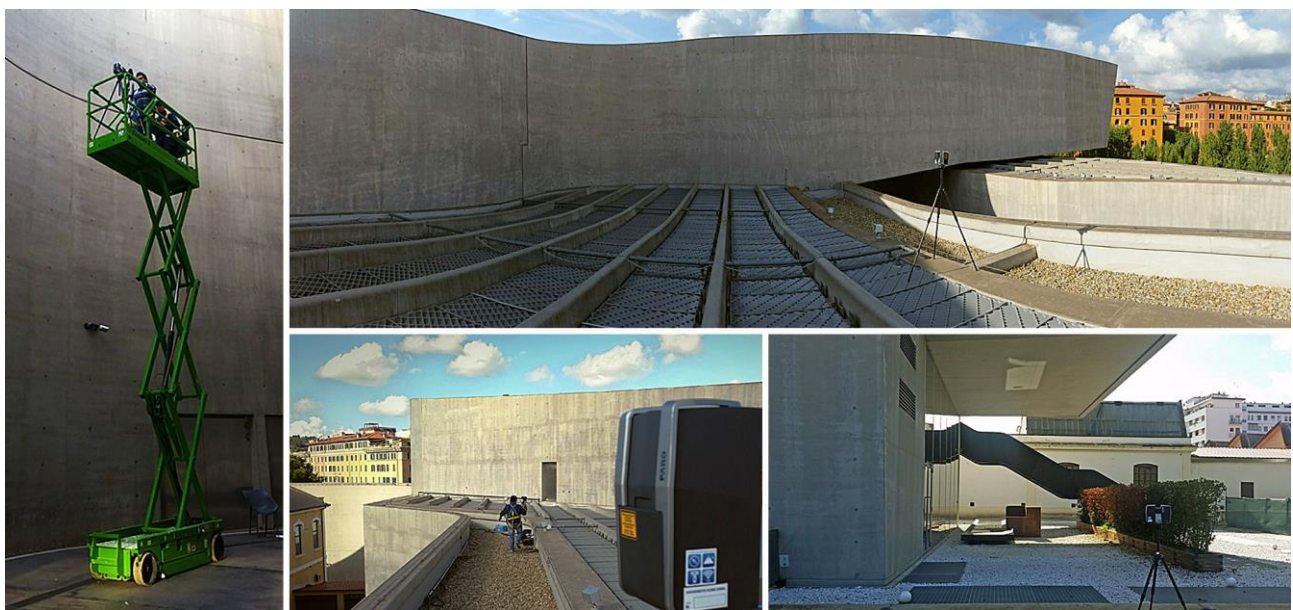
Figure 2. Architectural survey by 3D laser scanning

Surveys undertaken have caught all these aspects. Never driven by an obsession for millimetre precision, the acquisition campaigns by active sensors were conducted in a painstaking manner, performing a hundred stations to ensure the necessary accuracy but above all to fully control the activity (fig. 2).

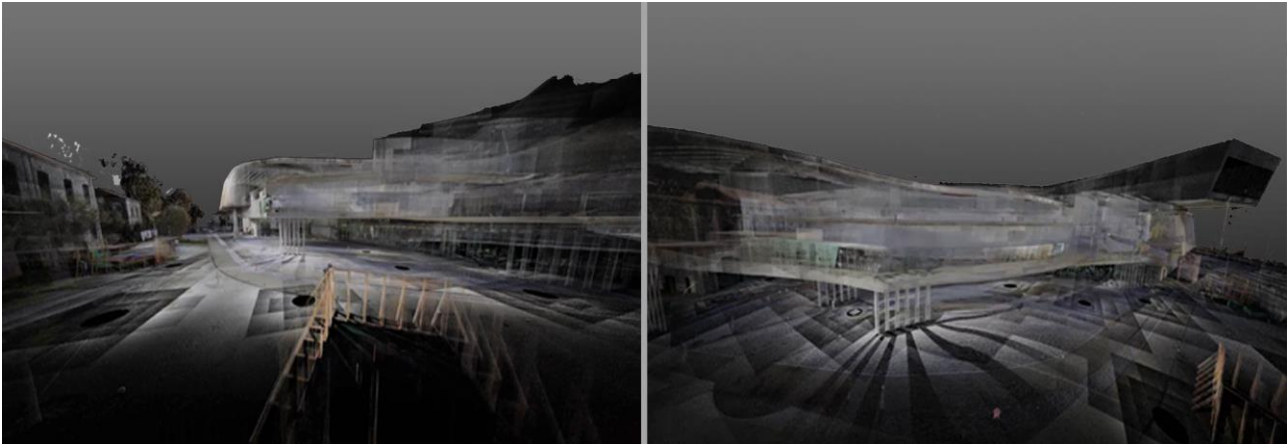
Figure 3. Point clouds obtained from the 3D laser scanning survey

For costs saving and a faster measuring execution time, it has been preferred not to resort to the 'classical' topographic support network, but to opt for a considerable number of acquisitions, with large overlapping areas (never less than 40%). This enabled the obtaining of a dense points cloud - composed of over 50,000,000 points with an average distance of 1-2 cm and a mean error in scans recording less than the required tolerance value for the 1:50 scale ( $\pm 1.5$  cm) - and, therefore, a reliable documentation of existing condition (fig. 3).

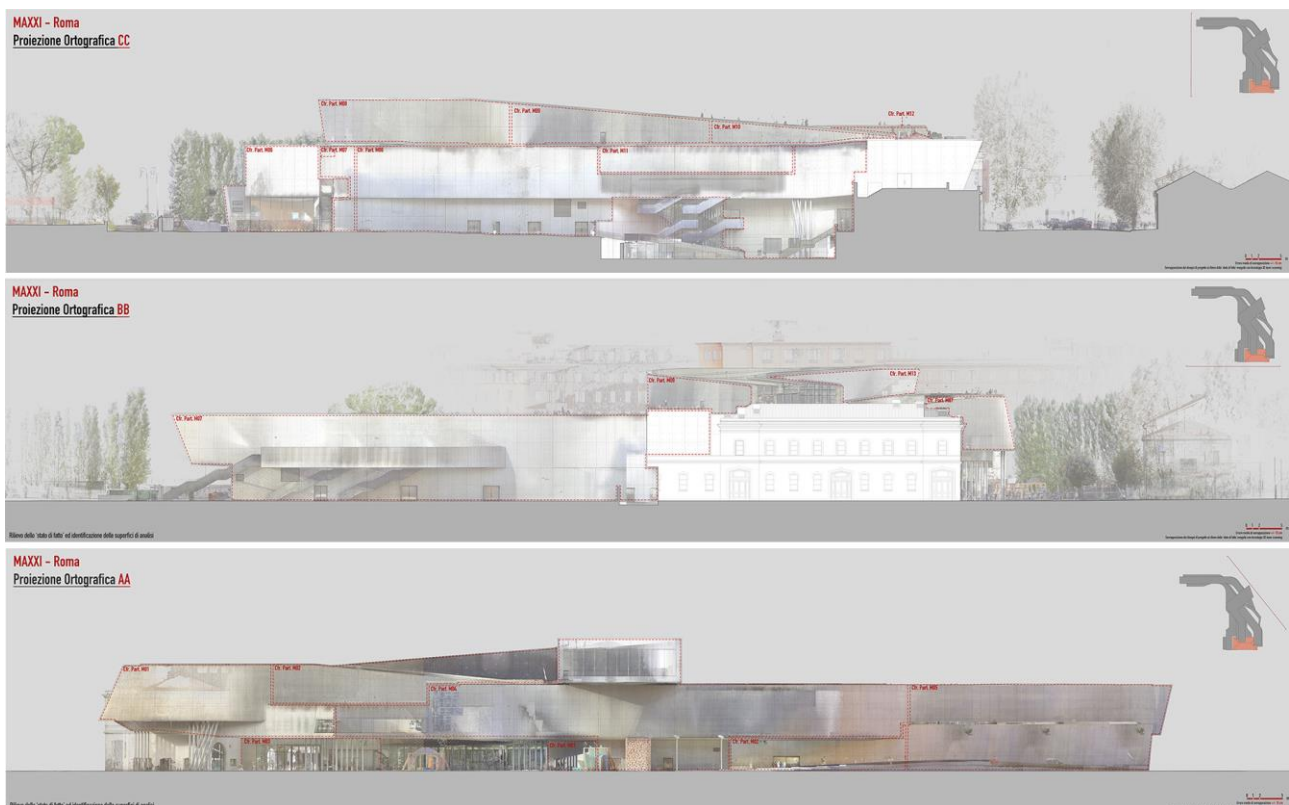
Figure 4. Orthographic projections obtained by 3D laser scanning survey

The procedure of 3D model construction comprised four main stages: the photographs alignment, the point cloud building (sparse and dense), the creation of polygon mesh, and then, finally, the model was textured by using the original photos. For a more successful estimation of the information on lens focal values and distortions, the camera was calibrated manually. The relative distances of the ground control points have allowed scaling, orientating, and verifying the quality of the textured model, from which hyposcopic views and orthographic projections were derived, also with a view to elaborating reliable bill of quantity estimates.

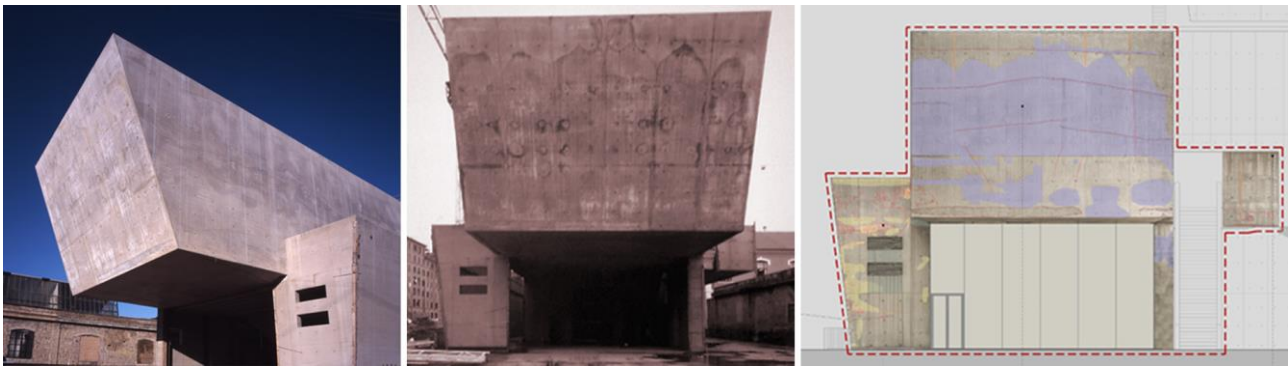
For the MAXXI, numerous interventions of *maquillage* were needed to please the designer, by removing the peculiar defects of the matter and those due to its production. Unfortunately, these interventions were short-lived and the structure is today just as prematurely deteriorated, maybe because of a certain technological inadequacy that over time has boosted the irregularities, making them visible in an even more striking and unpleasant way (fig. 5).

Figure 5. Detail of the west façade today (a), after the removal of the formwork (b) and decay mapping (c)

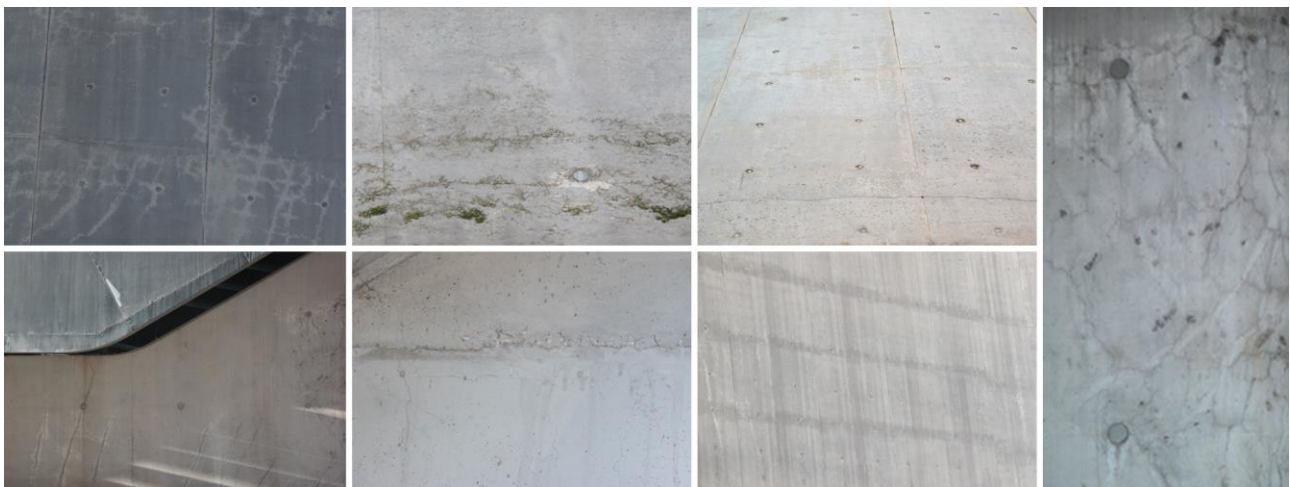
The considered phenomena were distinguished based on their occurrence. The pathologies were divided into two categories: a first, mainly related to congenital defects (constructive and/or design errors), which also caused the emergence of minor but recurring and widespread crack patterns (i.e. mistakes in the choice of raw materials, in the conglomerate and laying production, in the concrete curing, in the removal of the formwork, in the protection, etc.); and a second linked to the external environment (i.e. arisen in later times as a result of atmospheric phenomena, air pollution, natural ageing, etc.). In this sense, the identification was made according to the principle of prudence, with the purpose of isolating the most characteristic or potentially ‘dangerous problems’, where avoiding redundant overlapping, to facilitate the recognition and understanding of the phenomena, and so to drive the project intervention, in any chosen direction by the client (fig. 6).

Figure 6. Some of pathologies and alterations affecting today the MAXXI

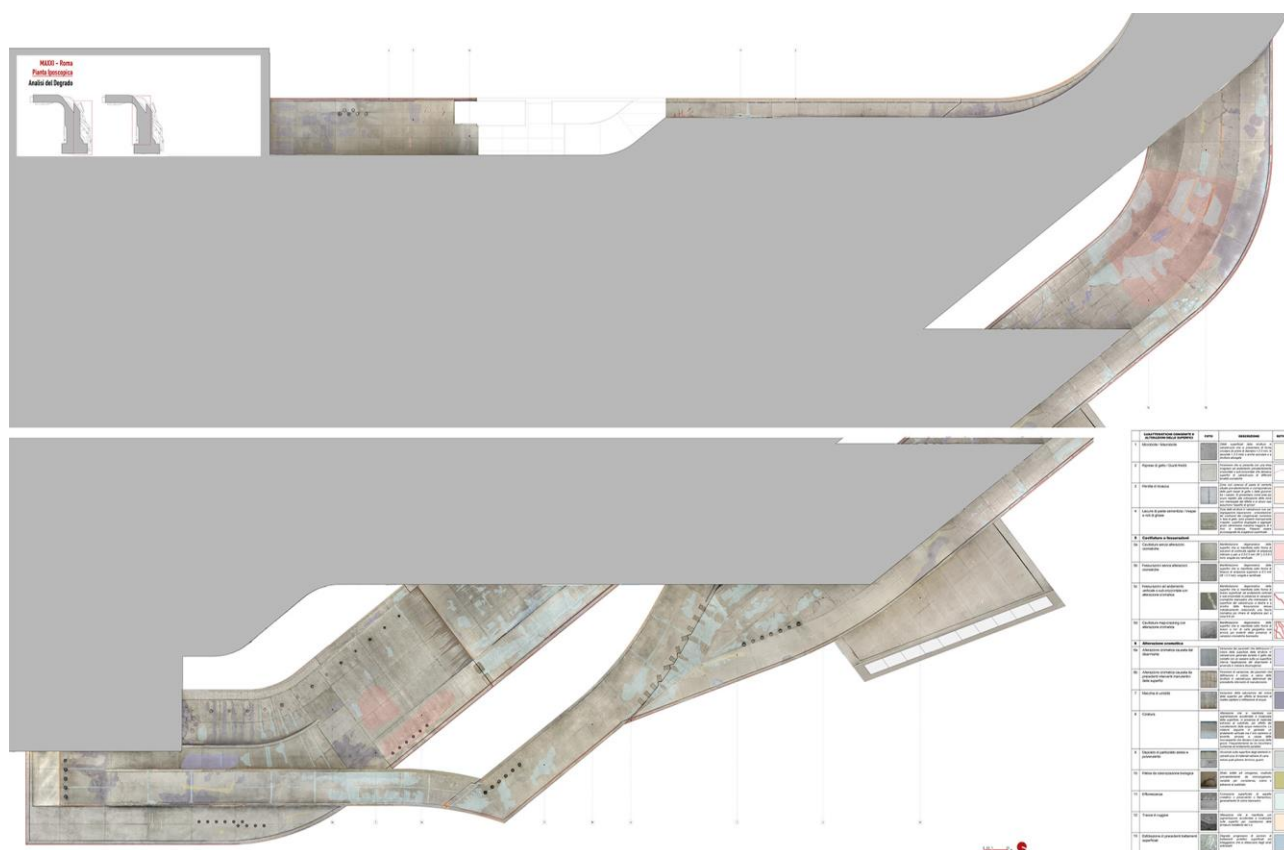
This did not make it possible the use of the traditional (Normal 1/88) and/or opaque hatches but imposed the combined use of CAD software (for perimeters) and 2D graphics design software to produce high transparent screens to be superposed on cement colours and ensure a proper reading at several levels. To better highlight the discolorations phenomena, it was also decided to slightly warmer the colours tones, of course without adulterating the overall chromatic adherence of photo planes to the reality (fig. 7 and 8).

Figure 8. Decay mapping of hyposcopic view
