THE CASE OF CAPOGROSSI IN ROME: COLLECTING DATA WITH DIFFERENT TECHNOLOGIES ON A CONTEMPORARY MURAL PAINTING

Paola Mezzadri ^a, Jacopo Russo ^b

KEY WORDS: Capogrossi, Contemporary Mural Painting, Collecting Data, Technologies, Digital Stereophotogrammetry, CAD and GIS graphic documentation.

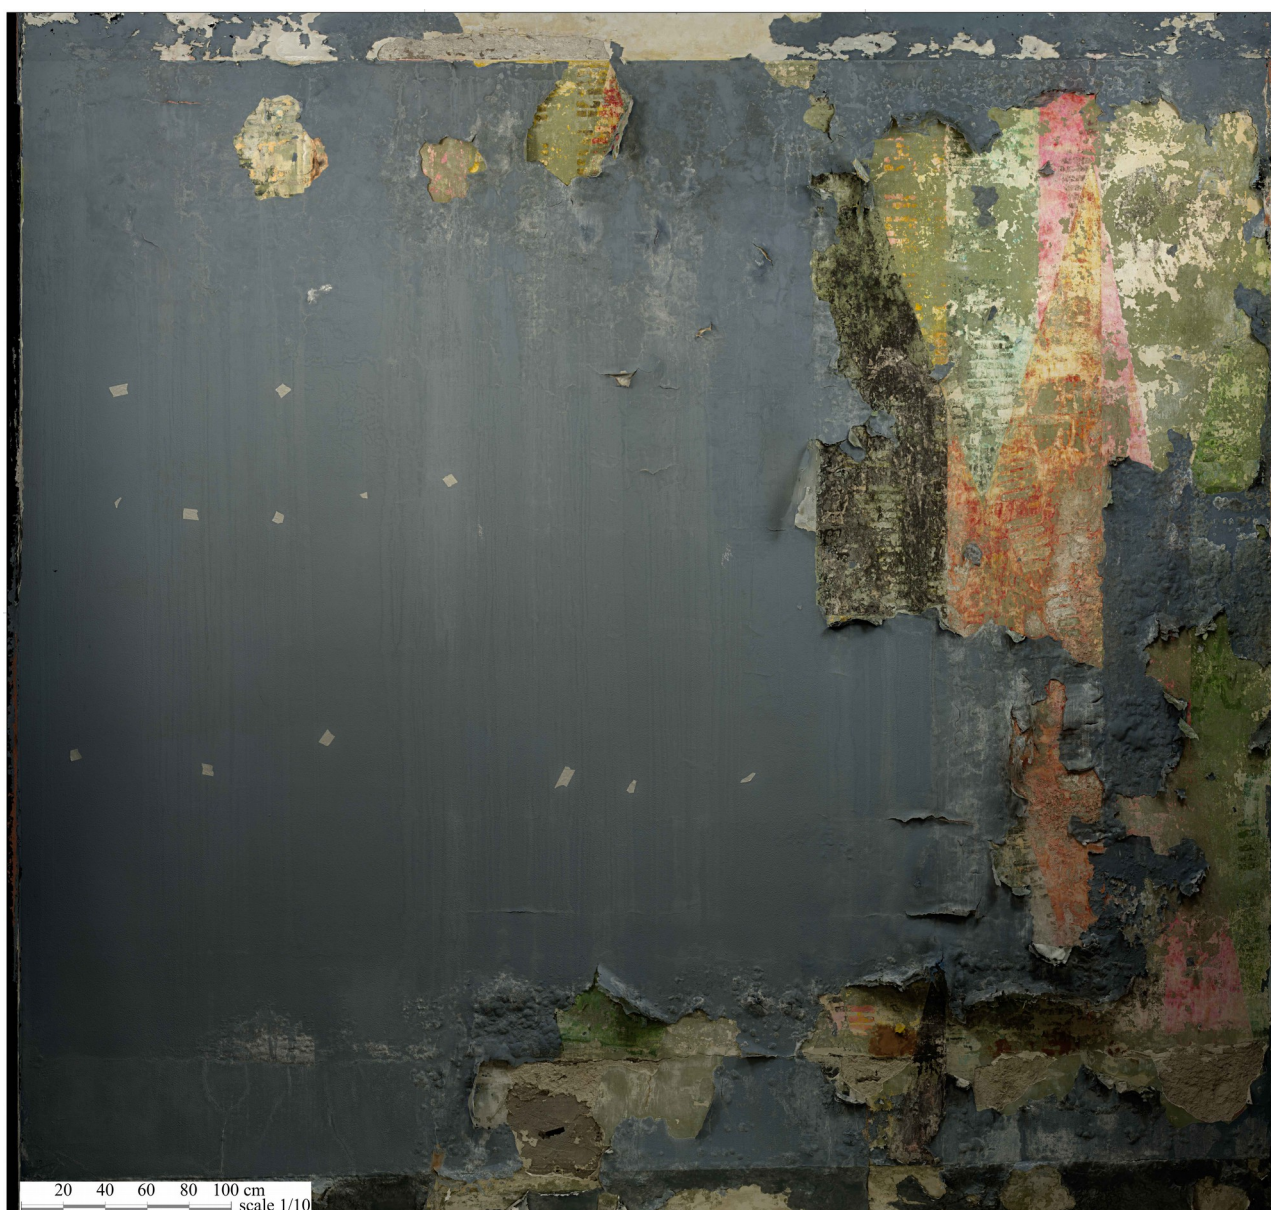
Figure 1. Orthophoto of the lower ceiling of the Capogrossi wall painting at the Airone cinema. Image: Paola Mezzadri all rights reserved.

generating a cloud of high-density points (dense cloud); each of these points was reconstructed from at least two photographs taken from different positions in which the point was visible. The photos were all acquired in RAW file and then were automatically linked and aligned together by the digital software Agisoft Photoscan that compared homologous points (pixel sequences that represent the same details) in the different frames. Once executed the alignment of all the photographs, the dense cloud was generated and was then interpolated by the software to obtain a dense network of triangles called mesh. Finally, the photographic texture - obtained starting from the same photos used to generate the dense cloud - was re-projected on the mesh; from this three dimensional textured model, projecting it on an imaginary plane with parallel beams between them, it was possible to obtain the orthographic image of the lower ceiling (fig.1).

An imaginary plane on which to perform the projection was identified by affixing three targets on the vertical walls, 70 cm below the ceiling. In this way it was built an imaginary parallel plane to the one of the ceiling shifted downwards of 70 cm, sufficient to accomplish the measurements without encountering obstacles constituted by the hanging portions of the overpainted layers. The position of the targets was determined downwards with a pendulum laser level.

The photographic shots were realized with the easel and with different exposures (fixed and variable time diaphragm) ensuring a correct exposure time in each area. All the photographic images were obtained by utilizing four halogen lamps, two placed at the landing between the double staircase and two at the bottom; the lamps were directed against reflector panels in order to illuminate the wall painting in the most homogeneous manner. Each stairway had 16 steps and was divided into three parts by two handrail columns. Therefore, 9 photos were performed for each step reaching a total of 144 photos to obtain the final whole orthophoto of the lower ceiling. All the 144 photos were acquired in RAW file and subsequently saved in TIFF format. Radial image distortion and spherical aberration were corrected (with Photoshop) during this stage; after that, all the photos were linked and aligned together obtaining a textured three-dimensional model and an orthographic image with a resolution of 0,5 mm per pixel.

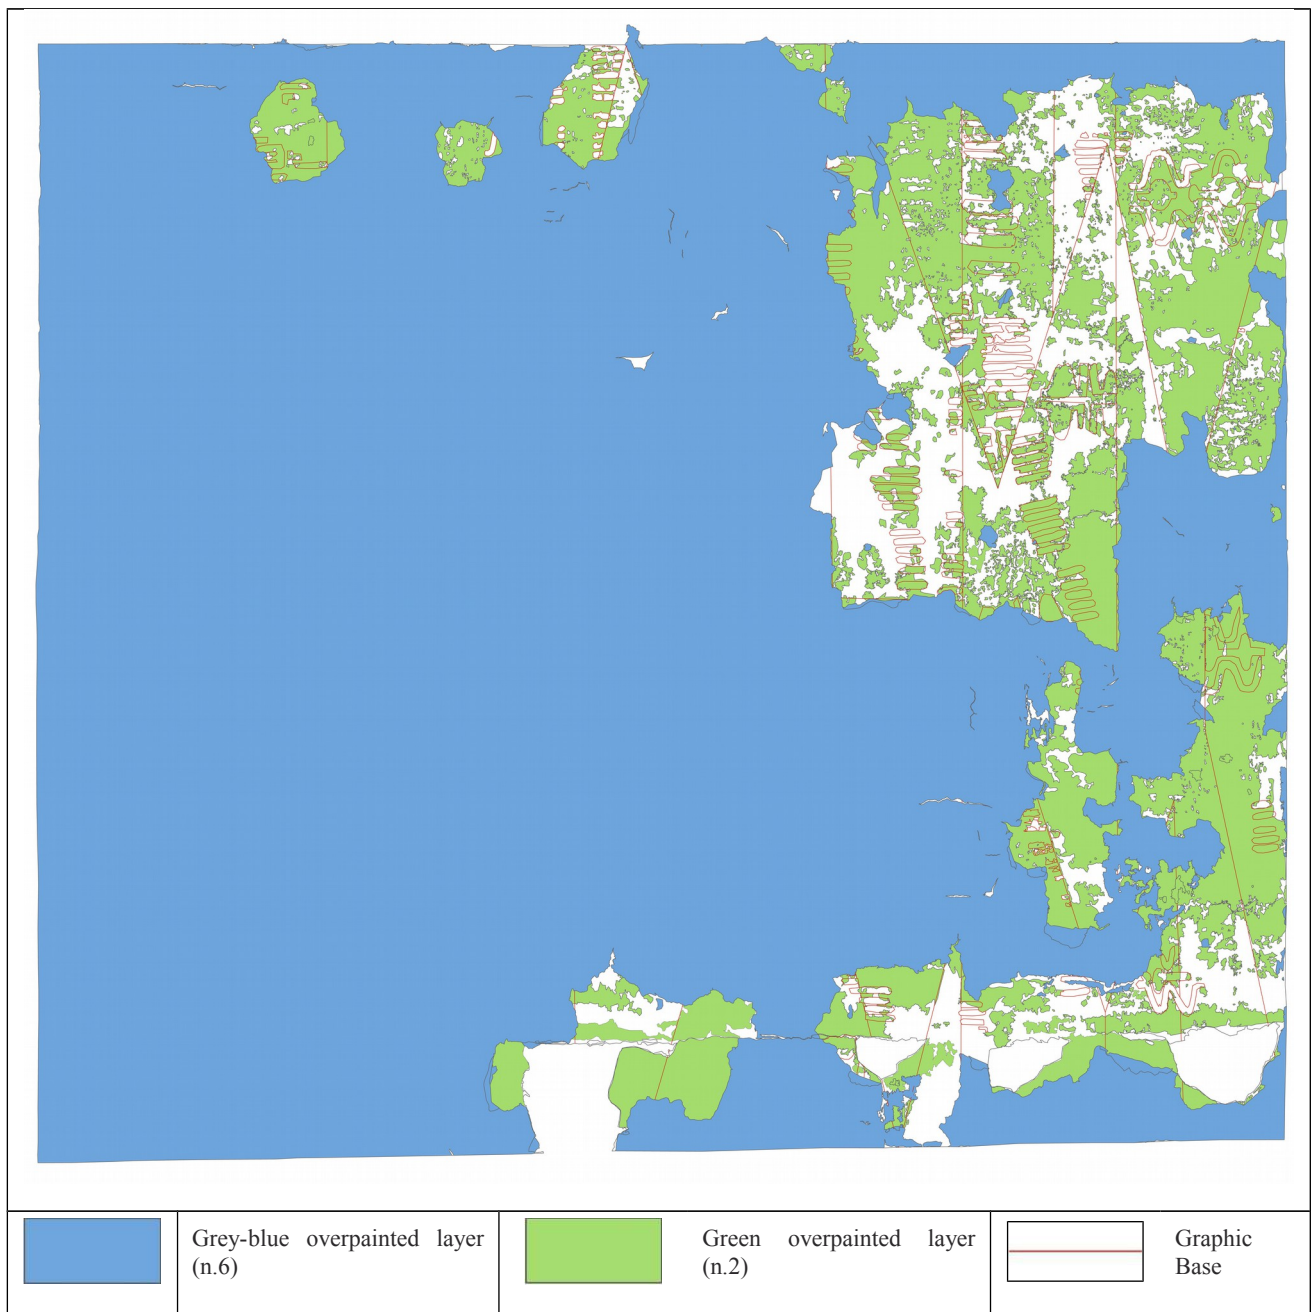
Figure 2. Thematic graphic table of the Previous interventions and its legend. Image: Paola Mezzadri all rights reserved.

These high quality images allowed to document precisely all the previous interventions on the painting, such as the six layers overpainted, within a thematic graphic table by utilizing CAD software (fig.2).

The table shows the overpainted layer n.6 (grey-blue colour) and n.2 (green colour) that were visible; the other layers were anyway present but hidden from the latter. Moreover, due to the persistency of the water ingress during the first part of the restoration project (RH 80-90% and T that was following the external fluctuations), another thematic graphic table of the overpainted layers, not reported in this paper, was accomplished. This table shows how some portions of the four overpainted layers were removed as a preventive and conservative operation in order to facilitate the evaporation process after the re-roofing by the construction company in charge; the table, based on the second and final georeferenced orthophoto, was necessary to cross all the data collected in CAD and to facilitate GIS documentation.
