CHARACTERISTICS OF TEXTURE INDEX OF DAMAGED BUILDINGS USING TIME-SERIES HIGH-RESOLUTION OPTICAL SATELLITE IMAGES

KEY WORDS: Disaster, Earthquake, Damaged buildings, Texture analysis, dissimilarity

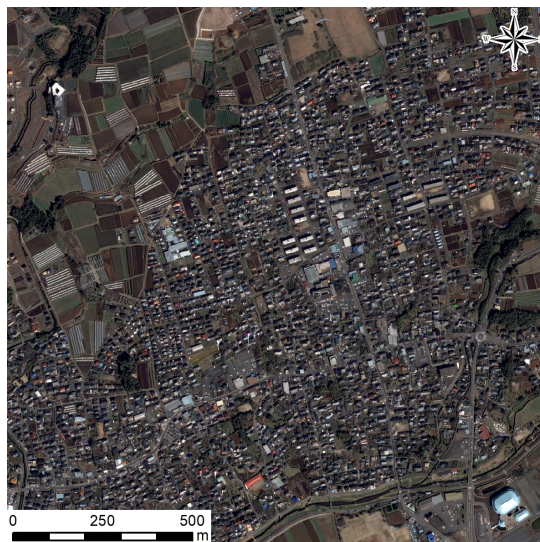
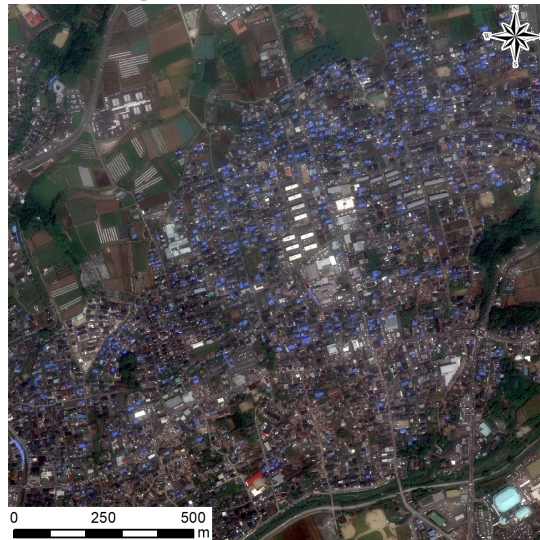
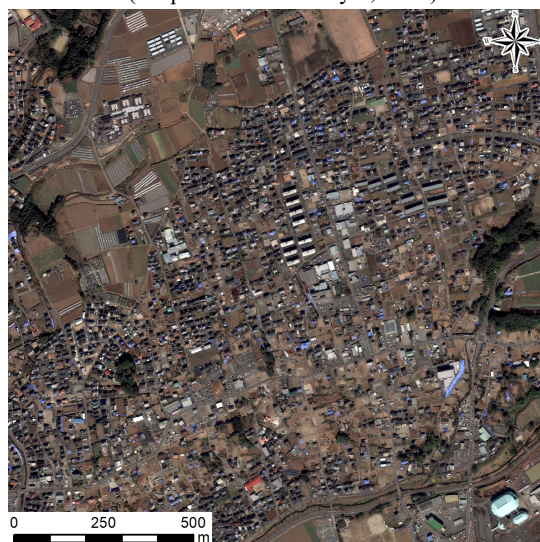
Figure 1. Satellite image in study area

QuickBird satellite data observed before the earthquake (March 24, 2004). QuickBird satellite sensor produces 4-band multispectral images and a panchromatic image with a resolution of 0.6×0.6 m and 2.4×2.4 m, respectively. WorldView-3 satellite data observed after the earthquake (May 5, 2016) and 1 years after the earthquake (March 11, 2017). WorldView-3 satellite sensor produces 8-band multispectral images and a panchromatic image with a resolution of 0.3×0.3 m and 1.2×1.2 m, respectively. These three satellite image data have almost the same season (Figure 1).

(a) Before disaster
(Acquisition date: March 24, 2017)

(b) Immediately after the disaster
(Acquisition date: May 5, 2016)

(c) After the disaster
(Acquisition date: March 11, 2017)

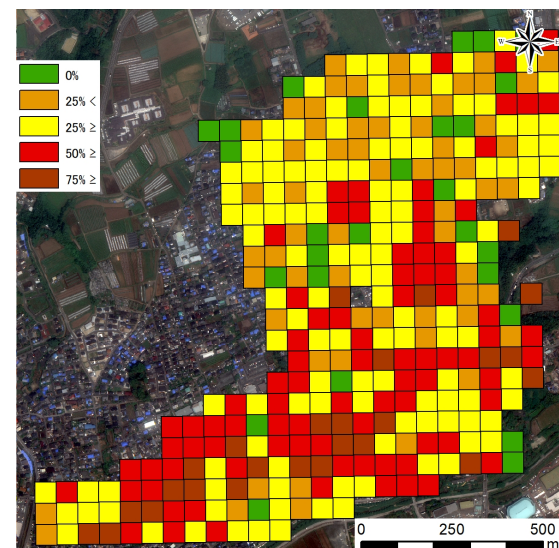
(a) The buildings damage rate with mesh calculated from the dissimilarity

(b) The building damage survey (destruction rate) by AIJ
Figure 6. Comparison of the destruction rate and the buildings damage rate using the dissimilarity

mean value of the dissimilarity within the building polygons immediately after the disaster was set as the threshold value. In addition, the results classified into 5 levels are shown in Figure 6-(a) for comparison with the results of the building damage survey results. Figure 6-(b) shows the results of a comprehensive survey by the Architectural Institute of Japan (AIJ). There was a tendency for overestimation on the north side of the target area where damage was particularly small. Assuming use during a disaster, it is important to identify a location where damage is large during a disaster and take prompt rescue measures. Therefore, we compared meshes with a crushing rate of 50% or more between the building damage survey results and satellite analysis results. It was found from the building damage survey results that the damaged area was concentrated in the old river channel, and the mesh created from the satellite analysis results showed a similar distribution. The extraction rate was 73%. The extraction rate indicates the ratio of buildings with 50% or more of damaged buildings in satellite image analysis for meshes with a crushing rate of 50% or more as a result of the building damage survey results. From these, it was shown that the distribution tendency of damaged buildings could be grasped from the dissimilarity obtained from high-resolution satellite images immediately after the disaster.
