ADOBE VERNACULAR HOUSING TYPOLOGICAL ANALYSIS IN CALIMAYA DE DÍAZ GONZALEZ, STATE OF MEXICO

D.S. Romero Olguín¹, L. F. Guerrero Baca^{2,*}

KEY WORDS: Typology, Construction techniques, Vernacular architecture, Calimaya

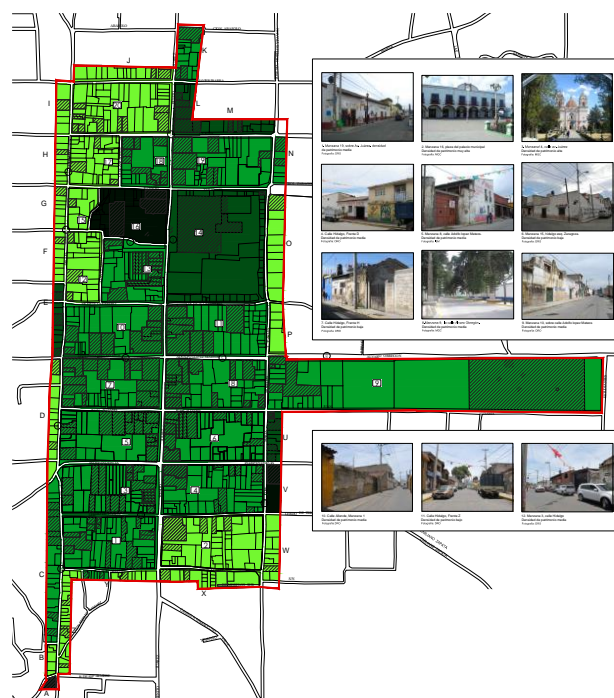
Figure 1. Heritage density level. (Source: own elaboration).

3. Identification of valuable buildings and/or architectural elements. When performing urban research within registry maps, the presence of formal-functional features and historical materials in real estate were seen. This systematized information has allowed the preparation of planimetry identifying the density of heritage for every area of the locality; this has made possible to perform an assessment of the selected area (Figure 1).

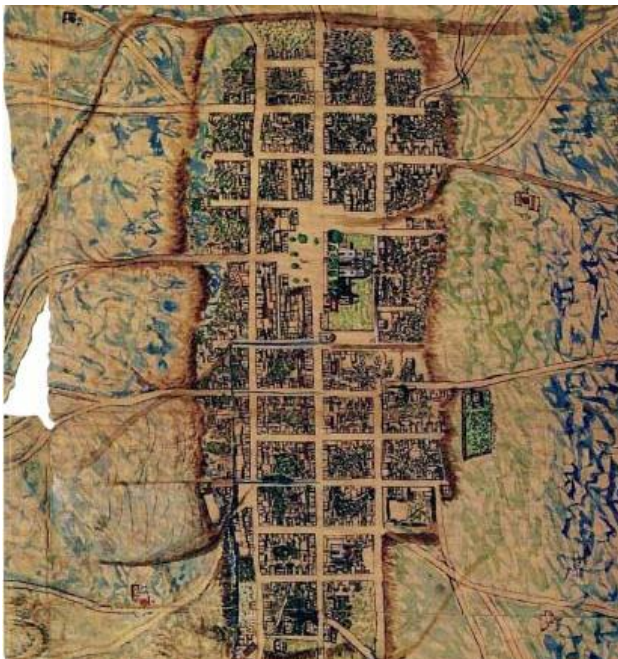
Figure 2. Sketch of the municipality of Calimaya made by C.L.F. ca. 1824. (Source: Atlas of the State of Mexico).

The properties on Avenida Juárez retain their original trace and their block centers are tree-lined boulevards where the majority of the housing estates of interest are. Outside this linear axis, blocks do not retain the same morphology, nor remains the same urban pattern where growth has been messy; likewise, some block centers have been subdivided for distributing them among the children of the ancient inhabitants (Figure 2).

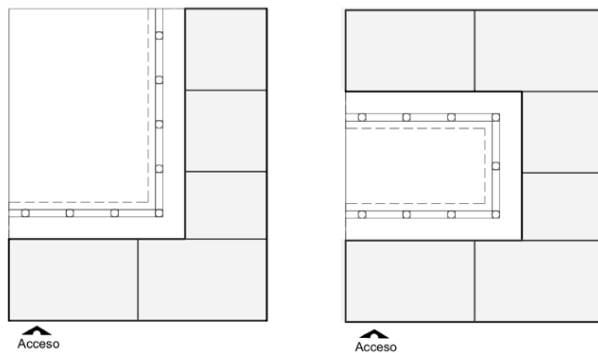
Figure 3. Shape types in Calimaya. (Source: JAPN)

Two types of shape were seen, differing in the distribution in the land; the first type is the “L shape”, where housing is open toward the back, connecting to the central courtyard. The second type is the “C shape”, in which all rooms revolve around a hallway and a central patio. In this case there may or may not be a back yard. In all the examples, the buildings are aligned to the vertical surface of the street (Figure 3).

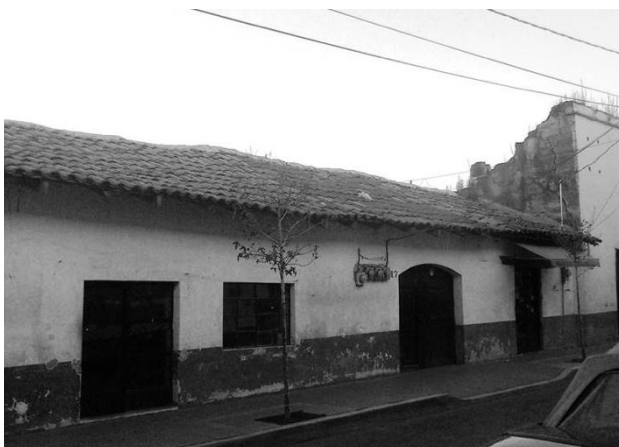
Figure 4. Vernacular architecture in the surrounding streets.
(Source: DSRO)

Secondly, exclusively residential use; this type recurrently occurs in houses that are not on the main road, those that are located in the surrounding streets, where there is a direct contact with Avenida Juárez; however, there are a few cases on the avenue. This section allowed determining that traditional buildings still retain the use and formal characteristics dating from the eighteenth and nineteenth century, the period of greatest economic boom in the community (Figure 4).

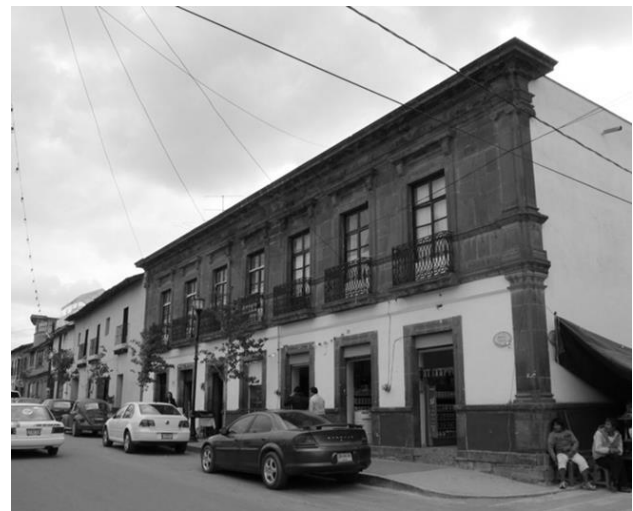
Figure 5. Two-story housing typologies. (Source: DSRO)

Having performed the analysis concerning the morphology of housing in facades, the results showed that the one-story houses, with double height are the 48.6 percent of the locality; low height is due to the continuity of the telluric movements, caused by the proximity with the volcano. The second type are two-story houses; the main characteristic is that they have retained the use of the balconies with blacksmith ornaments. The covers for this typology can be either one or two pitched roofs with curved or flat clay tiles, which in many cases have already been replaced by concrete roofs (Figures 5 and 6).

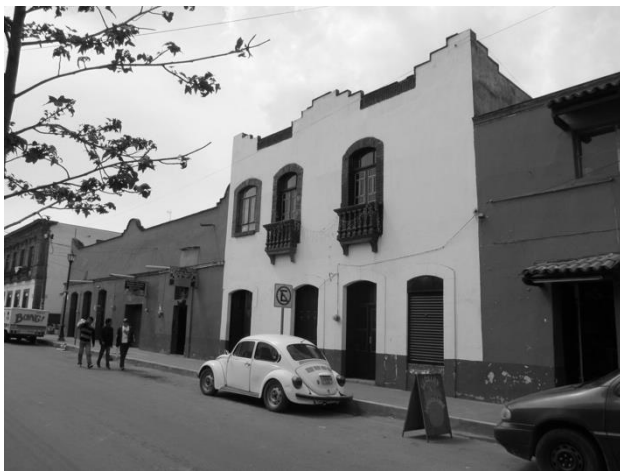
Figure 6. Two-story housing typologies. (Source: DSRO).

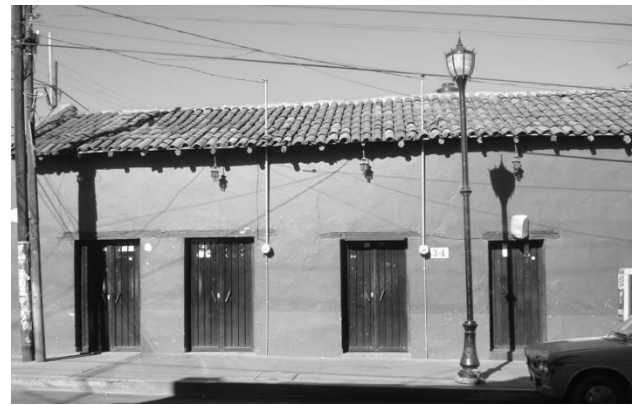
Figure 7. Type of facade simple in vernacular housing. (Source: DSRO).

The ornamentation on the facade is quite simple, smooth walls. In some cases, the windows and doors have lintels and carved quarry door jambs; cornices of brick and stone quarry were observed as well. Gutters are made of steel and quarry stone, some of them garnished. Blacksmithing in windows and doors is simple and clean. The study identified that housing without quarry lintels prevail; lintels are made by wood covered with mud coating (*enjarre*) and in some cases instead of the wood, *adobe* (Figure 7).

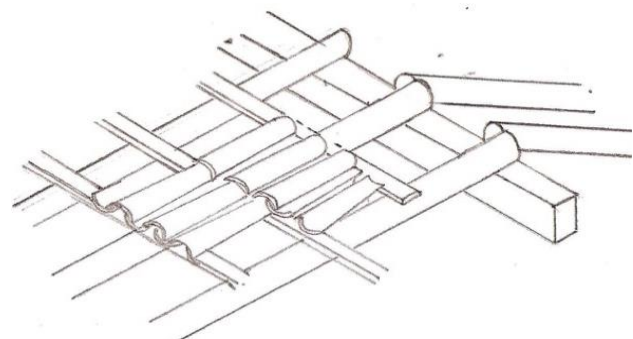
Figure 8. Sketch of constructive system typology. (Source: own elaboration).

The mezzanines have been classified into: 1. loft of wooden beams of 0.15 x 0.10m, 5m in length every 0.15m between each one, filled with earth and covered with slabs of clay; and 2. cover of concrete slab, where the original roofing has been modified by the owners (Figure 8).

We have identified three types of covers: a) wooden beams with clay tile; subdivided in roofs with a slope and covered with two slopes; b) concrete flat slab, which does not correspond with the original features; and c) collar beam roof with clay tiles.
