## ENSEMBLE OF CONSTRUCTIVE TECHNIQUES IN THE CASTLE OF RICOTE (MURCIA, SPAIN)

**KEY WORDS:** Murcia, Ricote, Castle, Rammed Earth, Constructive Techniques, Building Archaeology

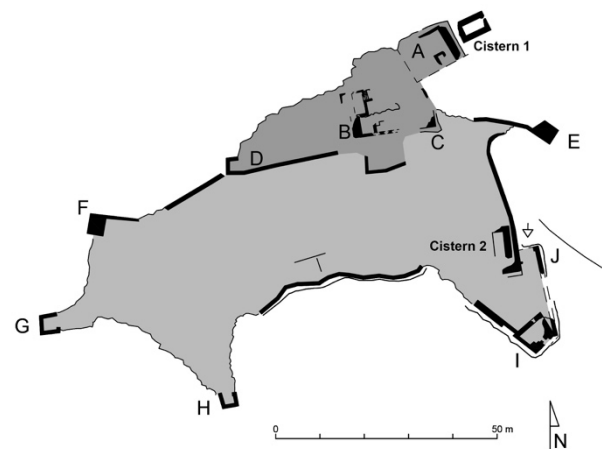
Figure 1. Layout drawing of the castle.

The work that we carried out was based on a first survey that comprises different aspects, such as the drawing of a draft general plan of the castle (Figure 1), the documentation of visible and well preserved structures, the collection of data for photogrammetry and planimetry, the archaeological analysis, and the elaboration of stratigraphic recording sheets for each stratigraphic unit.

Despite this, based on the observations that we were able to make of the ensemble, both enclosures follow the same display (Figure 1).

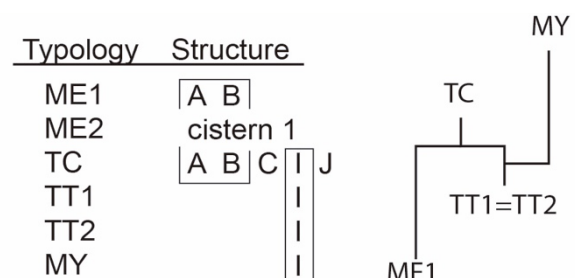
Figure 2. Table of typologies-structures and typology matrix.

Unfortunately, the technical challenges presented by this castle have prevented us from completing an exhaustive archaeological analysis. Nevertheless, due to the relevance of the set of construction techniques, we decided to attempt to classify them (Figure 2).

As consequence of the lack of a comprehensive understanding of all the structures and the absence of an exhaustive stratigraphic analysis, it was not possible to establish a phase sequence that would allow us to explain the complete evolution of the castle. However, a partial analysis of each structure made it possible to identify a set of stratigraphic units and their relations, since each unit features a specific construction technique (Figure 2).

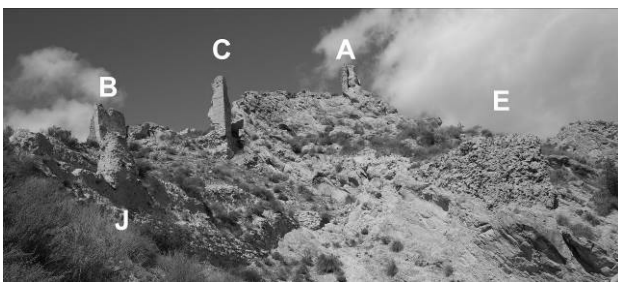
Figure 4. View of the east elevation and the upper enclosure.

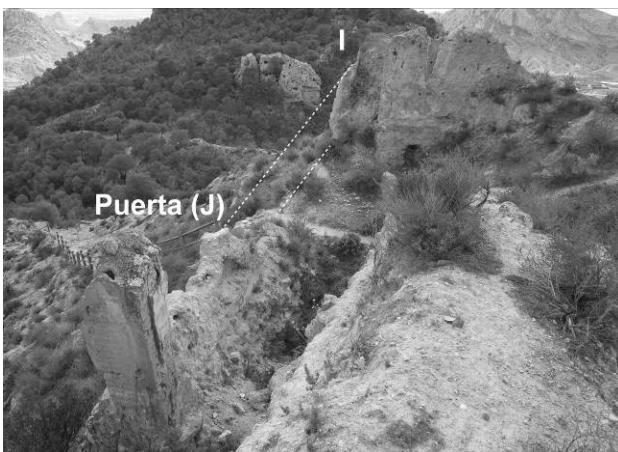
Figure 5. View of the ensemble composed of Tower I and Gate J.

The lower enclosure, whose function could effectively be that of an *albacar*, extends to the southwest of the upper enclosure and adapts to the usable area of the hilltop, restricted by steep slopes. Its layout presents at least four towers, three in the western area (F, G, and H) and another one of greater dimensions (I) in the southeast corner, which serves as connection with the eastern wall of the enclosure. This last tower, one of the best preserved, has a trapezoidal plan and features several reinforcements. Its eastern front is the most solid one, since it was covered by the end of the eastern wall (Figures 3 and 4). The main gate stands next to this tower (J). It is structured as a bend between two walls. The foundations and one of the jambs of the access are still in place (Figure 5). Attached to the inner side of this wall there is a collapsed cistern.

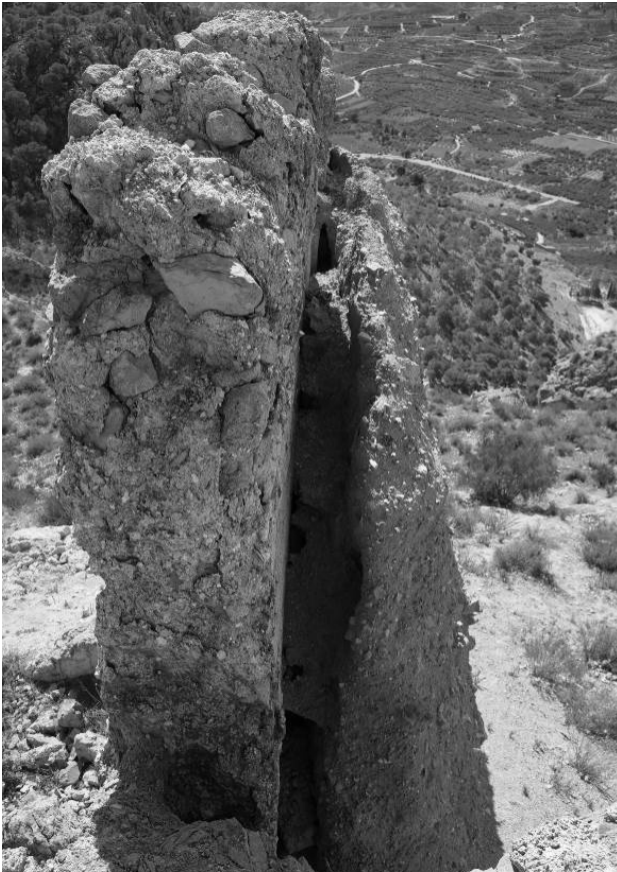
Figure 6. Tower B. Top view of (TC) attached to (ME1).

The west elevation of Tower B is largely preserved and comprises a wall built using this technique. It is 0.53 m wide and consists of shuttering work of medium and large stones (limestone, dolomite and marl) agglomerated with lime mortar (Figures 6 and 7). The stones are not set in regular courses. The mass includes pieces of tile and pottery. The boxes are 0.82 m high and they present putlog holes sealed with the same mortar as the mass. In the corner, it is possible to see how the boxes are interlocked between the two walls (Figures 8 and 9). There is an outer layer of gypsum plastering.

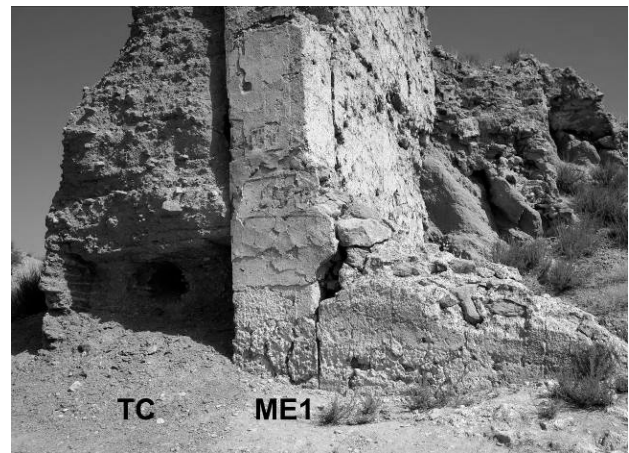
Figure 8. Tower B. Southern front. Connection between (ME1 – TC).

Both Building B and Tower A present thin walls built with this technique, so it is not surprising to find that in both cases they have been refurbished with an external coating. This relation is evidenced by observing how this lining was attached to the plastering of (ME1) (Figures 8 and 9). This means that this technique could be one of the oldest recorded in the castle.

In both A and B, the boxes are 0.79 m high and have rectangular putlog holes. It is possible to notice the casting sections on the wall faces, although for recognizing the lime-crusted technique in more detail it is necessary to observe the lower part, where the wedges and lime mortar beds are more clear (Figure 8). The difference between both materials (earth and lime mortar), has surely prevented the correct adhesion of the layers, causing the detachment of the lime crust.

In the lower part of B there is a cylindrical horizontal hole inside the wall. This seems to correspond to a possible log introduced in the mass of the wall for improving the resistance of the wall against traction (Figure 8). As for putlog holes, some of them still present remains from logs due to the considerable thickness of the wall. In Tower A, the (TC) was built on a slope masonry base (Figures 10 and 11).

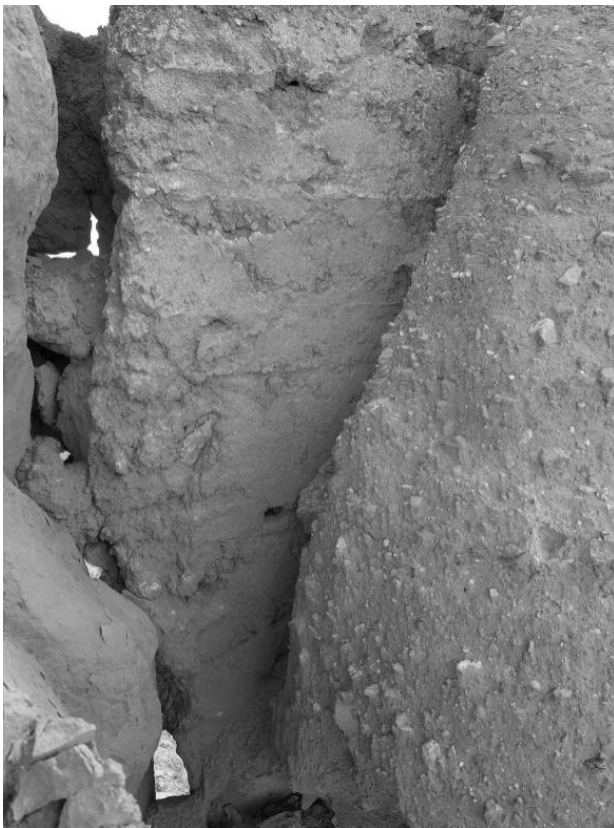
Figure 7. Tower B. (TC) attached to the outer face of (ME1).

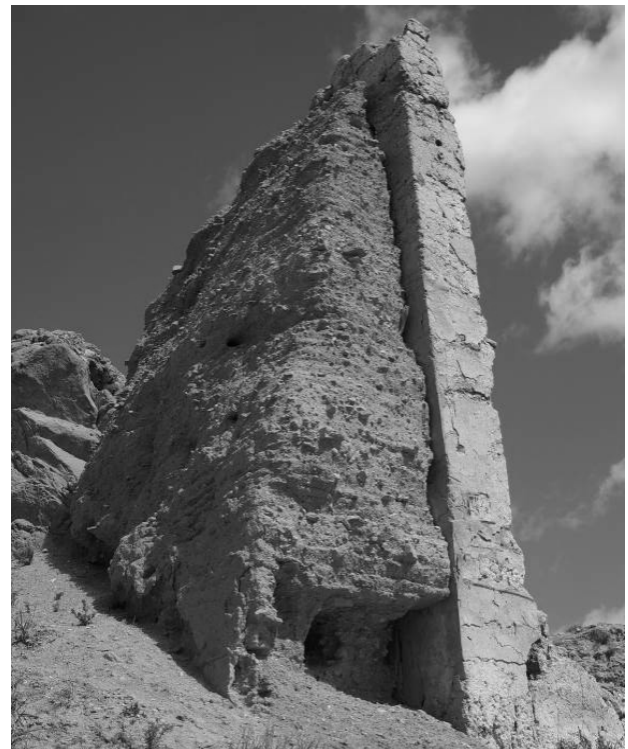
Figure 9. Tower B. (TC) attached to (ME1).

In towers A and B, where it has been possible to observe this technique correctly, it is up to 1.44 m wide, and the composition is very earthy, with much waste (pottery and bones) included. There is a smaller ratio of stones, that are different sizes. Likewise, gravel predominates (Figure 9).

The first one, (ME1) is quite remarkable as it is the typology used in the oldest units. Its masonry and materials reflect a long-lasting intention, which contrasts with its narrowness. This last aspect gives these walls little mechanical stability in the case of high-rise walls, like Building B (Figure 9).

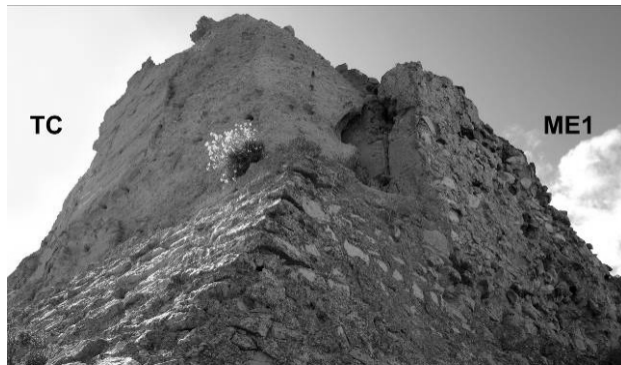
Figure 10. Tower A. North-eastern angle.

Tower A also preserves its large east-facing front and part of its north side, which form a solid corner together (Figure 10). The imprint of the *barzón* (wood strip of the shuttering) near the outer corner is very interesting. The outer face of the eastern front is almost perfectly preserved behind a reinforcement wall of lime-crusted rammed earth (TC) (Figure 11). However, the northern front of Tower A was not externally reinforced similarly, and therefore its outer face is quite damaged.

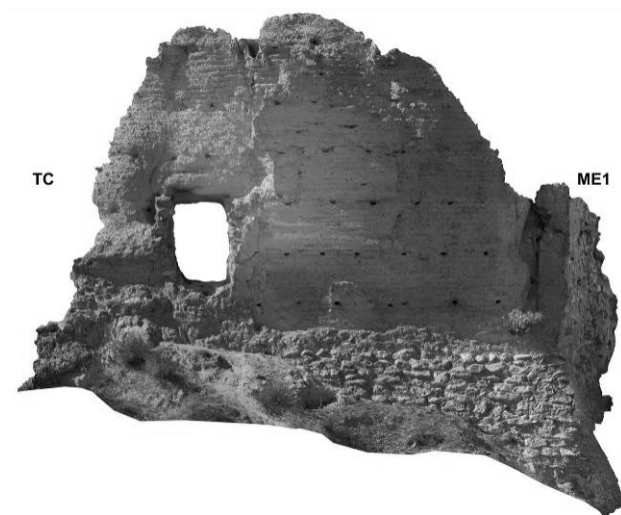
Figure 11. Tower A. Eastern front. Orthomosaic.

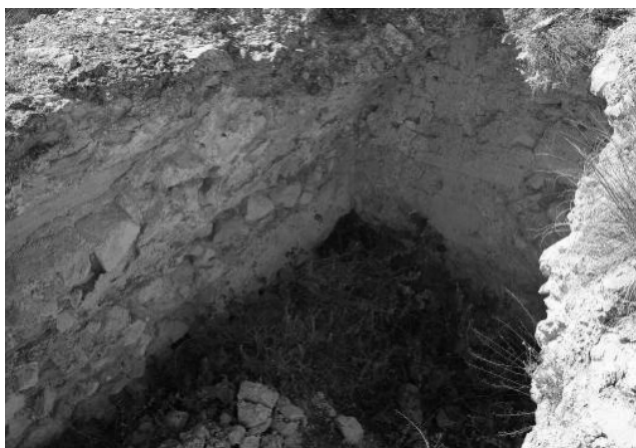
Figure 12. Upper cistern by Tower A.

In this case, the stones were set in well-defined and regular courses, which were set with a lime mortar rich in gravel. In addition, it seems that the interior faces of the walls were executed with a greater proportion of mortar and small stones, while in the exterior ones, larger pieces and less proportion of mortar were used (Figure 12).

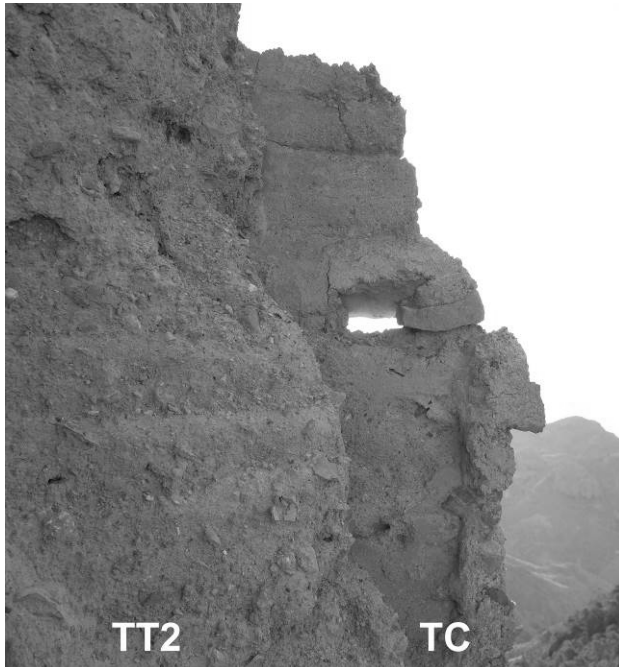
Figure 13. Tower I. Angle of (TT2) and (TC).

As for Tower I, the (TC) surrounds the southern and western fronts. It lies on a masonry base and is covering an older rammed earth wall (TT2), as shown by the burrs on the inner corner (Figure 13). This wall is part of the eastern wall that begins at the main gate (J) and surrounds Tower I, although the middle section was lost and the area is used as current access to the castle (Figures 3 and 5). Likewise, the same technique is found on the recessed wall that stretches from the gate to the north, although it is very deteriorated.

Tower I features another different technique on its southern and western fronts, where remains of previous work reinforced by (TC) can be found (Figure 13). It consists of a very light earthy wall, possibly mixed with lime or gypsum like the previous technique (TT1). Its mass includes small stones of variable size and the presence of waste (ceramic and bones).

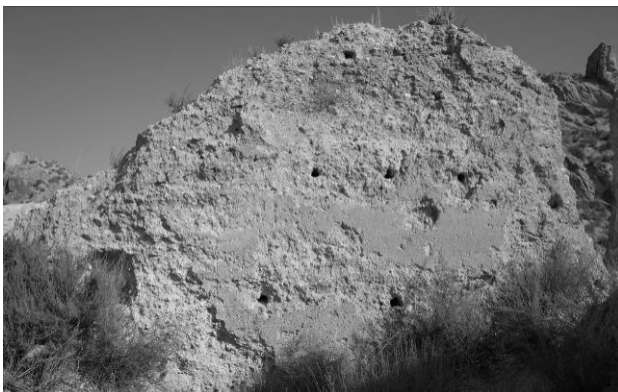
Figure 14. Tower I. Northern front built with (TT1).

The northern front of Tower I was built using the technique of rammed earth, whose composition possibly includes a very low proportion of a binder, such as lime or gypsum (both materials were abundant in the area), boulders, small stones, and gravel, and features small quantities of waste (brick, ceramics, and bones). This wall is 0.98 m thick. The mixture used has favored the cohesion and conservation of both faces, which also seem to present a crust (Figure 14). The boxes are 0.85 m high and were built with circular putlog holes, unlike those found on (TC). Outside the tower, it is possible to notice how the wall was built on top of a previous construction, which was evened with rows of small stones and bricks that served as support for the first putlog holes of the new work (TT1).

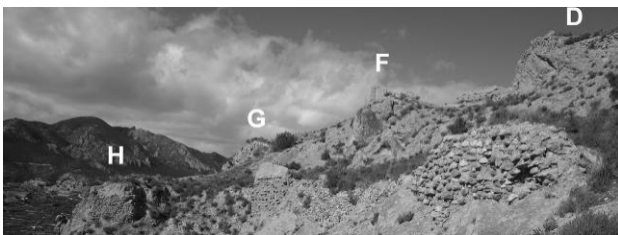
Figure 15. View of the lower enclosure from Tower I.

It seems that this technique is also present in other points of the castle, such as the southern wall between towers H and I, where a much deteriorated fragment appears over a stonework wall (Figure 15).

Masonry work is widely present throughout the castle. In most cases, it appears as foundations of rammed earth walls. This is why the existence and trajectory of the missing walls can be proved through the masonry works that survived to our day (Figure 15). Their features are diverse—rows found are regular as well as irregular, stones vary in type and size, and different types of mortar were used.
