## CONSIDERATIONS ON THE JOINT RECOVERY OF THE MONUMENT AND ITS ENVIRONMENT: THE TOWN WALLS OF ALBARRACÍN (SPAIN)

The city walls of Albarracín (Teruel) show an exemplary trajectory of restoration and conservation works, thanks to a fifty year-long trajectory of interventions carried out by different architects. The last of these projects, promoted by the City Council and driven by *Fundación Santa María de Albarracín*, was drafted in 2019 and involved the restoration of the southern end of the wall. For the first time, this project has addressed the recovery of the monument and its surroundings in a joint effort that bets on a global vision for the city's public space system. The keys to this binomial are based on the following premises: a well-coordinated monument-environment relationship, the emphasis on a conservative approach to the restoration works, the promotion of public use and the dignification of the space in a coherent way with its context. The joint treatment of the building and its environment goes far beyond an aesthetic or functional issue – which may have been achieved through independent projects – and verifies the criteria adopted for both dimensions of the proj

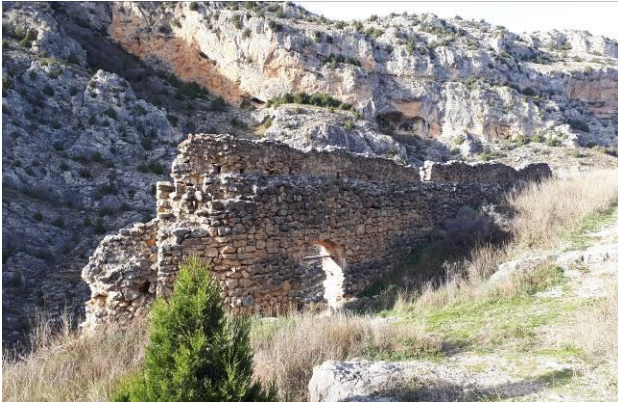
Figure 4. View of the wicket gate from the interior of the fortified precinct (J. Díaz).

Some water drains conserved in the exterior of the wall show the original height of the ground in its inner face, which is now silted up to its crowning with debris. It has a wicket-gate opened in the path that descends towards the river (Figure 4) and the remaining of a structure that, according to Almagro (1987), may have been the watchtower that controlled this area until the construction of the tower of *Doña Blanca*.

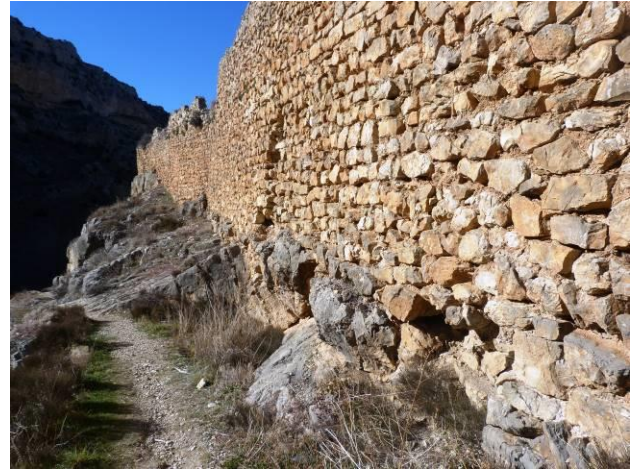
Figure 5. City wall of Albarracín, outer face of the *Torre Blanca* section (F. J. Gómez-Patrocinio).

All the stretches of the wall are formed by two external masonry layers, affixed using lime mortar, that confine a nucleus filled with lime concrete (Figure 5). Thick joints are due to the irregularity of the rough limestones, coming from the quarry known as *Barranco de Rusia*, that were used in the masonry walls. Only the protruding corner that starts the stretch with the wicket gate includes some coarsely carved ashlar.

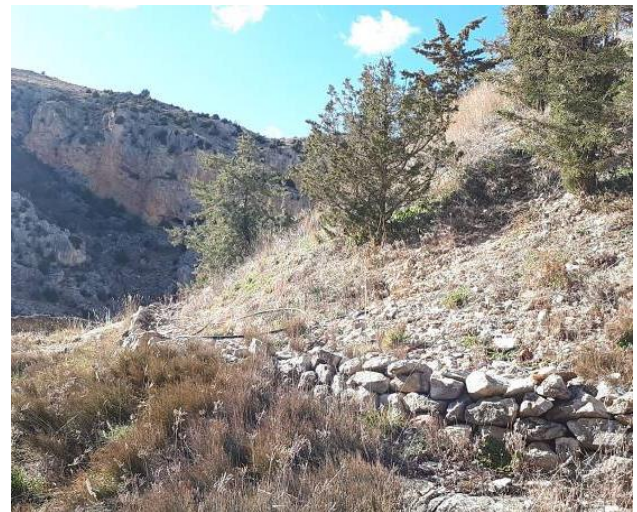
Figure 7. Historical debris dumped in the surroundings of the southern end of the city wall (J. Díaz).

The vast volume of debris accumulated in this area, which was the local landfill for over a century, made it impossible to address the recovery of the original ground level to the interior of the wall (Figure 7). Consequently, the project plans the substitution of the materials silting in the inner face of the wall by a draining filler relieved by the original gutters. However, the height of this filler will be lowered about a meter from its current level, which is even with the crowning of the wall.

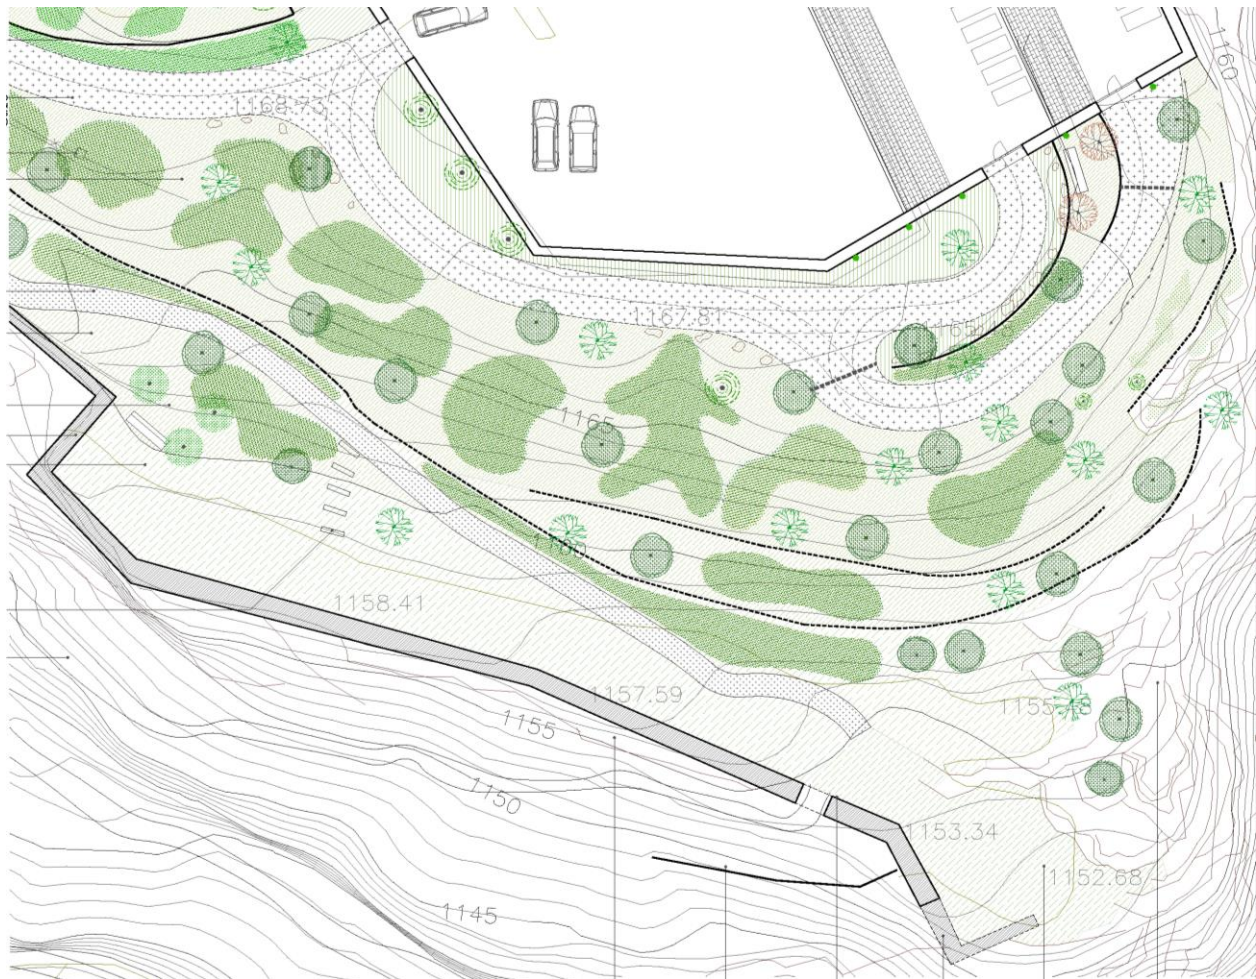
Figure 9. Plan of the projected landscape intervention (Díaz and Baró, 2019).

The joint vision of the open space system and the patrimonial dimension of Albarracín has provided the key elements of the planned intervention. The project proposes the re-naturalisation of the area by removing imported, distorting elements and substituting them with autochthonous species. It aims to revert the effects of some inappropriate interventions (relief alterations, species planted with inaccurate criteria, uncontrolled dumps, obsolete conductions, etc.) to dignify the environment of the monument and unify it with the lowly anthropized slopes that surround the city (Figure 9).

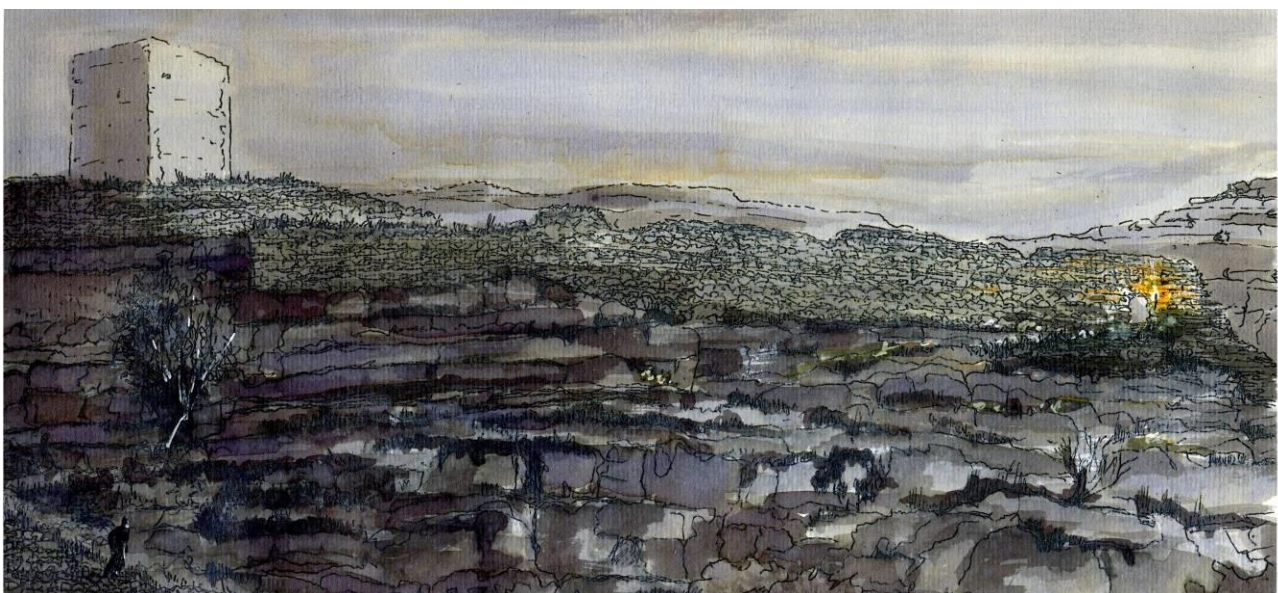
Figure 10. Sketch of the wall and its surroundings (J. Díaz).

The first element benefitted from these synergies is the historical path that descends towards the river from the terrace next to the graveyard. Its itinerary runs next to the wall at this area and, thanks to a coordinated design, will include small haven-viewpoint spaces that will improve the perception of the monument. Some metres further, the path crosses the wall through the wicket gate and leaves the fortified precinct. A lonely, tenuous uplight has been installed at this point, underlining its singularity as an inflexion point and turning it into a milestone in the landscape: from here on, the path abandons the city and plunges into nature (Figure 10).
