STUDY ON CONSERVATION AND RESTORATION OF LIUGOU ANCIENT TOWN EARTHEN SITES IN BEIJING (CHINA)

KEY WORDS: Ancient Castle, Earthen Sites, Great Wall, Conservation, Restoration

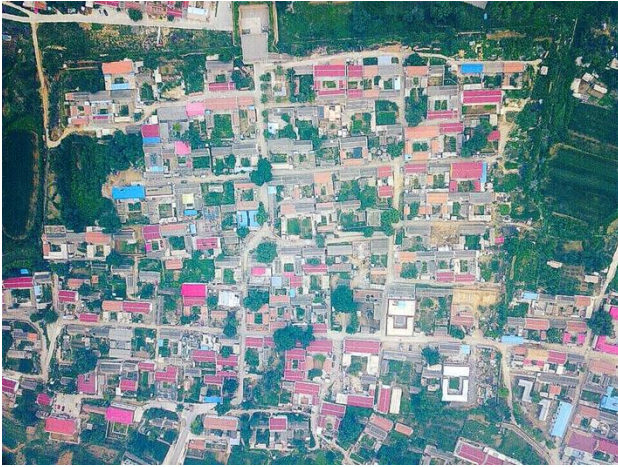
Figure 3. Aerial photo of Liugou Ancient Town.

The Earthen Great Wall: There is a section of rammed earth Great Wall in the southwest of the castle. It is 129m long in the east-west direction and 3.5m high at the highest point. There is a height difference of 5m between the north and south sides of the Great Wall. The earthen wall is continuous as a whole, but the weathering collapse is severe, and the extra height of the west end is only 0.3m.

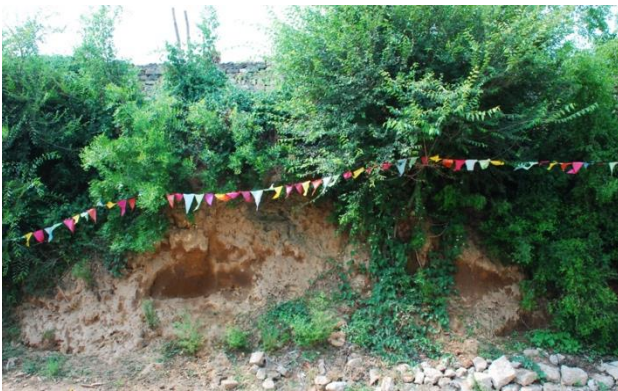
It is found that natural factors cause the primary technical diseases it faces by analysing the geographical and social environment of the earthen sites. Under the combined effects of wind and rain, flaky peeling diseases such as wind erosion peeling, rain erosion peeling, and crack peeling have been produced, undercutting diseases such as blister alkali, wind undercutting, and freeze undercutting, as well as fissured gully diseases and animal and plant organisms damage. The damage caused by human production and life is the leading social disease faced by soil sites. Such diseases are not solved merely by specialized treatment but also involve various factors such as law, economy, security, and stability.

Figure 5. Present situation of peeling diseases of the south town wall.

The protection of the soil site surface is a combination of spraying protective agents and mud layers. Besides, the repairing material should be cohesive soil, and avoid mixing plant rhizomes, slippery stalks, pests and molds, and plant damage. When rebuilding in a large area, it should be rammed according to the original method and pattern.

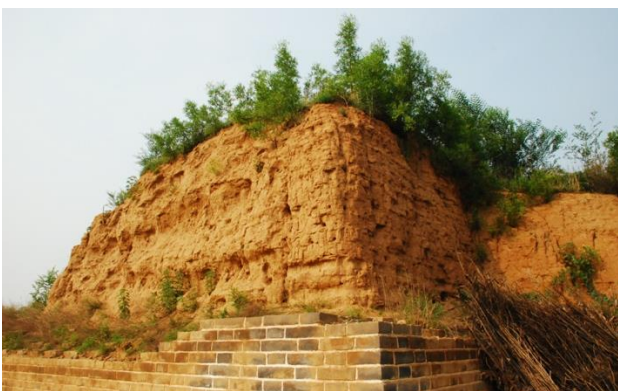
Weathering and collapse of the rammed earthen wall: The weathering status of the rammed earthen wall of Liugou ancient town earthen sites is divided into a weathered layer, a semi-weathered layer, and a slightly weathered layer. The soil structure of the weathered layer is loose, and the lack of cohesion between the soil makes the body of the earthen site extremely vulnerable to wind and rain erosion so that the wall gradually shrinks, and the imbalance eventually collapses. Humans excavate the soil at the bottom of the wall also destroy the stability of the rammed soil structure and cause the collapse.

Figure 6. Present situation of weathering and collapse in the northwest corner of the town wall.

3.3.1 Reinforce the earthen wall structure: For the loose part of the rammed earthen wall, the method of rammed earth grouting combined with soil anchor and solid phase is adopted.

The internal loose soil is grouted and reinforced so that the inner soil is reunited into a whole, and then the soil anchors are used to anchor the part of the external brickwork. The vertical cracks of the earthen wall are closed with clay plugs to prevent further weathering of the internal soil. For horizontal cracks in the wall, soil anchors need to be used to anchor the soil with a sliding tendency, and then the soil cracks are closed. For the pit formed by the weathering and peeling of the wall, the weathered and loose part shall be cleaned until the stable interface is exposed, and then the rammed earth shall be used for filling. For the pits formed by water scouring, the problem of water leakage needs to be solved, and regular maintenance and overhaul should be performed to avoid leakage of the eaves and leakage of cracks on the top masonry paving, causing internal damage.

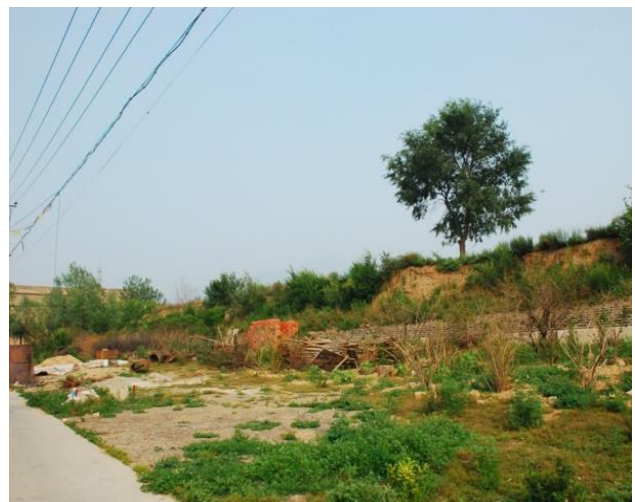
Plant diseases: These are the most critical diseases faced by earthen sites. Shrubs and weeds cover the top surface of the earthen sites. The root system of plants grows in the earthen wall cracks, which will not only destroy the original structure of the earthen wall but also cause water to run along with the plant root flow into the wall, which is directly causing the internal soil loss, leading to the problem of hollow and collapse of the wall.

At the same time, plant decay increases the content of organic matter on the surface of soil sites, further aggravates weathering and plant damage. From the perspective of the exhibition, plant growth has reduced the recognition of the ancient earthen wall and has destroyed the authentic town of heritage. Therefore, standard plant removal work is needed.

Figure 7. Present situation of plant diseases on the north town wall.

3.3.4 Clean up the plants: Plants damage is the most typical problem of the Liugou ancient town earthen sites. Not only does the plants' canopy affect the appearance of the city wall, but its root system also becomes a hidden danger that threatens the structure of the town wall. Therefore, cleaning up the plants on the walls and controlling the development of their root systems is the key to conservation. Common vines and shrubs can be removed directly, trees can first cut down their trunks, and then use chemicals to inject the roots. After they rot, add soil to tamp them. Do not directly dig out the roots of the tree, as this is causing more significant damage to the site. If removing the plant is cause the wall to collapse, temporarily retain the plant and treat it after the town wall is repaired and strengthened.

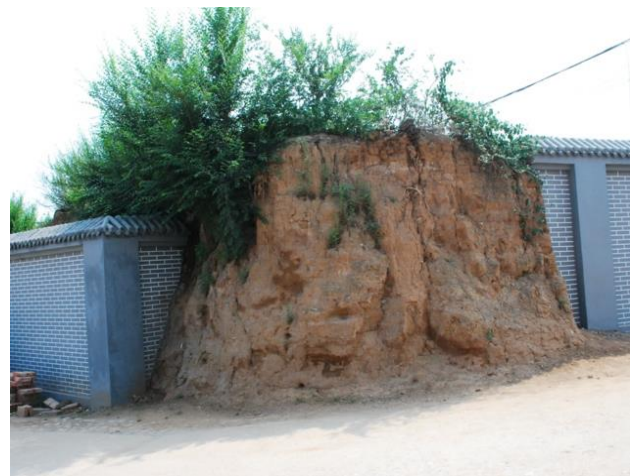
Human-made destruction: Due to the lack of awareness of heritage protection in the early days and the weakening of the defense effect of the earthen wall after the founding of the People's Republic of China, residents dug earth to build houses, resulting in the wall soil being exposed, collapsed and even disappeared. Also, there is no corresponding heritage management in the entire area, and arbitrary climbing and sightseeing by tourists also cause damage to the heritage.

Figure 8. Present situation of human construction damage of the east town wall.

3.3.5 Improve the surrounding environment of earthen sites: Based on the integrity principle of heritage conservation, the protection of the earthen wall should not be limited to the repair and strengthening of the body, but also the environment inside and outside the wall needs to be rectified. For example, the Kuixingge area in the southeast corner of the town wall has been reduced to a massive garbage dump. There are also many houses occupied by the west wall, and Captive sheep are raised near the east wall. These problems have reduced the integrity of the earthen sites. The planning and construction need to be considered systematically.

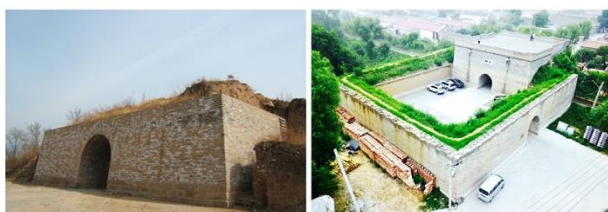
The brick-encased soil gates: The north gate of the town gate was repaired in the first phase in November 2007, and preliminary restores were made to the town gate coupon hole and some of the town gate's outsourced brick walls. At that time, there was an "L" -shaped the Wengcheng (enclosure outside the town gate) wall 20m away from the North Gate. Only the outline was arguable. It was 28m long, and the wall was about 4m high. The wall is almost entirely non-existent, and some of the remaining walls are weathered, collapsed, and severely cracked. The thickness of the wall at the eastern end is less than 50cm. In May 2010, the second phase of the restoration project was carried out, repairing 483.3m of the north town wall and the town wall of Wengcheng.

Figure 9. Comparison before and after the repair of the north town gate.

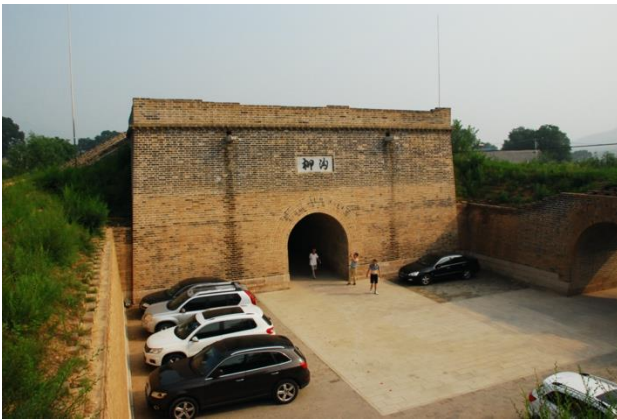
3.3.3 Improve the waterproof and drainage systems: The Liugou ancient town earthen sites had a waterproof and drainage system in the early stage of construction. The waterproof layer was paved with lime mortar and brick, which was equipped with a drainage ditch and a spout. However, due to the destruction of multiple factors such as war, these systems have mostly lost their effectiveness. Currently, only the North Town Gate has an entirely waterproof and drainage system through repairs. Therefore, when repairing and strengthening the earthen walls and the earthen Great Wall, temporary or permanent waterproofing measures should be taken, and the drainage system should be dredged and transformed.

Figure 10. Drainage system of the north town gate.
