THE MULTI-TECH PROTECTIVE MONITORING OF THE LION FOREST GARDEN STONY ARTIFICIAL HILLS (SUZHOU, CHINA)

KEY WORDS: Stony Artificial Hills, The Lion Forest Garden, Monitoring, World Heritage, 3D Scan, Side-Scan Sonar

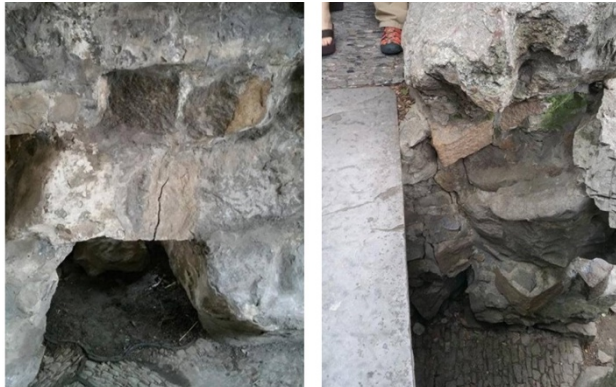
The stony artificial hills of the Lion Forest Garden are now facing the problem of damage (Figure 2). The main causes of damage are: 1) the artificial hills are extremely heavy and their structure cannot sustain the increasing live loads caused by the large number of tourists, resulting in cracks, falling off and collapse; 2) the foundation bearing capacity of the artificial hills changes with time passing, resulting in uneven settlement, and in the damage of the artificial hills; 3) the roots of the trees present on the hills continue to erode and push the stones as time passes, and their growing crowns increase the wind load, aggravating the damage caused by roots; 4) the erosion of rainwater, especially acid rain, leads to the erosion of the gap between stones and the stone surfaces; 5) tourists stand and lean against the rocks, resulting in the fracture of the rock peak; 6) the long-term immersion in the water body causes the loosening of rocks, resulting in the collapse. In recent years, there have been many events of damage in the garden, including the falling down of stones, stones broken and the collapse of revetment. Most of these damage events suddenly happened without any obvious sign before. Once the problem appears, it will affect the authenticity of artificial hills, hurt the tourists and cause economic loss to the garden.

Figure 2. The cracks on the stones of the artificial hills

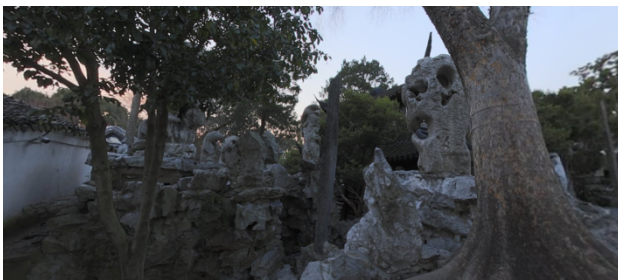
Figure 3. The artificial hill in the south of the Woyun Chamber.

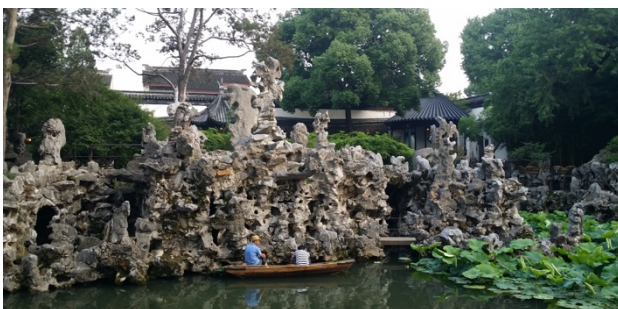
Figure 4. The artificial hill in the pond.

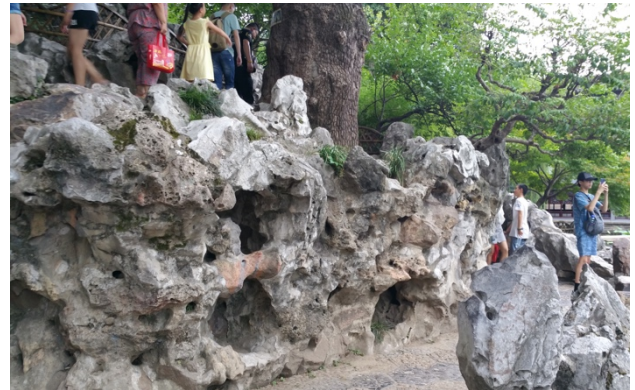
More, in 2019, a new underground line was proposed along the road in the west side of the Lion Forest Garden and its construction started in late 2019. The underground line is only 60 meters away from the west wall of the garden. The vibrations during construction and then into operation will affect the garden, including the artificial hills, especially the western hill (Figure 5).

Figure 5. The western hill.

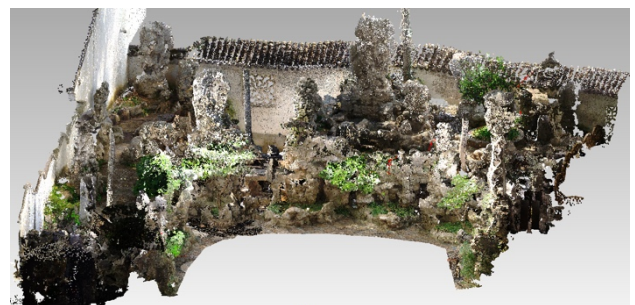
The first step of the work on the artificial hill in the south of the 'Woyun' Chamber has been to 3D scan the artificial hill to gain the 3D data for reference (Figure 6). Due to the complicated shape of the artificial hill and the holes on the stones, large 3D scanner and portable 3D scanner have been needed. We have selected two large 3D laser scanners: Zhonghaida HS650 and Faro F330. The first can scan at a larger range, but it is bigger and heavier and the point-cloud data is relatively sparse, about 500,000 points per second (PPS); the second is smaller and lighter, easier to operate, and good in point-cloud data, 960,000 PPS, but its scanning range is smaller. The used portable scanner is the Creaform H700 3D laser scanner, used to scan the caves and holes on the stones.

Figure 6. The 3D point cloud model

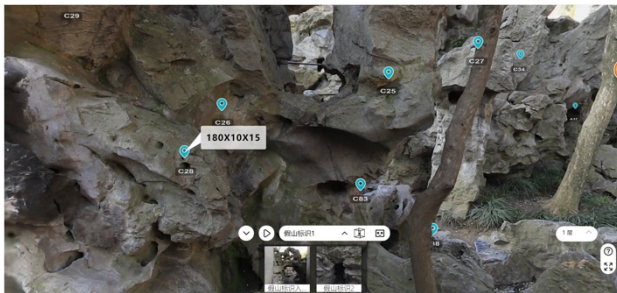
the complexity of the shape of the artificial hill, it was difficult to mark all the cracks on 2D drawings. To mark all cracks with dimensional data on 3D model was also difficult because the model was too big. Thus, panoramic photography was used to show data. All the cracks were marked with labels on which the data were written down, and then photographed by a Matterport 3D camera (Figure 7).

Figure 7. The panoramic photo to show data of cracks.

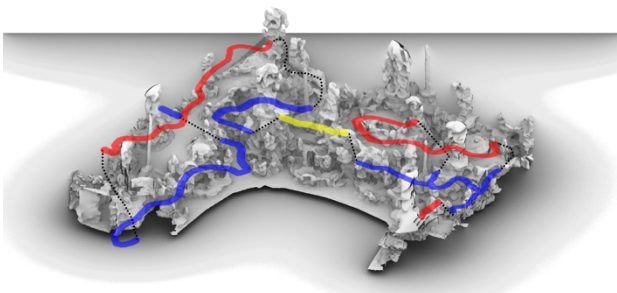
The fourth step was the data analysis. Other work also included fine mapping of the model and display of the paths (Figure 8).

Figure 8. The paths showing.

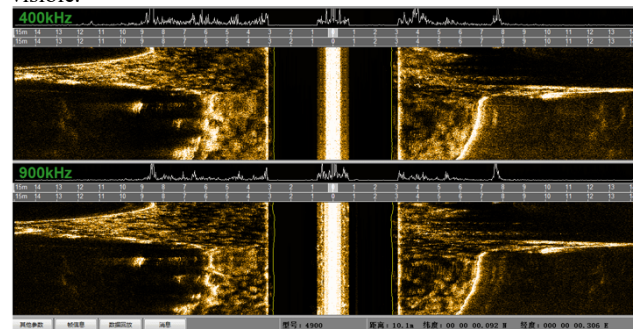
Due to the absence of suitable three-dimensional scanning equipment, image technologies were tried, including side scan sonar and endoscopy. After scanning the revetment by Iside 1400 side sonar scan, the course surface image was formed, and the shape of revetment could basically be recognized (Figure 9). And then a viZaar INVIZ SNK 40X endoscope was used to take

Figure 9. The images of the revetment by side sonar scan.

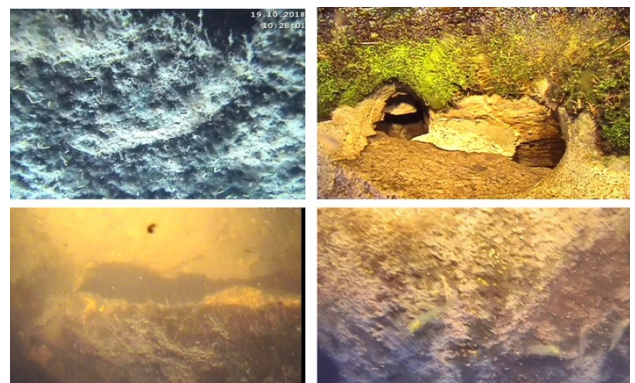
pictures of the revetment (Figure 10). Because the stone revetment was covered by algae and moss, the cracks were not visible.

Figure 10. The images of the revetment by endoscope.

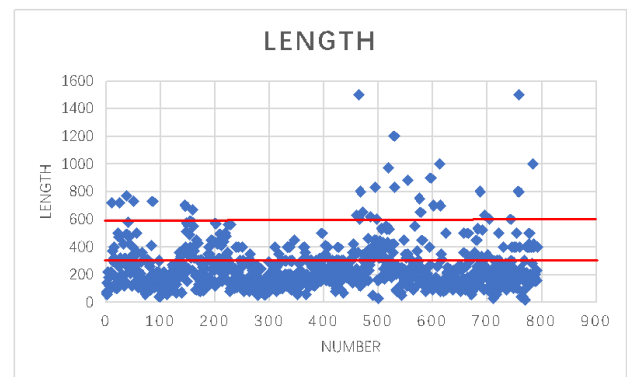
Based on the analysis of the scatter diagram, three kinds of protection measures can be taken for cracks with different values: from top to bottom, the cracks in the first section can be observed and repaired if necessary; the cracks in the second section can be detected regularly to determine their development trend; the cracks in the third section can be observed regularly without treatment temporarily, and the retention period is taken as the mountain texture features.

Figure 14. The three section of the cracks' length.

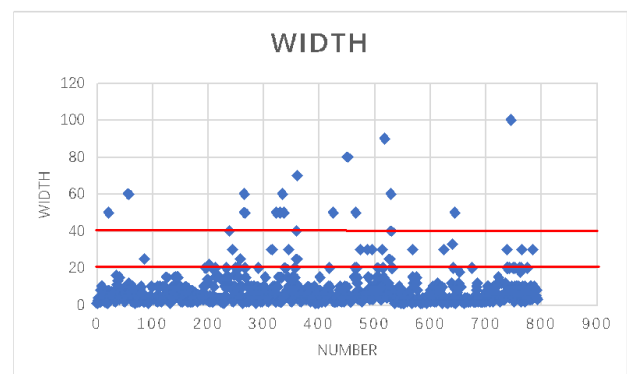
Figure 15. The three section of the cracks' width.

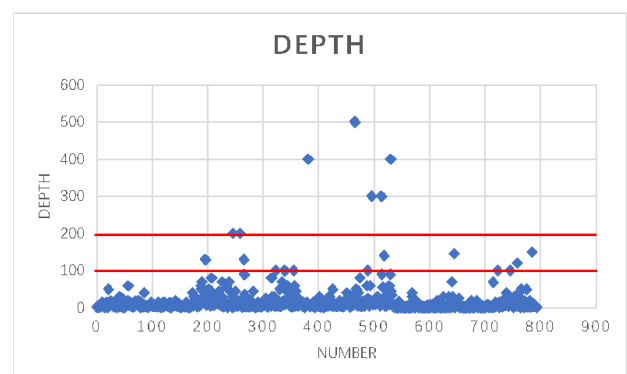
Figure 16. The three section of the cracks' depth.
