THE ROLE OF 3D DOCUMENTATION FOR RESTORATION INTERVENTIONS. THE CASE STUDY OF VALFLORES IN LOURES, PORTUGAL.

ABSTRACT:

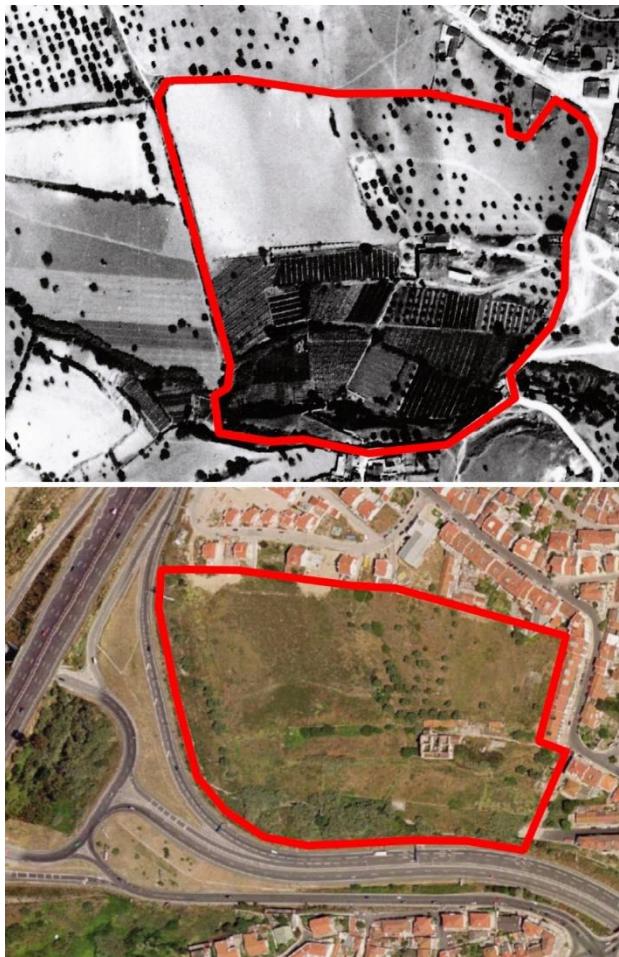
Figure 1. Aerial images oriented North/South. Top: 1944 (Source: Instituto Geográfico e Cadastral), Bottom: 2007 (Source: Municipality of Loures).

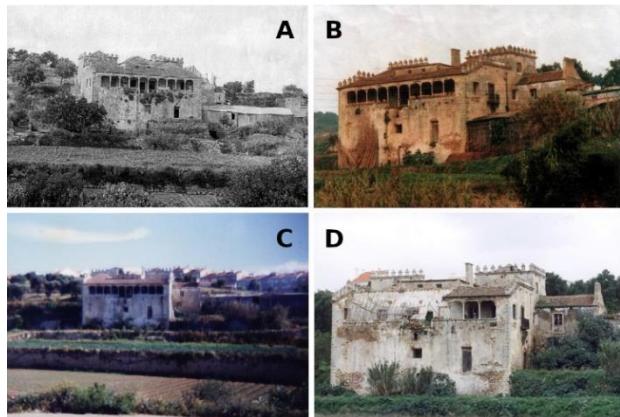
In figure 2 we can see the progress of degradation of the house between 1960 and 2001.

Figure 2. A: 1960, B: 1991, C: 1994(8), D: 2001. Source: SIPA and ADPAC.

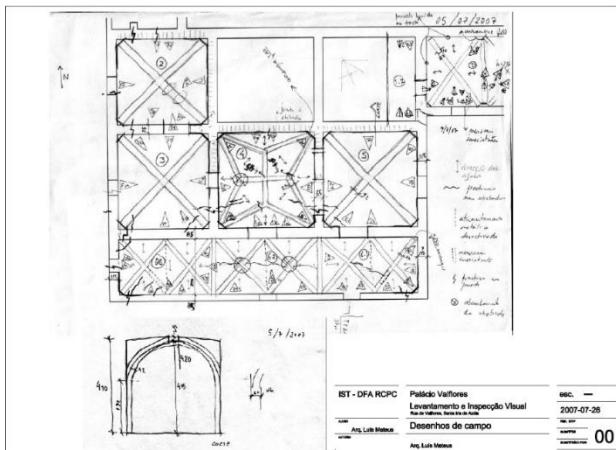
The first graphical elements gathered were archive photographs and the 2000 survey conducted by DGEMN. Our first approach in 2007, still with traditional methods, was to complete and update, as far as possible, those elements, and to complement them with photographs. For example, figure 3 shows how existing plans were used as a support to take annotations and measurements about the actual condition that were, later, integrated in accurate drawings.

Figure 3. Using existing plans from DGEMN as support for annotations.

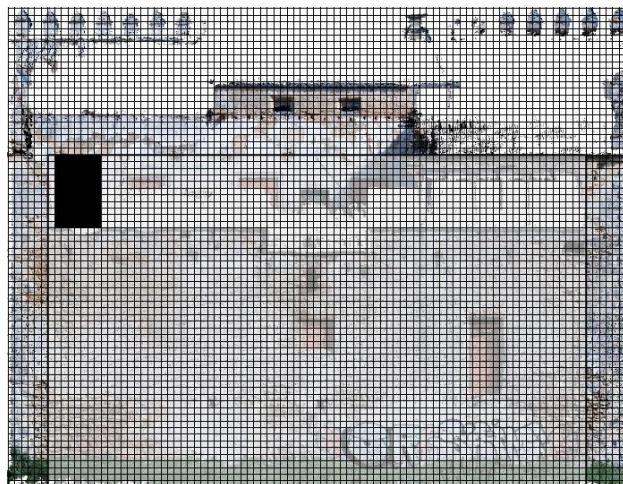
In this research project, in which Valflores was included as a case study (<http://archc3d.fa.ulisboa.pt/galery.html>), it was possible to develop some exploratory actions for recording and documentation. The focus of this research project was to understand the impact of the new (at that time) surveying technology of 3D laser scanning and the new research paths in photogrammetry, namely automatic and semi-automatic methods of 3D reconstruction, in the study and analysis of the architectural heritage within conservation, restoration and rehabilitation. So, in 2008, it was commissioned a laser scanning survey of the house and aqueduct. First, for safety reasons, only the exterior was surveyed. It was used a ZF 5006 scanner to capture 46 point clouds with multiple resolutions. Simultaneously, the municipality carried out a topographic survey of the entire property which included all the control data to geolocate the laser scanning survey. Moreover, in strategic viewpoints, it was gathered images to colorize the laser scanning point clouds. These viewpoints, although they include those that were used in laser scanning (scan station locations), were in greater number. This initial laser scanning survey allowed to have a preliminary perspective, quantified, about the integrity of the structures of the property, namely the house and the main aqueduct. For example, it was possible to conclude that the composition of the main facade of the house was ruled by the 22cm palm (Figure 4), an ancient measurement unit. Also, about proportions, it was verified that the golden ratio is present in the composition of the facade.

Figure 4. A 22cmx22cm grid overlaid to the front view of the main façade.

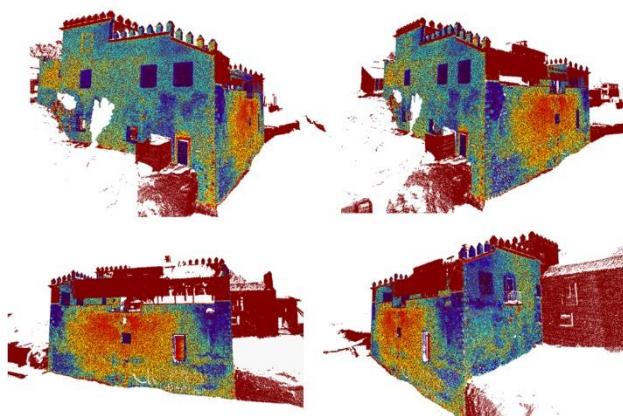
Figure 5. Deformation pattern of the facades.

In fact, this preliminary surveying campaign allowed us to quantify some of the anomalies that were already evident at the naked eye.

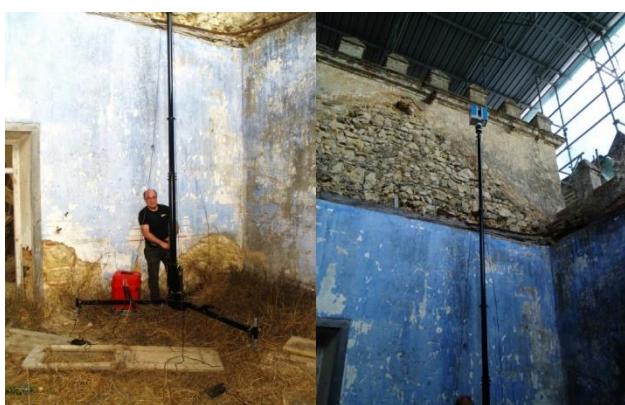
In a second phase of this first campaign, in 2010, it was possible to access the interior of the house although it was not possible to access all rooms. Areas where ceilings had collapsed were not accessible yet. Other areas were walled either to avoid vandalism and for safety reasons due to anomalies in the supporting vaults. As it will be seen in the next section, it was only possible to access those areas in 2018 when the preparatory works of the interventions begun. Again, it was used a ZF 5006 Scanner to capture 47 point clouds for both floors. At the same time, and following the previous strategy, a thorough photographic survey was carried out. In figure 7 it is shown the adopted strategy to reach the higher parts of the building.

Figure 7. Using a hydraulic mast to reach the higher parts of the building.

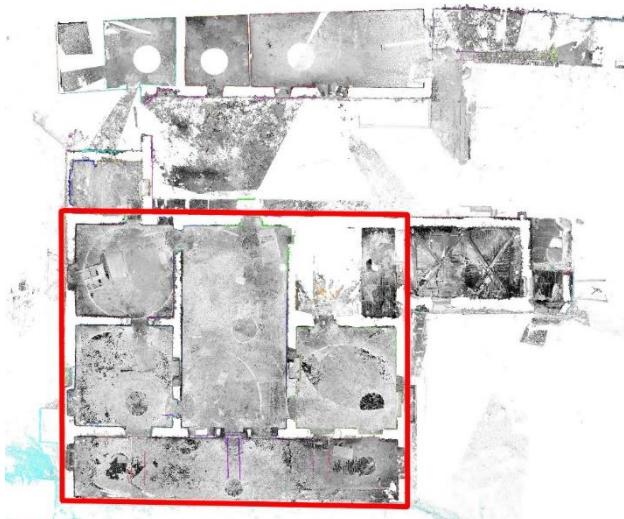
The laser scanning survey of the interior was merged with the one from the exterior, generating a complete point cloud of the building. In figure 8 it is shown the distributive relations of the rooms in the main floor where it is clear, in the highlighted area, a typical layout of Italian *villas* of 16th century and is also evident the resemblance with the plan of plate 3 from Serlio's treatise, book 6. Form this survey it became clear that there were severe anomalies that were

Figure 8. Planar view of the point cloud showing the first floor of the house.

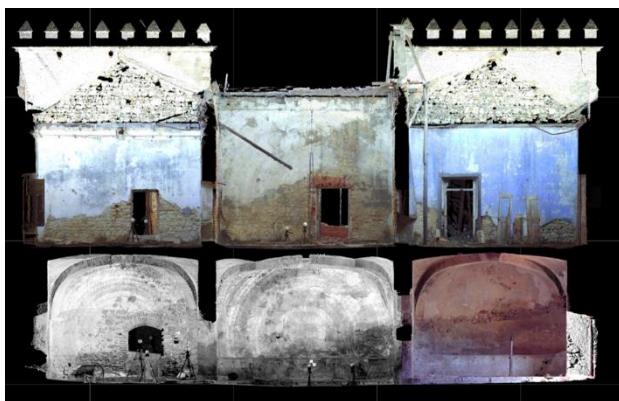
Figure 10. Ortho-image from laser scanning data from which drawings can be obtained.

The method used to produce the basic elements, such as plans, sections and elevations, was the cross reference between laser data (Figure. 10) and direct observations (Figure. 11). Laser data assured a global geometric soundness of recording. Direct observations resulted from a close contact with the real fabric, or with remains of the building stored in other locations. For example, the municipality stored some elements that were at risk, such as the *loggia* columns that fell and some tiles. Direct observation is fundamental in restoration and, although it can be enhanced by indirect methods like laser scanning or photogrammetry, it cannot be replaced by them.

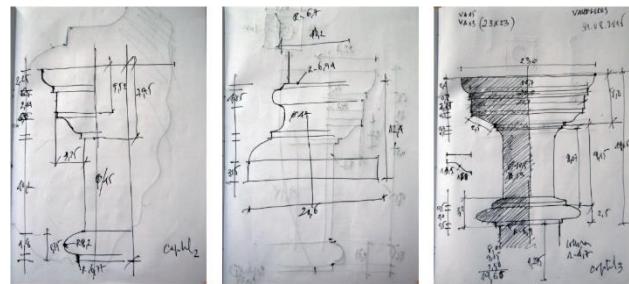
Figure 11. Direct observation drawings.

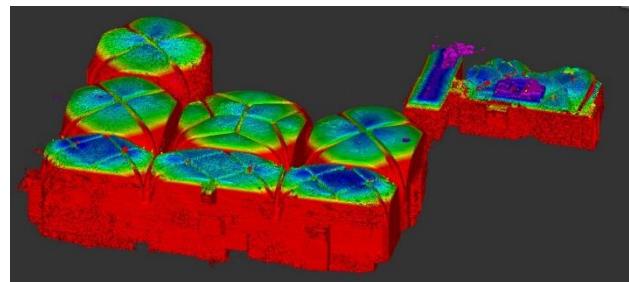
A correct geometry depiction was fundamental for the structural analysis, diagnosis, and intervention. In figure 12 it is shown an analysis of the deformation of the vaults of the ground floor. This analysis was done with laser scanning data. By analysing how the height map pattern changes, it is possible to understand the morphology and the type of deformations.

Figure 12. Analysis of the geometric deformation of the vaults in the lower floor.

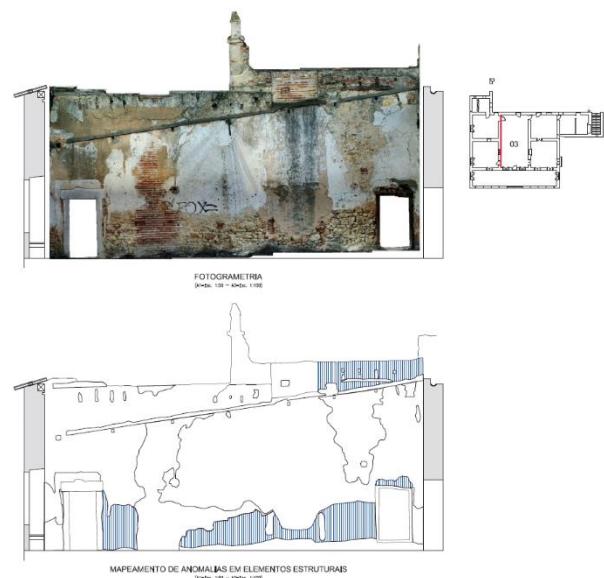
The photogrammetric outputs are also important tools for the engineers and architects. They allow them to infer about the integrity of materials, to perceive singularities about the element's assemblage, to understand constructive patterns and methods and to provide the basis for anomalies recording (Figure. 13).

Figure 13. Anomalies recorded over a photogrammetric base.

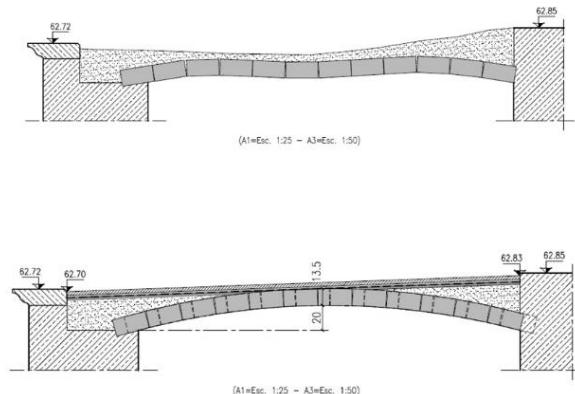
With this data it was possible to document the existing condition and compare it with the desired outcome of the intervention, as it can be seen in figure 14 for the vaults of the *loggia*. The use of laser scanning proved to be fundamental for

the observation and identification of anomalous structural behaviours. In Valflores, it allowed to understand the original constructive system, and to locate the main focuses of anomalies. Based on the deformed configuration it was possible to restore the original configuration and to decide about the adequate levels and methodologies for the restoration, considering the safeguard of the constructive and material authenticity of the elements to restore. In the vaults, whenever possible, the reconstructions were done using the existing materials; and using compatible materials, techniques, and processes when necessary.

Figure 14. Cross section of the vault of the loggia. Top: existing, Bottom: to execute.

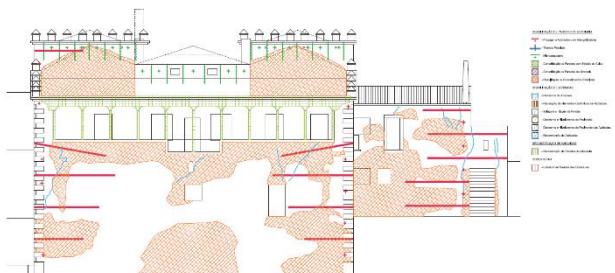
Moreover, all the prescribed interventions were mapped over drawings produced using these mixed sources and methods (Figure. 15).

Figure 15. Structural interventions schematized over the elevation drawings.

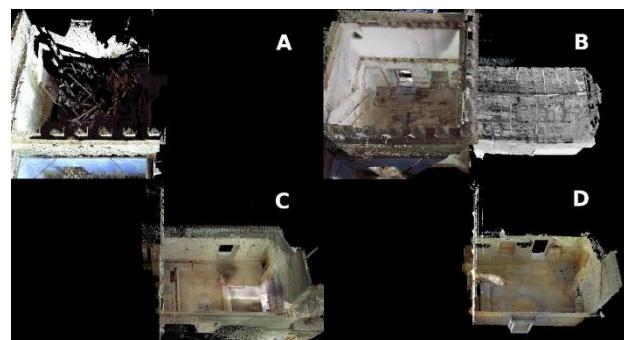
Given the fact that, by definition, when we intervene in existing fabric there are unknown things *a priori*, which are only unravelled as works advance, there needs to be a commitment of all the partners to accept some degree of uncertainty. This means continuous adaptation and implies a continuous update of the records. An example of this can be seen in figure 16. The upper left corner (A) corresponds to survey done in 2016 for the preparation of the intervention project. When the works started, the room was cleaned and in 2018 it was possible to survey the interior of the room as well as the adjacent space in the right side (B). Later, in 2019, two other surveys were done, one after the removal of the roof (C) and another one after intervention in the walls (D).

Figure 16. Continuous update of the laser scanning survey. A: For the project, B, C and D: During construction works.

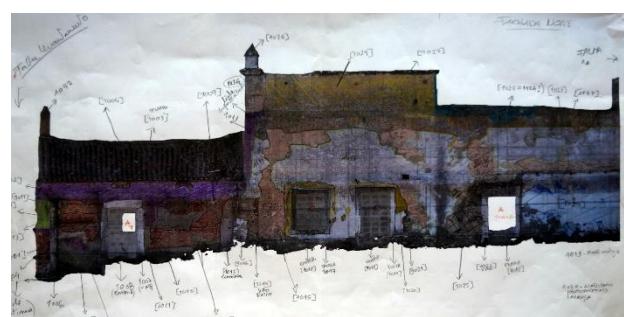
From the practical point of view, for the archaeology analysis, the ortho images generated using laser scanning and photogrammetry were used as the support for field work (Figure. 17) and for the final records and reports.

Figure 17. Archaeology field work record.

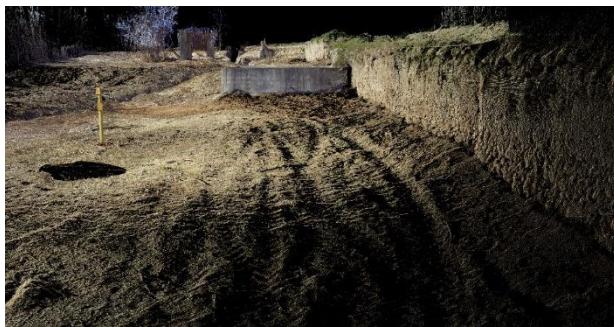
During the first phase of construction, in which the work focused on the house and the aqueduct, the team deepened the project in the landscape dimension. For this, it was also necessary to complement the surveys to document all the existing structures of the farm. For that reason, another laser scanning survey was done. This time it was intended to capture the topography, the support walls of the platforms, the morphology of the water stream, and the remains of the hydraulic structures (Figure. 18).

Figure 18. Exterior survey with laser scanning in 2018.

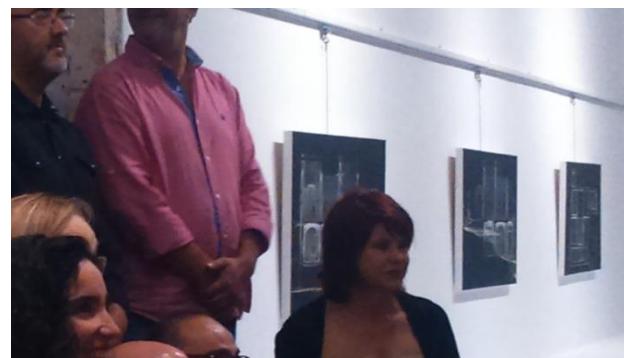
Figure 20. Public exhibition where point clouds were transformed in "paintings".

In 2019, ADPAC promoted an initiative entitled "The days of renaissance" aimed to promote the interconnection between local stakeholders and local heritage, with a specific focus on Valflores. It was an opportunity to discuss the future and to celebrate the starting and conclusion of the works of phase 1. It were organized several talks with different experts, walks to visit the construction site, exhibitions to show the works done, thematic artistic performances with music, literature, and theatre. In this context there was an unexpected use for laser scanning data. Images where extracted from the point clouds, printed in canvas and included in one of the exhibitions. The aesthetic of the images made visitors compare them to paintings (Figure. 20) strengthening the bonds between art and science.
