# SEISMIC VULNERABILITY ASSESSMENT OF THE TRIUMPHAL ARCH OF CARACALLA IN VOLUBILIS (MOROCCO): PAST EVENTS AND PROVISIONS FOR THE FUTURE

**KEY WORDS:** Archaeological Site, Volubilis, Kinematic Analysis, Timeline Reconstruction, Seismic Vulnerability, Safety Assessment

The triumphal arch of Caracalla in the Roman archaeological site of Volubilis dates back to 216 AD. It was built in a strategic position at the intersection of the main roads leading to the Forum, the *decumanus maximus* to the east and the roads from *Porte à trois baies* to the west, that almost certainly was the main gate to the city. The current arrangement of the monument is the result of a restoration intervention carried out in the 1930s by French restorers. Some ancient photos witness that the monument was just a ruin in 1915, when Chatelain carried out the former archaeological excavations and, as a consequence, that it was totally rebuilt. In fact, the monument suffered wide damages provoked by the 1755 Lisbon earthquake, that affected also Morocco, which almost completely destroyed it. By means of the drawings made by the travelers Henry Boyde and John Windus, that retraced the monument thirty years befor

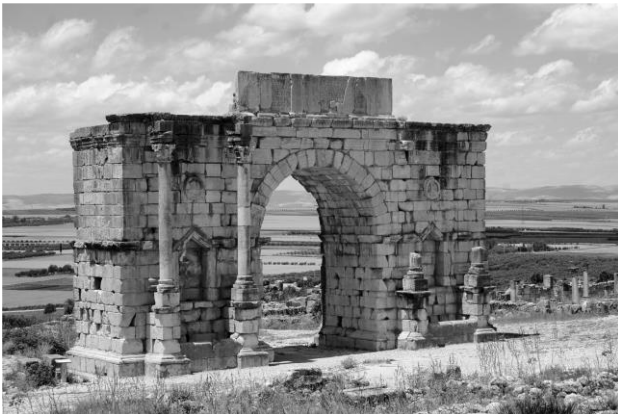
Figure 5. Arch of Caracalla (photo by G. Pancani, 2017).

The triumphal monument has a front with a single arch, framed by two massive piers each of which is enriched by two pairs of pedestals that originally supported as many Corinthian columns, of which only two remain today on the eastern front (Figure 5).

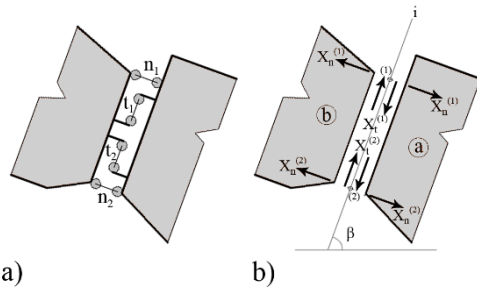
Figure 11. Joint device between block ‘a’ and ‘b’ of the mechanical model.

In turn, the joints are modeled through an interface device composed by two links orthogonal to the interface ( $n_1$  e  $n_2$ ), which transfer the axial force  $X_n$ , and two links arranged along the interface ( $t_1$  e  $t_2$ ), which transfer the shearing force  $X_t$  (Figure 11).

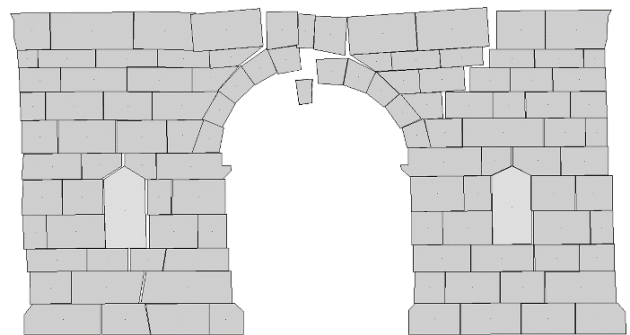
Figure 13. Collapse mechanism and current seismic vulnerability.

Figure 13 shows the collapse mechanism of the structure plotted by the program and the results of the analysis are presented in the first row of Table 1, that shows the collapse factor  $\alpha_0$ , the participating mass  $M^*$  and the spectral acceleration  $a_0^*$  of activation of the mechanism.

Figure 13 clearly shows that the vault and the left side of the right pier are the former portions that collapse, while the left pier suffers wide damages. The vulnerability of the structure is explained by the lack of a monolithic behaviour of the right pier, which suffers a sudden diagonal crack that provokes, in turn, the collapse of the vault.

The computed value of the spectral acceleration points that the structure can resist a very low intensity earthquake and, therefore, that the preservation of the monument is currently at risk.

Finally, in order to follow the timeline of seismic events that affected the monument in the 18th century, the model in figure 13 has been taken as the new reference structure for the analysis. Indeed, such a model is effectively capable of describing the damage suffered by the monument during the first choc of the 1755 earthquake.
