ANOTHER TRADITIONAL ARCHITECTURE IN CANADA AND THE USA: EXPLORING SOME UNIQUE CONSTRUCTIVE TECHNIQUES

KEY WORDS: Stovewood Construction, Sod Houses, Cobblestone Structures, Vernacular architecture, Canada, USA

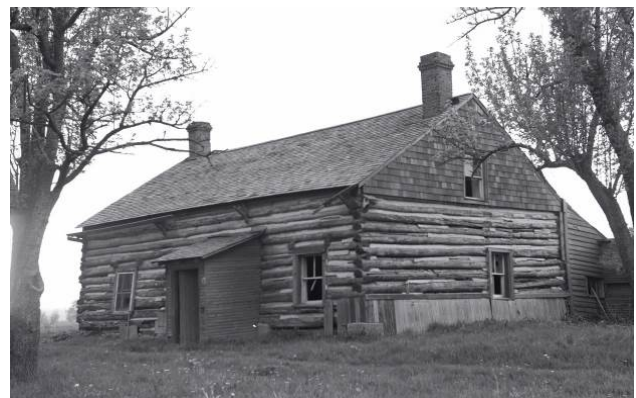
Figure 1. Log cabin in Victoria Park Ave., at end of Ellesmere Rd, Toronto, 1956 (Source: Courtesy of Toronto Public Library).

It is practically impossible not to associate traditional architecture in Canada and the United States with wooden constructions, that is, log cabins or sawn wooden frame houses (Figures 1 and 2). However, timber has not always been readily available in the vast North American expanse due to the lack of forest areas in wide parts of both countries, such as the Great Prairies, or it has been a material requiring greater expense and more skilled labour, unattainable for many first settlers.

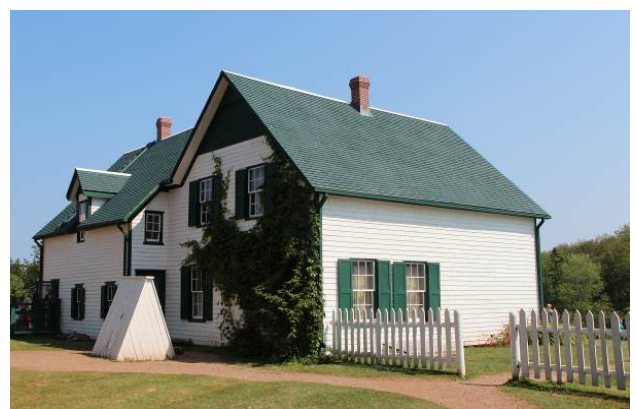
Figure 2. Traditional Wood construction on Prince Edward Island, Canada (Source: author).

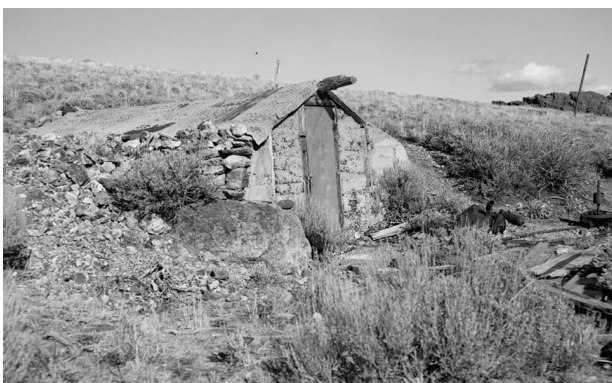
Figure 3. Bell Family Residence, Dugout, East slope of Buckskin Mountain, Paradise Valley, Humboldt County, NV (Source: Historic American Engineering Record - Library of Congress).

According to Morrison (1987) the first colonists in the 17th century built four types of constructions or temporary shelters: dugouts, cabins, wigwams, and cottages. The first were simple holes dug in the ground and roofed over by poles and bark; sometimes they were only half-excavated with an upper wall built of sods (Figure 3). Morrison's 17th-century interpretation of a cabin depicted a flimsier structure than that observed today. These cabins were made of vertical stakes driven into the ground, with wattles (willow or hazel withes) woven between them and daubed with clay with a roof of poles and turf or thatch. From Quebec to the Carolines, wigwams were oblong round-roof structures which consisted of a framework of slender poles, with butt ends stuck into the ground, and tops that were bent over and lashed together to form a semi-cylindrical roof, a framework covered by woven mats or pressed bark or skins (Figure 4). Finally, cottages were built with frames of hewn planks or squared timbers, covered by wide boards laid flush or smaller lapped clapboards. In some cases it was possible to observe wattle-and-daub walls, like those in England, although these were most likely used as filling. Therefore, these constructions were not made exclusively of wood and some of them, such as the wigwam, took their inspiration from Native American Indian constructions (Figure 5).

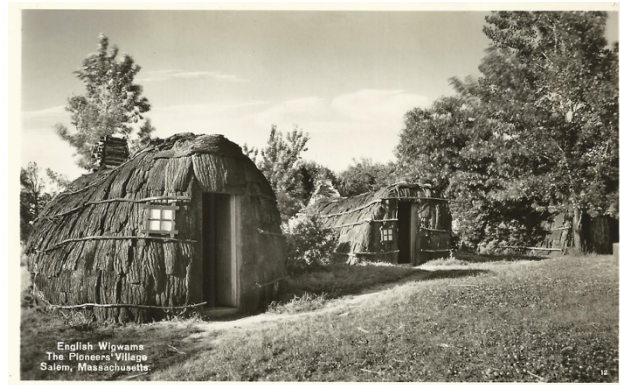
Figure 4. English wigwams at the Pioneers' Village (Source: Salem Public Library, accessed April 6, 2020, <https://digitalheritage.noblenet.org/salem/items/show/46>).

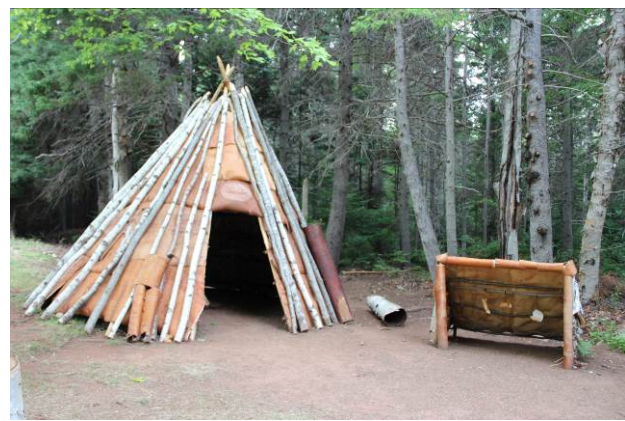
Figure 5. Traditional Mi'kmaq construction in Skmaqñ–Port-la-Joye–Fort Amherst National Historic Site, near Charlottetown, PEI, Canada. Mi'kmaq are a First Nations people of the Northeastern Woodlands (Source: author).

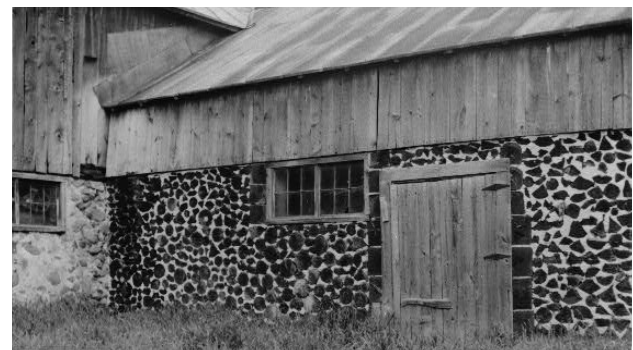
Figure 7. Wood Block Masonry Barn, No. 1, Lena, Oconto County, WI (Source: Library of Congress).

Stovewood constructions differ greatly from traditional North American log constructions or balloon-frames, as they are made from logs of uniform lengths cut into sections, set in lime mortar, and stacked perpendicular to the length of the wall. They got their name from their similarity to logs stacked as fuel, as the ends of the logs are left exposed (Figure 7). Cedarwood, with characteristic high insulation and resistance to decomposition, was normally used, as well as oak, as can be seen from the early examples of construction in southern Wisconsin and northeast Iowa in the mid-19th century (Tishler, 1982). Furthermore, according to the studies by Tishler, three basic types of stovewood construction can be distinguished. The first, found mostly in granaries, sheds, and chicken coops in the county of Door (in Mideast Wisconsin), has a characteristic structure framed with heavy timbers with wall panels filled with a nogging of stovewood, resulting in a type of half-timber construction. The stovewood here has no structural function and the length of the logs is conditioned by the measurements of the timber frame. However, in the second type the walls are load-bearing and therefore solid. These solid stovewood walls are built without an encasing structural framework and different constructive details were added on the corners. As Figure 8 shows, solutions on the corner could feature a wood section used like stone ashlar (A), a squared piece of wood placed vertically along the height of the construction (B), or alternating layers of pieces of wood (C). Although found mainly in Wisconsin, this typology is also the most common in Canada. Finally, the third option, which is more recent than the previous ones, is a balloon-frame system of rough sawn lumber in which relatively short sections of stovewood are stacked between the studding in the walls. This type of structure was mainly used for dwellings and sided with clapboard, as the stovewood was used primarily for insulation.

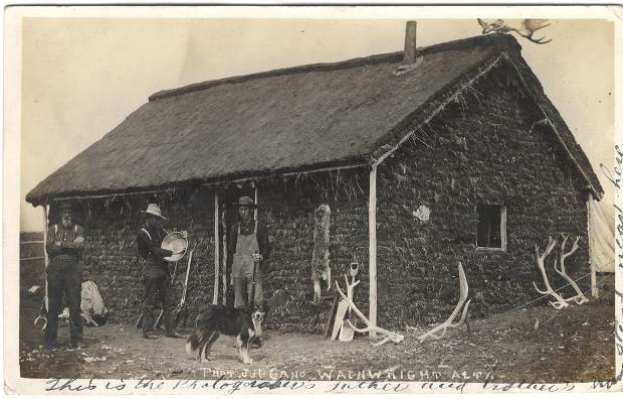
Figure 9. Sod house in Alberta in 1911 “That J. H. GANO Wainwright Alberta” (Source: jasonwoodhead23).

The technique consisted in extracting grass in areas where it was tougher and more fibrous with heavy roots, ploughing it and cutting it into strips 2 to 3 feet long (60-90 cm) and 16 or 18 inches wide (40-45 cm). The sods were then placed with the grass facing down, one directly on top of the other, with the joints overlapping as if they were bricks or stones. The blocks of grass were superimposed and held together by their long fibrous roots. When applicable, doors and windows were built and the sods piled up around them. It was also common to place telegraph poles in the ground to support the walls, while log plates finished off the walls. The roofs were built using light elm boards or posts, which also tended to be covered with grass, hay or straw depending on the materials available. The interior walls were then rendered in a layer of mud or lime, or heavy white wallpaper (Ritchie, 1967) or fabric was added to the walls.

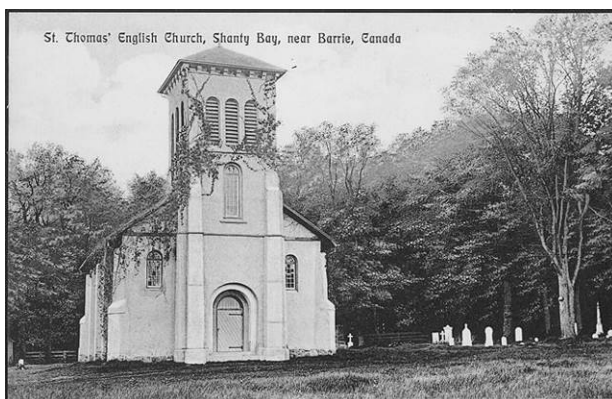
Figure 11. St. Thomas' English Church, Shanty Bay, near Barrie, Canada, N.W.E. King, Picture, 1910
(Source: Courtesy of Toronto Public Library).

In the same way, in Canada an important example of this technique is found in St Thomas' Church in Shanty Bay, Ontario built in 1838, which according to its commemorative plaque is "...one of the few surviving structures in Ontario built of 'rammed earth'. This method of construction utilized wet clay mixed with chopped straw, compacted into forms and covered, when dry, with plaster or siding for protection against weather" (Figure 11). This is therefore a clear example of a building erected with a simple rammed earth variant, but with the peculiarity of incorporating chopped straw in the mix (Mileto, Vegas, 2018). However, different publications

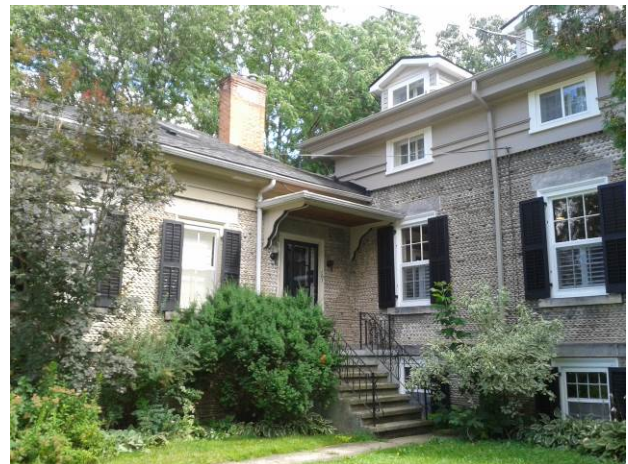
Figure 12. Cobblestone construction, Hamilton Place in Paris, Ontario, Canada (Source: author).

The cobblestone technique is characterised by the use of pebbles incorporated into a thick layer of lime mortar, with a major axis at right angles to the wall and only a small portion projecting beyond the outer surface. Cobblestones tend to be the size of a fist, can be held with one hand, and are extracted near rivers or crop fields.

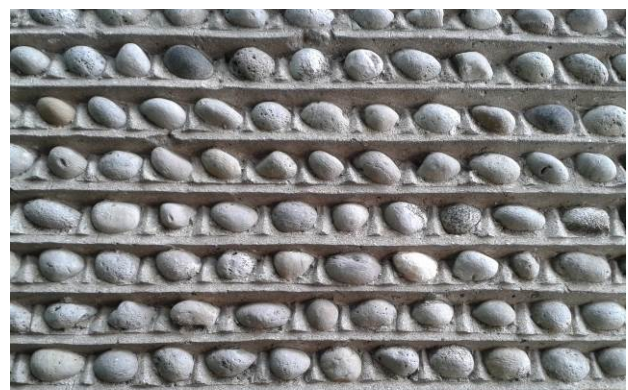
Figure 13. Cobblestone detail in Hamilton Place in Paris, Ontario, Canada (Source: author).
