TEMPORARY EMERGENCY SHELTER AGARIYAS: A CASE STUDY FROM THE FLOOD PRONE SITE OF KUMANO, JAPAN

ABSTRACT:

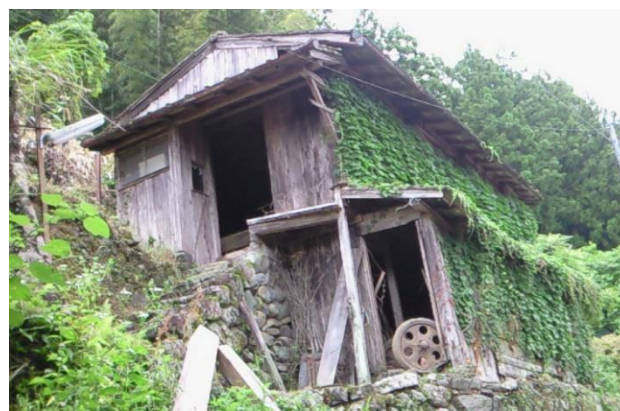
Figure 2. One of the oldest *Agariya*, in the Ukegawa area in Hongu-cho, destroyed after the flood of 2011.

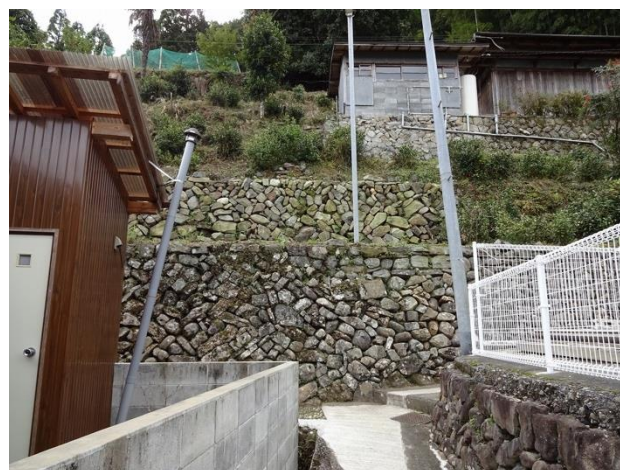
Figure 3. Basement raised and covered by stones of the *Agariya* in Figure 2.

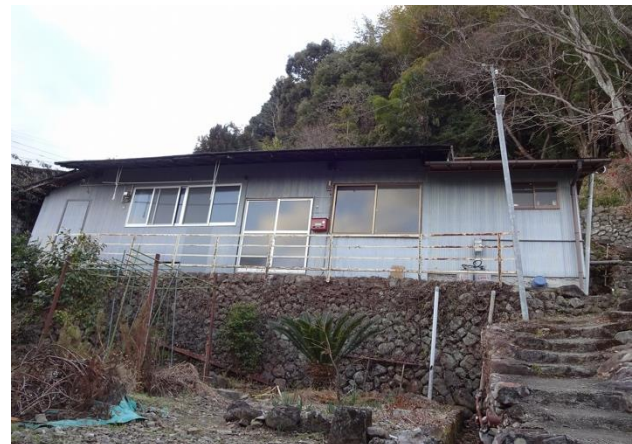
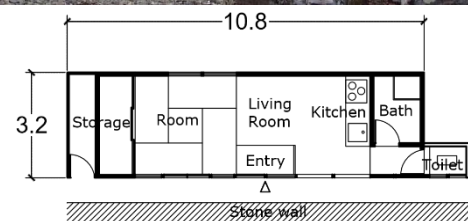
Figure 4. *Agariya* type A.

Residential type (A): This structure has a living room where people can sleep in and it is equipped with facilities such as tatami mats or planks, daylighting windows, living/bedrooms, kitchens, and toilets.

The *Agariyas* were classified into three types by following the basic classification of other water prevention/preparedness architecture (Ito, 1986). Among the different classifications, A) to C) are shown in Figures 4, 5 and 6.

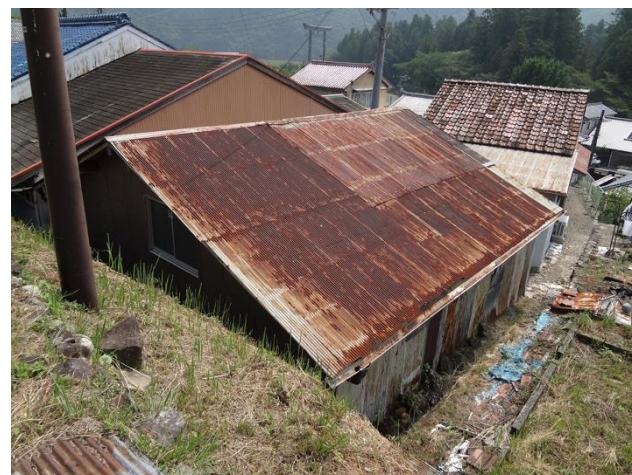
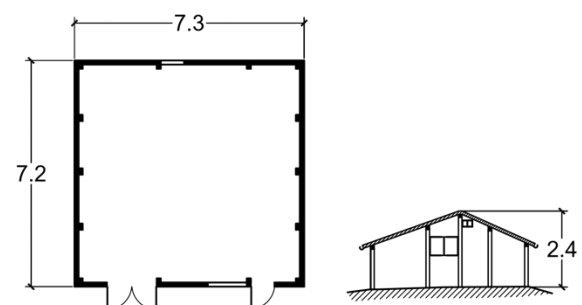
Figure 5. *Agariya* type B.

Warehouse type (B): This type stores food (rice, miso, pickled plums, etc.), goods, and household goods (futon, clothes, dishes, etc.). There is almost no daylighting window. It is dark inside; however, during flood times, it can be used as an evacuation shelter.

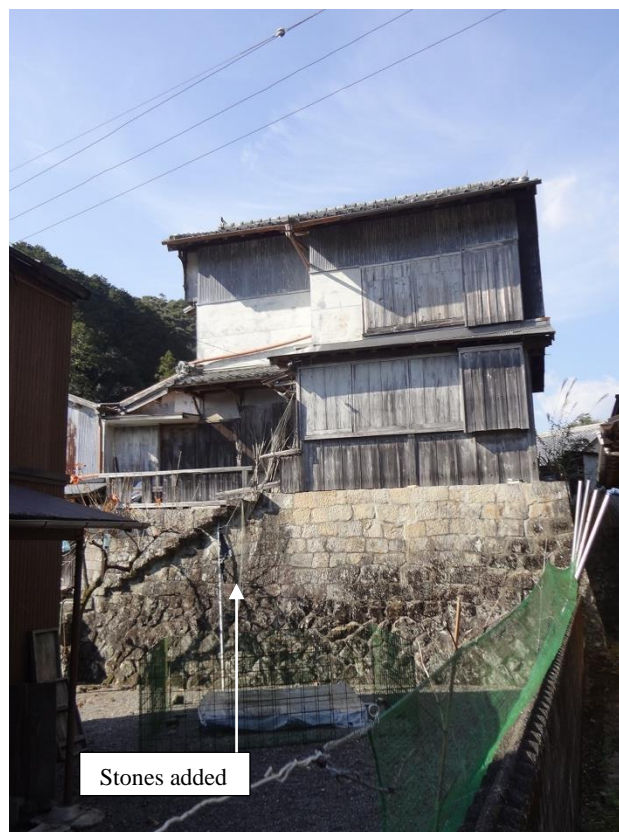
Figure 7. An *Agariya* still stands in the Hongu area in Hongu-cho.

The construction time of *Agariyas* can be roughly divided into before and after the flood of 1953. Additionally, it was confirmed that several buildings were built around 1965. Different measures were taken after different floods. For example, Figure 7 shows a traditional *Agariya* in Hongu, which is owned by a clothing store owner (No. 7 in Table 2/Figure 9). The lower part of the stone base was made before 1889, but it was affected by flood damage in 1953. Therefore, based on the flood water level of 1953, about 1.3m of new stone walls were added to raise its height.

Consequently, there was no damage in the 2011 flood (mentioned by the owner, a man in his 70s), although the residential section in front of it was profoundly affected. Even before the flood in 1889, there was a possibility that *Agariyas* were like this. Still, people believe that the flood in 1953 opened an opportunity to create many *Agariyas* in this area. Presently, the exact year of the beginning of *Agariya* construction cannot be identified.

After learning about the *Agariya* in Figure 7, and its history, the group walked towards the Oyunohara, where the Kumano-Hongu shrine was originally located. Afterward, the students walked along the Kumano riverbank. The river has almost no water flow at normal times and is filled with sand. However, it easily increases 5–6 m during flood time (Figure 11). To understand how vast the water pressure could be, the group visited the Kumano-Hongu World heritage center. The group also wanted to understand the historical background of the UNESCO heritage site and learn basic knowledge on the Kumano-Hongu shrine. After obtaining this, the group visited the modern Kumano-Hongu shrine by climbing many steep stairs. During the walking course, basic information about past and recent floods were explained to the students to increase their awareness.

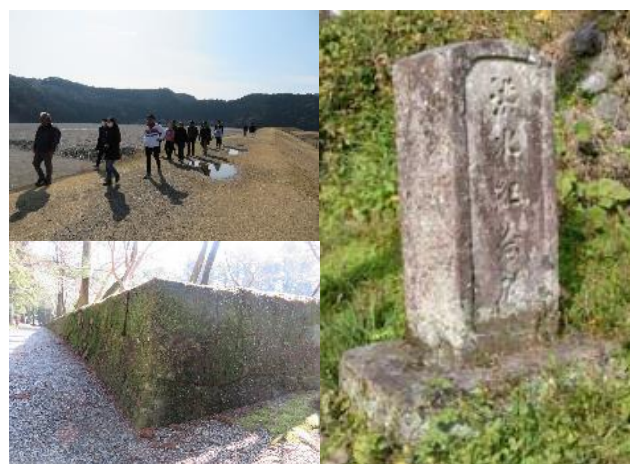
Figure 11. Photos of the disaster remains: a) Kumano Riverbank; b) Original location of Shrine; c) Stone monument.
