## Photogrammetry Laser Scanning and Reverse Engineering Conrad’s Jewel

**Keywords:** Photogrammetry, Laser Scanning, Reverse Engineering, Cultural Heritage, Timber Framing

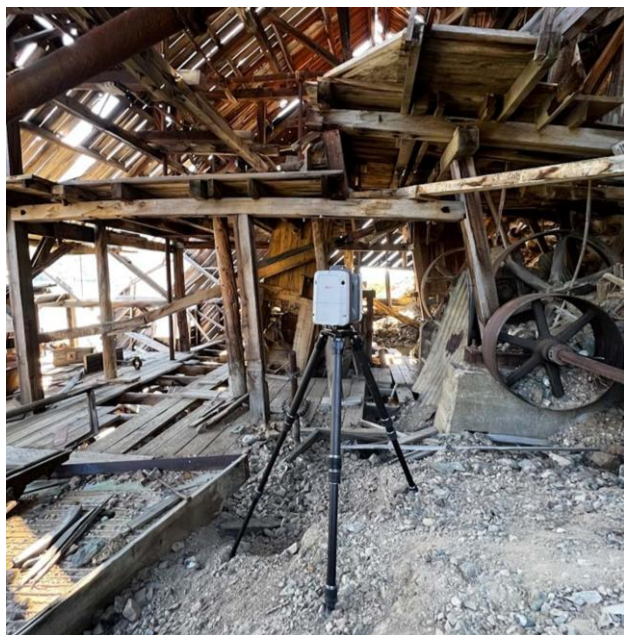
Figure 1. Laser scanning Conrad’s Jewel: Venus Mill

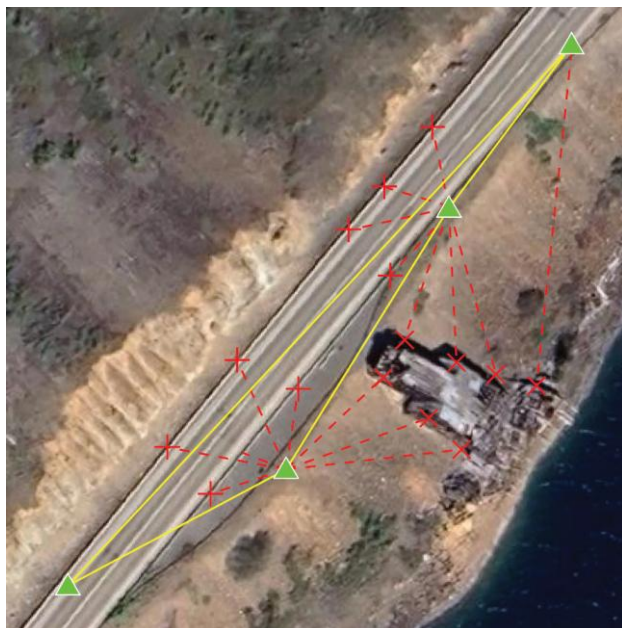
Figure 2. Illustration of Venus Mill survey control network and measured control points

A *Leica Geosystems TS11* total station was used to measure local points at the Venus Mill Site. A control network was established on the Klondike Highway road along the site; multiple setups were established with survey nails to balance distance with visibility to the structure, as shown in Figure 2. The loop error for the network was 11 mm over a 262 m loop length, with the longest leg of the loop at 130 m. Ideally, the control network would have been established around the entire building, but the steep slopes, eroding scree, and time constraints made this impractical. With the limited time and site restrictions, a total of four stations were set up along the highway.

Checkerboard targets were used as points, along with natural points that can be returned to in a future campaign; the checkerboard targets were placed such that they were included as targets in the laser scans and photogrammetry. Nail points were also created by setting survey nails into the ground for the control network. Drone targets were created using brightly coloured tape in an "x" pattern on the concrete barriers.

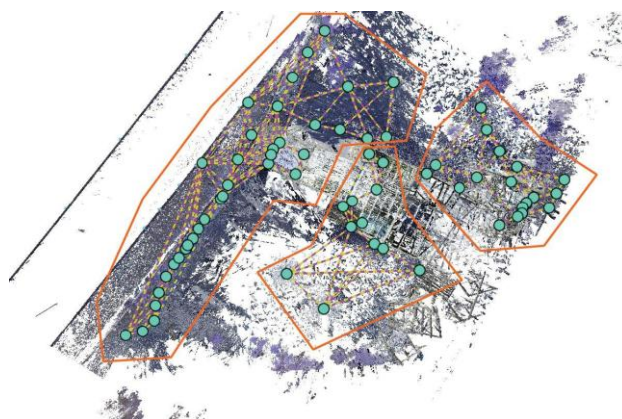
Figure 3. Laser scanning - three cloud-to-cloud registration bundles

The scans were initially all registered together by cloud-to-cloud registration; however, there were some errors in some of the scans on the steep sections of the slope. This may have come from the laser scanner shifting on the slope's scree and/or the high winds in the area. Consequently, the scans were split into three cloud-to-cloud registration bundles and were then registered to each other with the applied control from the georeferenced survey data. The cloud-to-cloud registration networks can be

seen in Figure 3. The applied control mean error was 4mm and the bundle error was 4 mm.

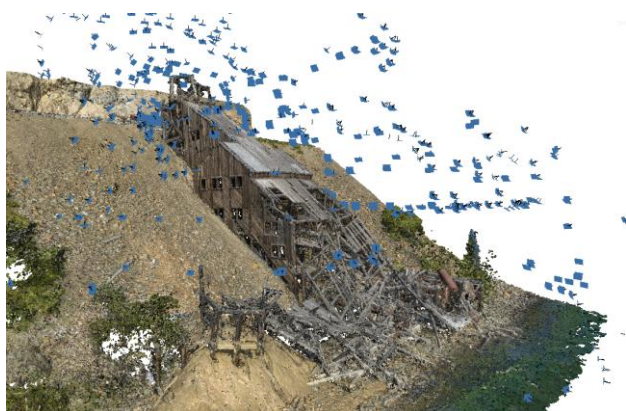
Figure 5. Photogrammetric network and point cloud

The corrected JPGs were input into the Agisoft Metashape and aligned on a ‘High’ accuracy setting. Then, the photogrammetric model was oriented to the cartographic reference system with georeferenced control points. The mean error of control points was 5mm. The aligned photos were used to generate a point cloud model (Figure 5) for creating measured drawings and a textured mesh for creating orthometric elevations.

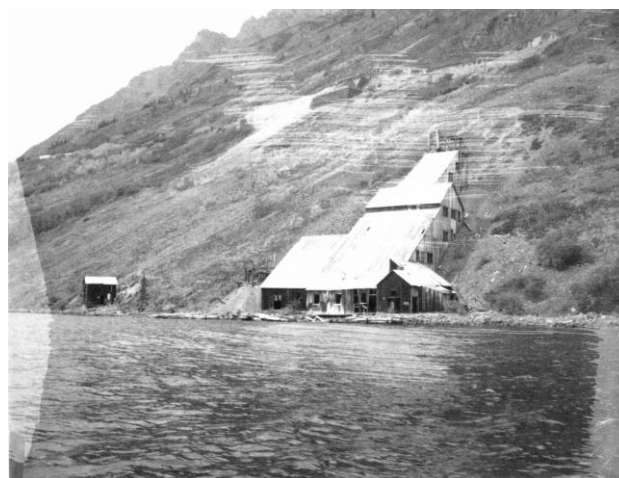
Figure 6. Historic photo of intact Venus Mill. Yukon Archives, Mervyn-Wood family fonds, 98/87 #402.

Lastly, historic photography can also be a great source of insight for reverse engineering. For example, a photograph from the Yukon Archives that shows the original form of the Venus Mill before the lower levels collapsed (Figure 6). When attempting to reverse engineer the original construction of the building, the historic photograph guides the virtual reconstruction.

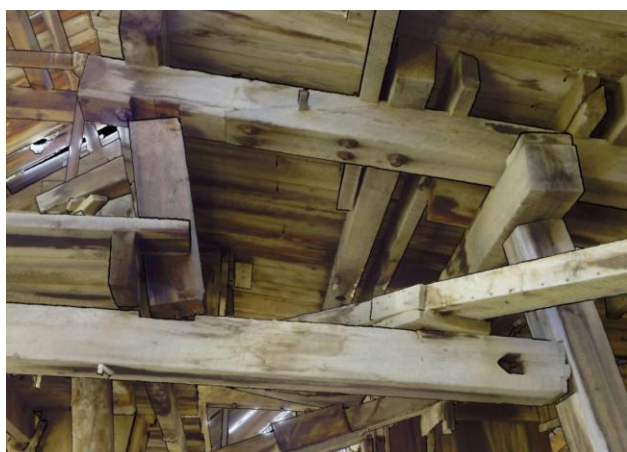
Figure 11. Failed joints showing iron fasteners

**5.2.1 Contextual Sources:** *Historic American Timber Joinery* and *Historic American Roof Trusses* are both foundational guides to understanding American timber frame joinery and joinery situations. Within this context, it is evident that the most basic and common joint used is the mortise and tenon; a joint cut solely from the timber members themselves. The mortise and tenon is characteristic to American timber framing (Sobon, 2002). When the failed joints in Venus Mill are inspected (Figure 11), no mortise and tenons are found. Instead, iron hardware is found to connect the timbers. Although metal fasteners are common today with mass timber structures, they are not consistent with Venus Mills joinery. Without fully disassembling the building, it is hard to determine the joinery configurations.

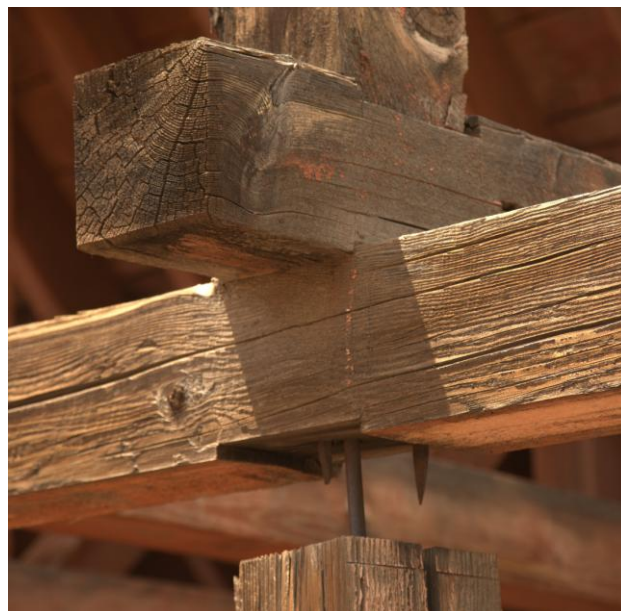
Figure 12. Withdrawn joint from Pioche Mine

This document provided insight into the realm of mine and mill structure design. Although it didn't show conventional timber framing, it still showed the construction of timber ore bins. Further investigation of design manuals revealed that trestle frames in bridges (Ketchum, 1912) and marine wharf structures use similar framing and joinery methods (Moffatt and Nichol, Engineers, 1983; United States, 1964). These manuals include details of the specific types of iron fasteners—drift pins, bolts, spikes, nails, and threaded rods. Additionally, an example of a similar industrial timber structure was found in the desert of Nevada. Pioche Mine, which was built in the same era as Venus Mill and features almost identical joinery. Figure 12 shows a withdrawn joint with protruding iron spikes and likely a drift pin.

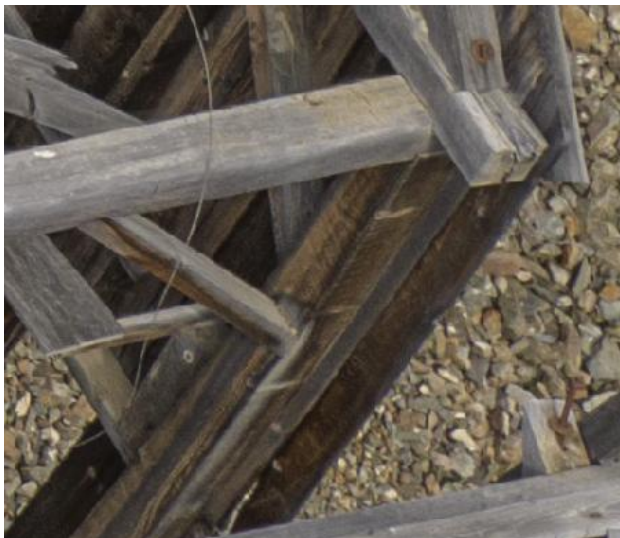
Figure 14. Aerial photography of timber joinery

Sometimes it is easier to identify the iron fasteners with the aerial photography that was taken for photogrammetry and 360 photos produced by the scanner. Aerial photography shows the opposite side of a joint that is not visible from below. For example, inspecting the braces in Figure 13 from below, it's possible to see iron fastener heads set into the braces. When the joints are inspected in Figure 14 from above, no iron joinery can be seen; therefore, the braces are almost certainly fastened with spikes. Conversely, the rafter to tie beam joint shows evidence of a bolt head, nut, and washer, seen from both sides; therefore, this is a bolted connection.
