# From Pixels to Policy: Using Geospatial Technologies to Assess Sand Mining Regulations

**Keywords:** Sand Mining, Remote Sensing, Sentinel 2, Google Earth, EIA

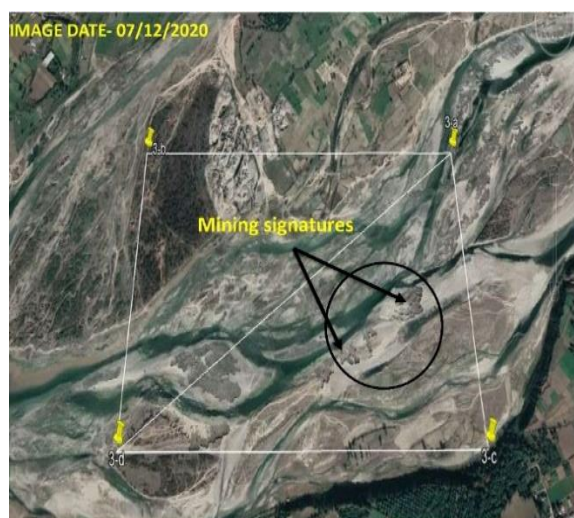
The site was also analyzed using Google Earth Pro, and similar observations were made. Figure 5 shows a Google Earth image from 2020, in which mining signatures are easily visible. Figure 6 shows the pop-up view of the circled area of interest in Figure 5, where mining activities can be seen.

Figure 5. Google Earth image of the site showing mining signatures

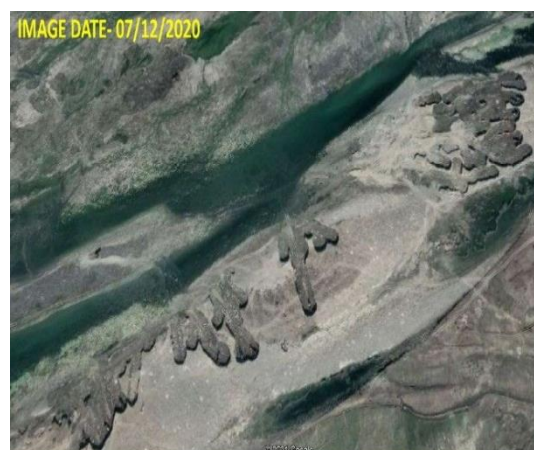
Figure 6. Pop-up view of mining signatures shown in Figure

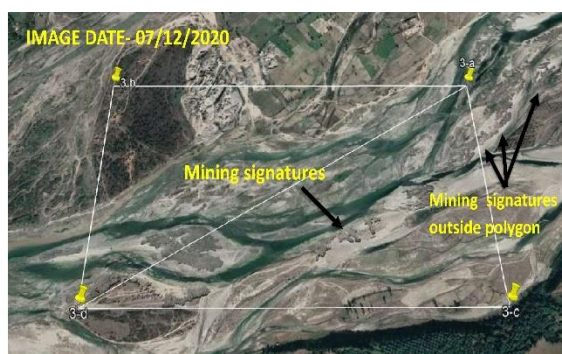
Google Earth images have also been used to identify mining signatures outside the polygon. In Figure 8, Mining signatures outside the polygon are visible in the Google Earth image.

Figure 8. Google Earth Images showing active mining signatures

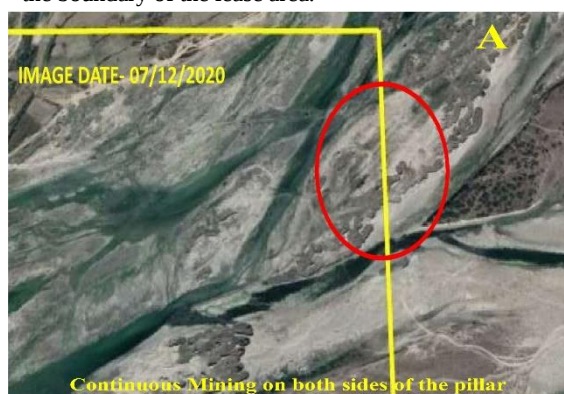
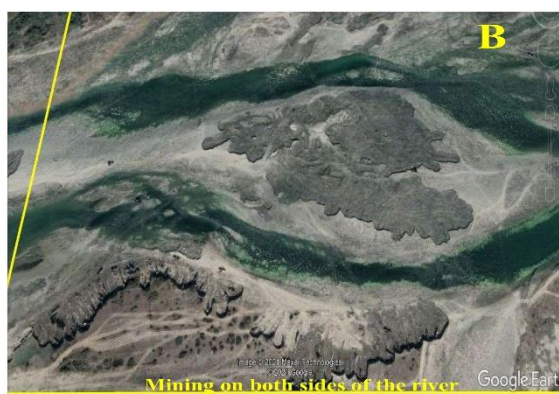
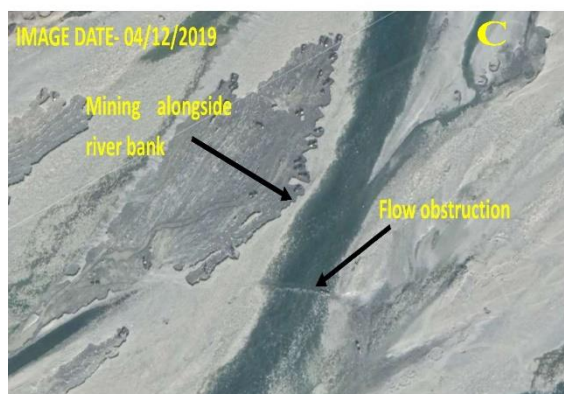
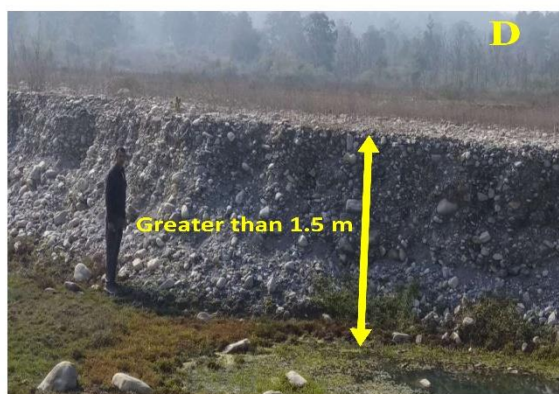
Figure 9. Verification of Mining Operations

- a) As per the guidelines, a buffer of 7.5m should be taken from the lease boundary to minimize the riverbank erosion. To evaluate this condition, the Google Earth tool was used, and it was observed that no such practice is being followed. Continuous mining on both sides of the boundary has been observed and is shown in Figure 9 (inside the red circle). The yellow line in the Figure below indicates the boundary of the lease area.

- b) The next criterion states that mining should not be allowed on the concave side of the river to prevent bank erosion. As per the findings, mining is observed along both sides of the river channel, as shown in Figure 9-b.

- c) Two additional requirements are to maintain the safety and stability of the banks of rivers, i.e., there should not be any type of stream diversion caused by sand mining, and 10% of the river's width or 3 meters, whichever is more, will be left untouched as a no-mining zone. No natural watercourse and/or water resources are obstructed due to mining operations, but as per our observation, no such buffer was taken, and flow was also obstructed, as shown in Figure 9-c.

- d) As per the guidelines, the depth of mining shall be confined up to 1.5 meters below ground level or above the groundwater level, whichever is less. So, there should not be any waterlogging in the area. However, during the field visit, waterlogging and pits greater than 1.5 m were observed at the site, as shown in Figure 9-d. The height of the person standing below the Figure is approximately 6 feet (1.8 m), and the depth of the pit is greater than the person standing. Such violations often expose the groundwater table, leading to permanent waterlogging and the formation of stagnant pools. This not only alters the local hydrology but also creates breeding grounds for insects and poses a safety hazard to the local community and livestock.

| Regulation Parameter | EIA/Mining Plan Requirement | Observed Status (Geospatial & Field) | Remarks |
|---|---|---|---|
| Boundary Buffer | 7.5m untouched zone from the lease boundary. | Violation: Mining occurs on both sides of the boundary. | Figure 9-A. |
| Mining Depth | Maximum 1.5m below ground level. | Violation: Pits observed exceeding 1.8m (6 feet). | Figure 9-D. |
| Riverbank Safety | No mining on the concave side of the river. | Violation: Mining active on both sides of the river channel. | Figure 9-B. |
| Flow Stability | No obstruction or stream diversion allowed. | Violation: Obvious flow obstruction observed. | Figure 9-C. |

Strict legislation is needed to enforce the 7.5m boundary buffer and 1.5m depth limit. Since depth violations (e.g., pits exceeding 1.8m) lead to permanent groundwater exposure and stagnation, automated alerts for waterlogged pits in satellite data can serve as early warning signs of environmental degradation.

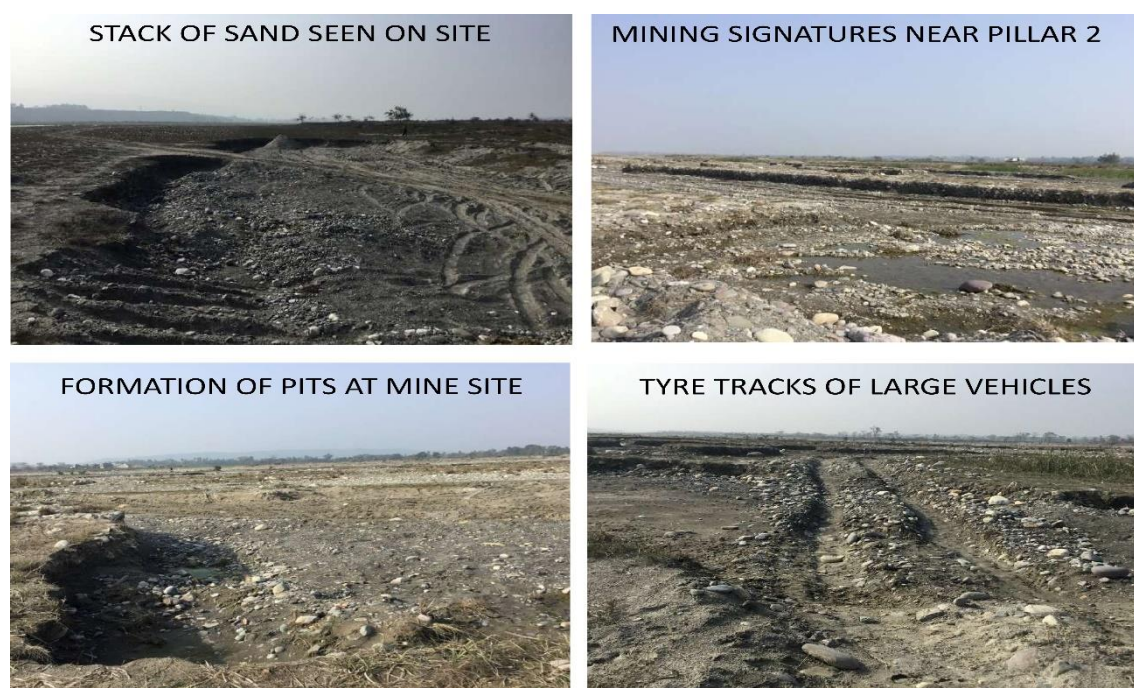
During the field visit, major mining signatures were observed near the site's pillar. Mining signatures were even present beyond the pillars shown during the field visit. Some fresh heavy vehicle tracks were also found between the pillars,

indicating the passage of large-weight vehicles that may have been used to carry minerals. In some places, water pits formed, indicating mining practices on the site (Figure 10). This also validates the results from the remote sensing and GIS images.

Figure 10. General observations during field visit -15-Jan-2022
