MANAGEMENT OF MESH FEATURES IN 3D REALITY-BASED POLYGONAL MODELS TO SUPPORT NON-INVASIVE STRUCTURAL DIAGNOSIS AND EMERGENCY ANALYSIS IN THE CONTEXT OF EARTHQUAKE HERITAGE IN ITALY

KEY WORDS: Reality-based modeling, 3D mesh models, structural survey, LiDAR, earthquake, endangered heritage, Italy.

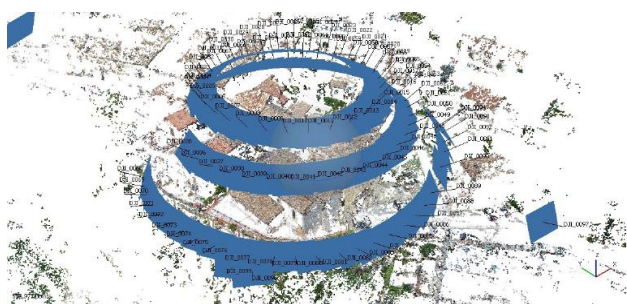
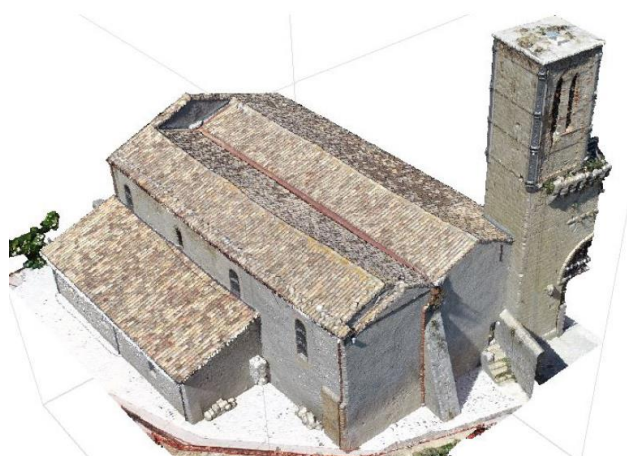
Figure 3. UAV digital survey and SfM point cloud.

Aerial camera acquisition campaign was focused on the church complex and the bell tower. Considering the high elevation of the main walls (9.5 meters for the nave, 19 meters for the bell tower), acquisition campaign from the ground has not provided sufficient photographic sharpness. In this way, two different drones for 3D photogrammetry have been applied for the on-site survey: DJI Phantom 4 Pro, with semi-automated flight options, and DJI Spark, with manual flight and shooting options.

Total photographic shots, limited to 35' from the on-site survey with adequate detail, included 4 flight plans. The first, performed with DJI Phantom 4 Pro for 5' flight, was focused on zenith and radial shots on the complex, framed automatically within the "Point of Interest" mode. The camera mode was ensured by an automatic control tool of the Remote-Control device, and it was set according to a center point and a distance radius gradually calibrated for width and height, to define a spiral shooting trajectory around the building. The second flight plan was performed manually with DJI Spark for 10' manual flight, ensuring the full coverage of the bell tower.

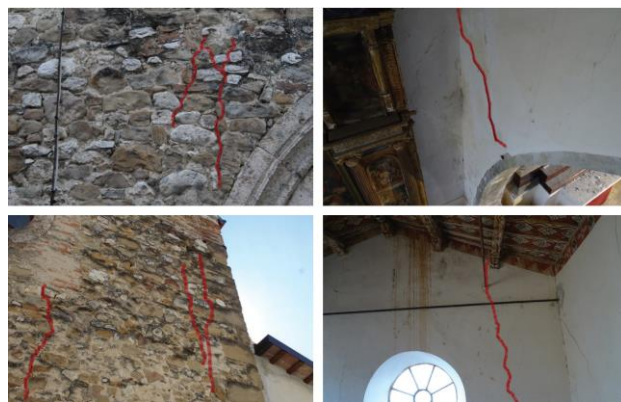
Figure 7. Detailed photographic survey on-site damages.

The photographic campaign for the 2D acquisition was focused on the purpose of reliable mapping cracks and visible damages on the masonry façades. The collected atlas was classified directly during on-site activities: cracks have been classified according to superficial or crossing type, defining a preliminary map to assess the census information within the post-produced digital databases. The acquisition was pursued with a reflex camera CANON EOS 70D as the most expeditious instrument for ground shooting (10"/photo), while a 3D EYE system with telescopic camera APS-C has been applied for integrating the shots elevated heights (3-10 m). In this case, times of acquisition have been extended for the arrangement, framing, and shooting actions of the interested area (30''-1' /photo).
