ARCHITECTURAL SURVEY TECHNIQUES FOR DEGRADATION DIAGNOSTICS. AN APPLICATION FOR THE CULTURAL HERITAGE

1.1 Case study: Chiesa dell'Annunziata of Sessa Aurunca

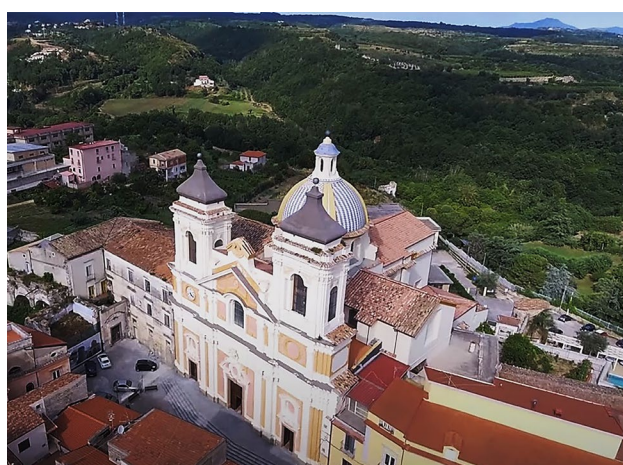
Figure 1. Chiesa dell'Annunziata, UAV photo

The Church in question (Figure 1) stands out in the landscape for its dome made in the 18th century and covered with blue, white and yellow majolica tiles that stand out on the roof of terracotta elements. The enamelled scales in various colours are arranged to decorate the dome with an alternation of parallel lines in alternating colours. The basic element of the majolica covering is a flat brick characterized by a rounded lower profile that better allows it to be placed side by side and favours its adaptation to curved surfaces. The anchorage of the scales to the substrate occurs by means of a hole in the upper part and the glazing involves only the outer face and the side edges that will remain visible.

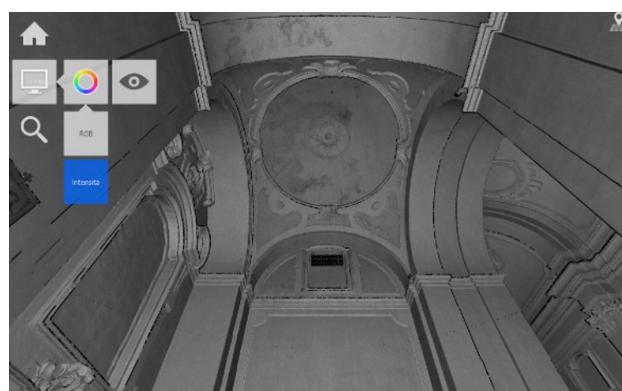
Figure 2. Intensity visualization mode in ReCap Pro

The Leica BLK360 was used only for the interior of the Church: the acquisition phase included 22 scanning stations made in a single working day. An accuracy of 4 mm at 10 m was set during acquisition. The data acquired in this way are initially recorded in the scanner and only later, transferred via Wi-Fi to a computer or tablet to be managed with Autodesk ReCap Pro. Point cloud alignment occurs automatically when the data has the correct overlap. Otherwise, manual registration (identifying at least three homologous points) is required. The ICP (Iterative Closet Point) registration, based on the minimization of the cloud-to-cloud distance (Sharp et al., 2002; Pomerleau et al., 2015) ensured the generation of a cloud of about 145.000.000 points. Among the various visualization modes proposed by the software, we highlights *intensity*, which measures the point reflectivity based on surface texture, surface angle, and the environment. This visualization mode has allowed in the case study (setting the visualization in grayscale) to localize the presence of dump stains of greater intensity with respect to the surrounding, allowing a first localization of the problem (Figure 2). The acquisitions, later on, proved to be indispensable also as a support for the alignment between the various surveys carried out in subsequent phases and through the implementation of different tools. The coordinates relative to the points cloud, in fact, have been used as a reference for the markers in the photogrammetric field, ensuring the generation of a model in real shape and size and allowing an alignment of the dense clouds with that obtained by laser scanner.

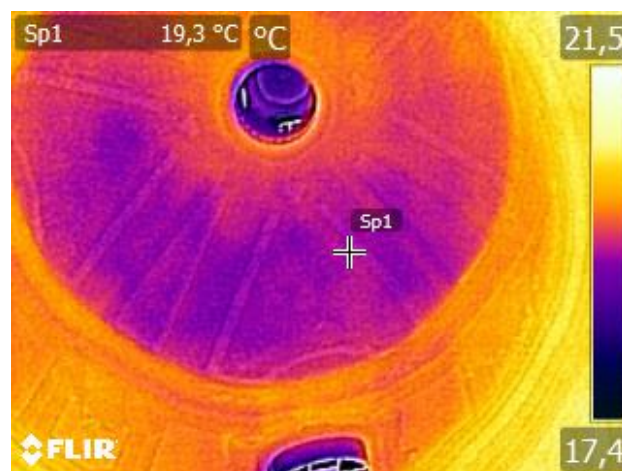
Figure 3. Thermal images visualization in FLIR Tools

The software with which the images were analysed is FLIR Tools. The application allows to modify the thermal images a posteriori by selecting, among the various palettes available, the mode that guarantees a better visibility of the infiltration phenomenon (Figure 3). The main difficulties during this survey were recorded both for the disproved weather forecasts, which led to investigations during the presence of light rainfall, and for the high altitude of the intrados of the domes, not being the instrumentation mounted on drone or photographic pole.

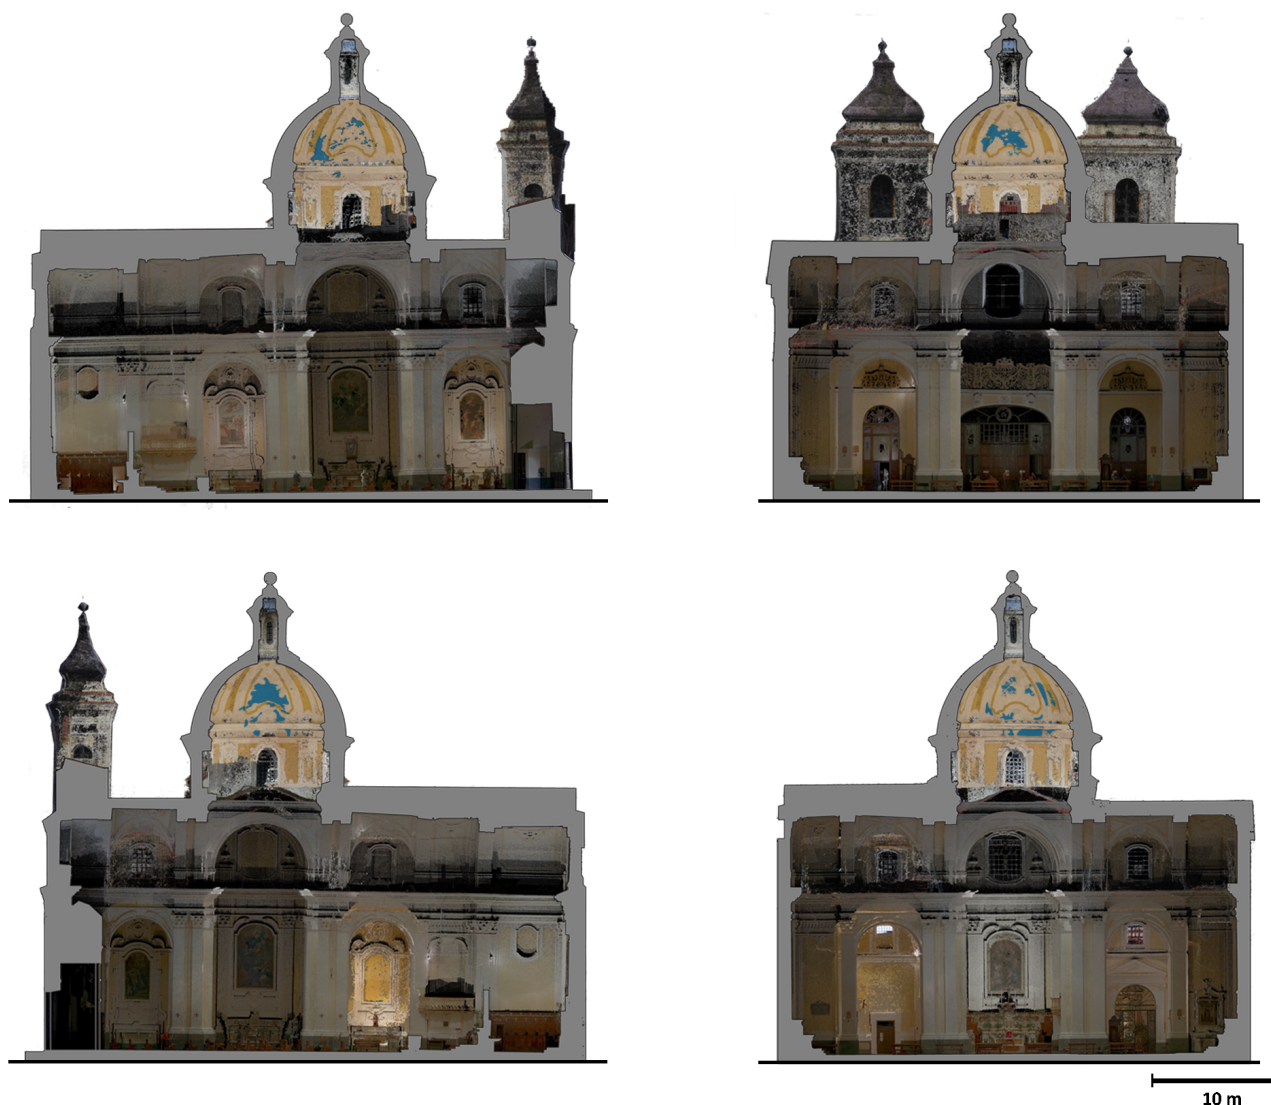
Figure 4. Sections of the Church with some moisture stains of the dome highlighted in blue: South longitudinal section, West cross section, North longitudinal section and East cross section

In order to ensure proper union, it was possible to improve the registration through the ICP algorithm (Iterative Closest Point). The model (internal and external) thus generated has been used for the realization of graphic designs (Figure 4).

The point cloud obtained from the laser scanning survey prove to be supportive for a quick inspection of the entire building as well as a metric reference base. Subsequent internal photogrammetric investigations allowed for the detection of visible stains, understood as localized chromatic variation of the surface, related to the presence of foreign materials such as water and possible organic substances and microorganisms, visible in the form of patinas. In limited areas, moreover, some detachments of the plaster can be seen that allow a glimpse of chromatic gaps.

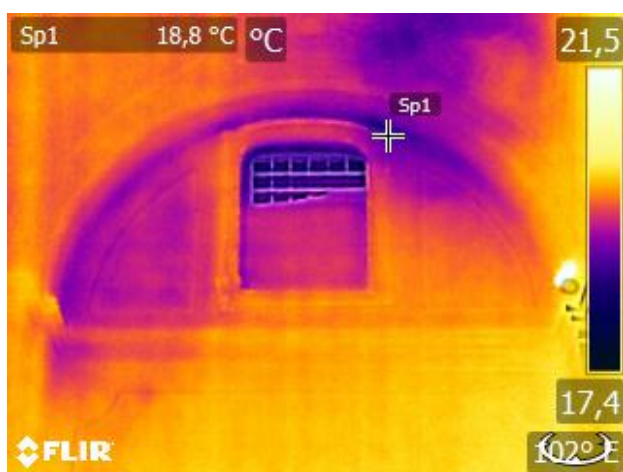
Figure 5. Moisture along the arch of the perimeter wall

The thermal image, finally, shows an evident irregular temperature map with a humidity level of greater extension than that visible on the surface by photogrammetric survey. Moisture in the walls reduces the resistance to heat transmission, depending on the amount of water retained, resulting in lower temperatures.

Moisture at the intrados of the roofs, in fact, is characterized, within the images, by a blue/violet coloration and in the case study is localized mainly in the central part of the domes and, for the dome on spandrels, along the arch of the perimeter wall (Figure 5). The flight with the drone DJI Matrice 210 has allowed visual investigations of the roof, which have proved to be decisive for the identification of degradation. Humidity at the intrados of the roof, in fact, seems to come from infiltration of meteoric origin, caused by an inadequate retention system and/or an inefficient system of rainwater disposal, favouring the penetration in different degrees in the masonry. Among the most evident forms of instability, a widespread discontinuity of the majolica tiles on the central dome of the Church stands out. From the pictures taken, in fact, it is possible to notice, in some portions of the dome, the absence of connection between the various elements that leave uncovered the various anchoring holes. In some points of the majolica covering, moreover, the instability is highlighted even more by the interruption of the wise chromatic alternation that distinguishes these types of dome, object of artistic and cultural value.

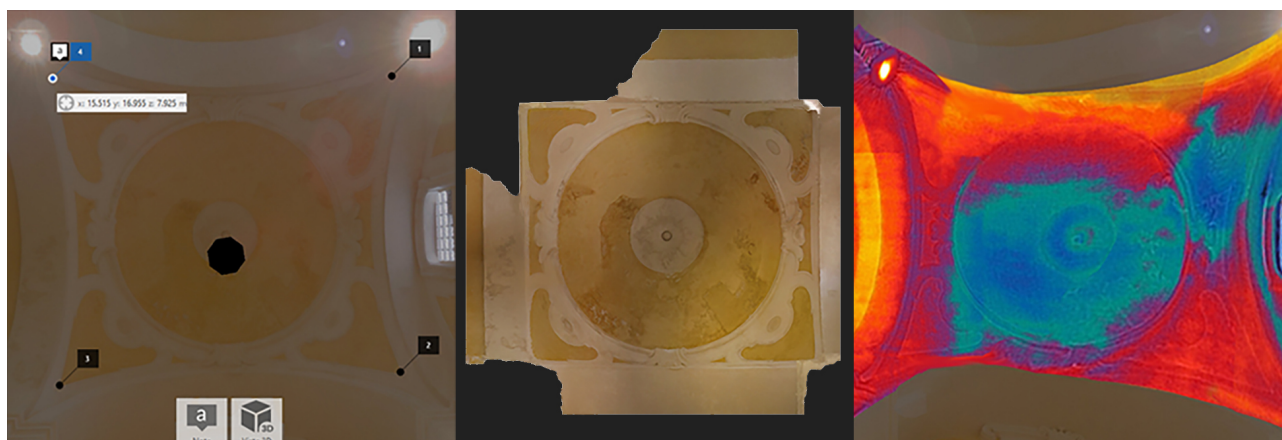
Figure 6. Dome acquisition using range-based, image-based, and IR thermography techniques
