STUDY ON DETERIORATION OF HISTORIC MASONRY IN THE FORBIDDEN CITY IN BEIJING AIDED BY GIS

KEY WORDS: ArcGIS, Forbidden City, Historic Masonry, Deterioration.

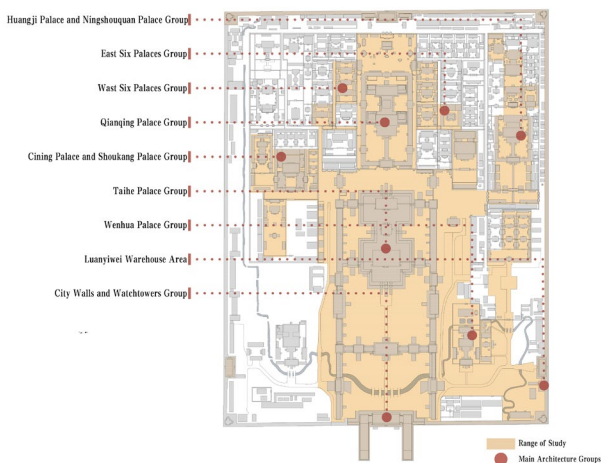
Figure 3. Main architecture groups, divided to better conduct the field survey.

The range of this research was the whole accessible area of Forbidden City, including all open tourist areas and some of the office areas. The city walls surrounding the Forbidden City were excluded, for 1) the city walls can be considered as a relatively independent monument rather than common masonry, and 2) there had already been detailed studies on the city walls. The bricks as floor tiles were also excluded because of its mass and the difficulty of completing the survey in several weeks. Since the research area was large, the whole Forbidden City was divided into several architecture groups, and the research was conducted group by group. The main architecture groups are: Huangji Palace and Ningshouquan Palace group, East Six Palace group, West Six Palace group, Qianqing Palace group, Cining Palace and Shoukang Palace group, Taihe Palace group, Wenhua Palace group, Luanyiwei warehouse area, city walls and watchtowers group (Figure 3). Though there were many inaccessible areas due to various reasons in Spring 2019, efforts were made to guarantee that the survey would cover as much open areas of the Forbidden City as possible.

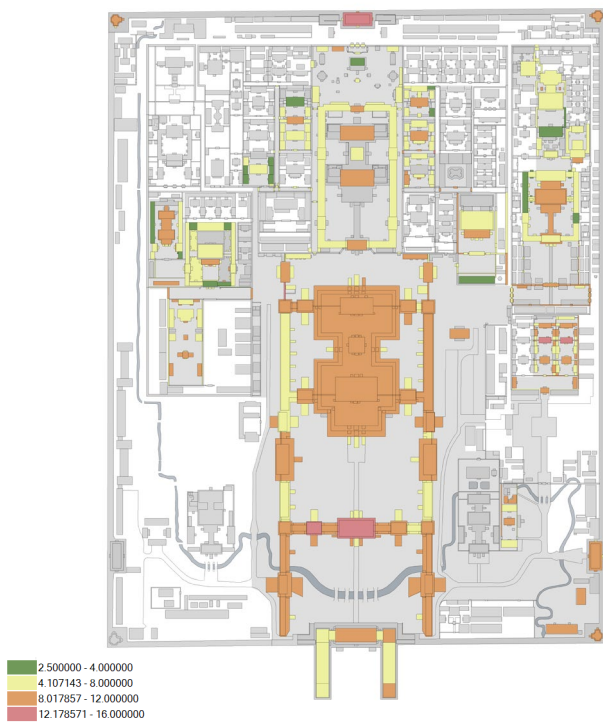
First, the comprehensive deterioration condition of brick and stone were analyzed. Every deterioration in the east, south, west, north, and ground of each architectural element was recorded and rated. Through the data, the comprehensive deterioration in each direction of each element was evaluated. To illustrate the overall deterioration condition of both brick and stone, the average deterioration condition and the most serious deterioration condition of each direction was both taken into consideration (Figure 6). Further obtained was the overall deterioration condition of masonry through the "mean + maximum" data processing method. That is, to calculate the mean value of all directions and then plus the biggest number of all directions, so that the overall deterioration condition could be reflected (Figure 7).

Figure 7. The overall deterioration condition of masonry.

The overall deterioration illustrations showed that the distribution of masonry deteriorations in large-scale building location may have certain patterns. The collation of these patterns would help to further analyze the influence of building location and deterioration distribution. The focus of location analysis was the basic trend of distribution, and conjectures about the causes of this trend were raised.

Jinshui River may be one of the factors affecting the distribution of deteriorations. Within the range of investigation, the deterioration gradings of buildings around Jinshui River were generally 3 or higher. The influence of Jinshui River on the buildings may lie in the evaporation of water and the infiltration of groundwater. However, the buildings near Jinshui River were influenced by high foundations or courtyard walls, which will interfere with the judgment of the results.

Considering the Forbidden City as a whole, the deterioration of the buildings near the central axis was higher, and the deterioration degree of the buildings on both sides of the main

axis was lower. There was a trend that the deterioration degree of the southern building complex is higher than that of the north.

Within a single architecture group, the deteriorations of main buildings were relatively high, while the deteriorations of affiliated buildings such as the side halls and verandas were relatively low. The overall deterioration of the main axis of the building was more serious, which may be related to the sequence of renovation. In architecture groups, the side halls were generally used for office, commercial and other functions, and the repair of these buildings might be more frequent than the main buildings.
