## USE OF GEOGRAPHICAL INFORMATION SYSTEM APPROACHES FOR THE DIAGNOSIS OF SAN ISIDORO RUINS (MADRID, SPAIN)

This article shows the application of different geoinformatic approaches for the diagnosis of a small hermitage located at the Spanish capital of Madrid. More specifically Structure from Motion photogrammetry for the 3D digitalization and orthophoto generation, and Geographical Information System (GIS) for uploading and management of the information were used. Both strategies were carried out using open-source software. In the case of the GIS approach the QGIS platform was chosen and some additional features were programmed to facilitate the diagnosis such as the creation of standardized HTML files to improve the interoperability. The pre-diagnosis phase was carried out by means of the Qfield android application that allows capturing the data on field. Additionally, several previous tests, i.e. X-ray diffraction, microscopy and physical tests were carried out with the aim of understanding the severe degradation process that this Hermitage is suffering. This multidisciplinary approach allows us to understand the current status and degradation mechanisms of the Hermitage on wh

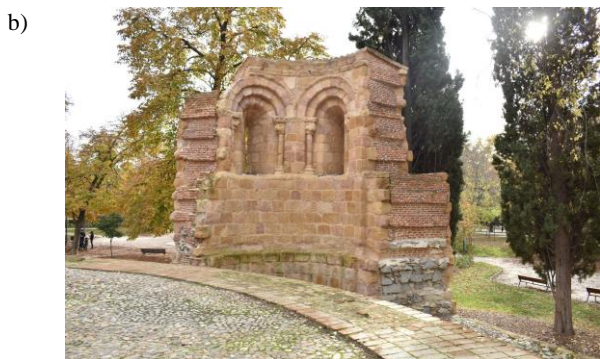
**Figure 4.** The unique remains of the ruins established in Madrid: a) front façade and; b) apse.

In the 19th century, only the head, part of the roof and the walls with the south portal remain. Then, an antique collector, Emilio Rotondo y Nicolau, bought the remains of the Hermitage and disassembled them to take them to Madrid. Later, the State bought the remains and in 1894 it was planned to rebuild the hermitage in the gardens of the Archaeological Museum. Finally, two years later, it was located in its current location, the Retiro park (Teijeira Pablos, 2015) (Figure 3 and Figure 4).

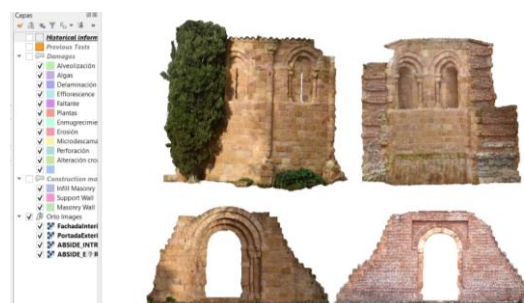
**Figure 6.** Orthoimages introduced within the QGIS project.

Figure 5 shows the result obtained during the blunder adjustment phase and the dense matching. Finally, a total of four orthoimages were obtained with an average GSD of 2mm. These orthoimages were introduced into the QGIS project, serving as a base for the pre-diagnosis and the diagnosis phase (Figure 6).

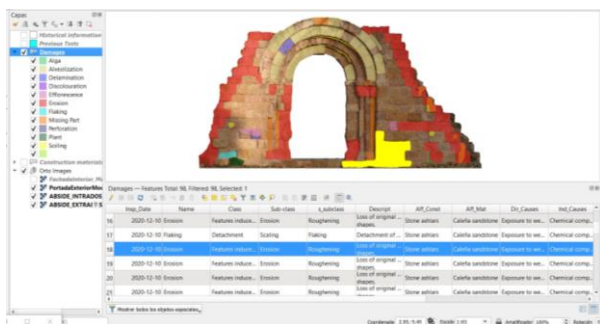
Figure 9. Damage mapping captured by using the Qfield application and managed in the QGIS desktop software.

During this phase it was possible to map the construction materials, construction systems as well as the different damages. All the data was complemented by several images captured by the mobile device. Once the in-field work was finished the data was imported to the desktop application by using the Qfield Sync plugin (Figure 9).

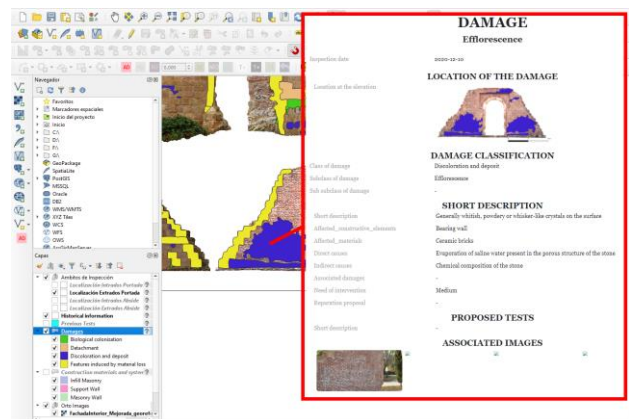
Figure 11. Access to the HTML file created for the efflorescences at the intrados of the façade.

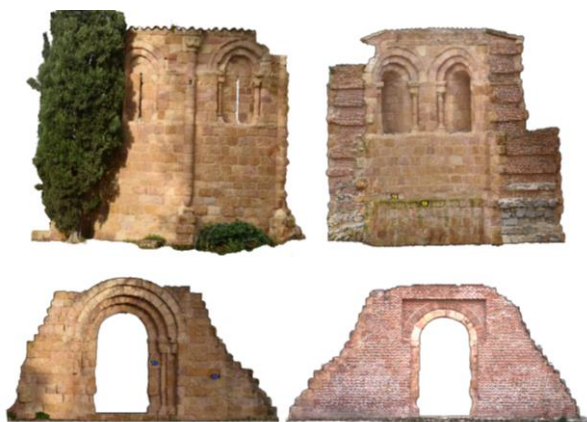
Samples *SI-1* and *SI-2* are evidence of the progression of stone deterioration. Both have been extracted from the apse, in the shady area, and have been compared with samples similar on the main façade (*SI-4* and *SI-6*) (Figure 15). In both cases, a loss of clay matrix material has been observed, this being more pronounced in the white stone. This conclusion is in agreement with the data extracted by using the GIS intersections during the pre-diagnosis phase (Figure 12).

**Figure 15.** Location of the samples. In yellow the samples *SI-1* and *SI-2* and in blue the Samples *SI-4* and *SI-6*.

Additionally, the results obtained during the physical tests reveal a stone with an extremely high-value of absorption coefficient (24%) and water-accessible porosity (36,3%), suggesting that there is a loss of clays and opal due to disintegration, which is completely breaking down the cohesive structure of the stone.

The most pronounced deterioration is found in the lack of cohesion and loss of the granulometric matrix of the granite materials, aggravated by the atmospheric conditions and pollution of the city as well as the humidity of the environment. That is the reason why a proposal is made mainly to focus on the consolidation and strengthening of its granulometric structure.
